2007 UPPER JOSEPH CREEK RESTORATION PROJECT
BPA Contract #33368
BPA Project #1992-026-01

Completion Report
February 2008

Abstract

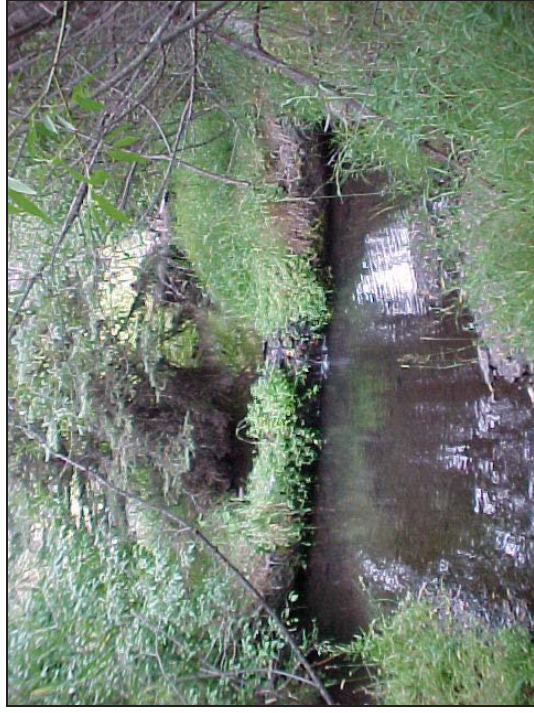
Elk structure #61, gabion weir, pre-2003 modification by hand

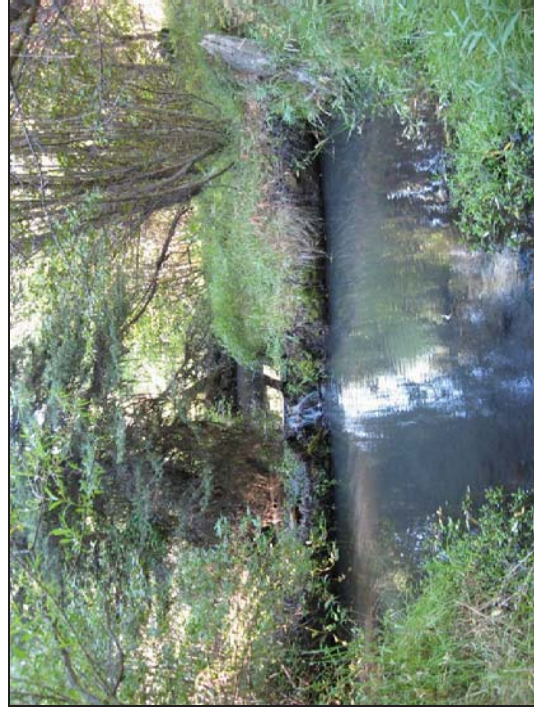
Elk structure #61, pre-modification by machine; Aug 2007

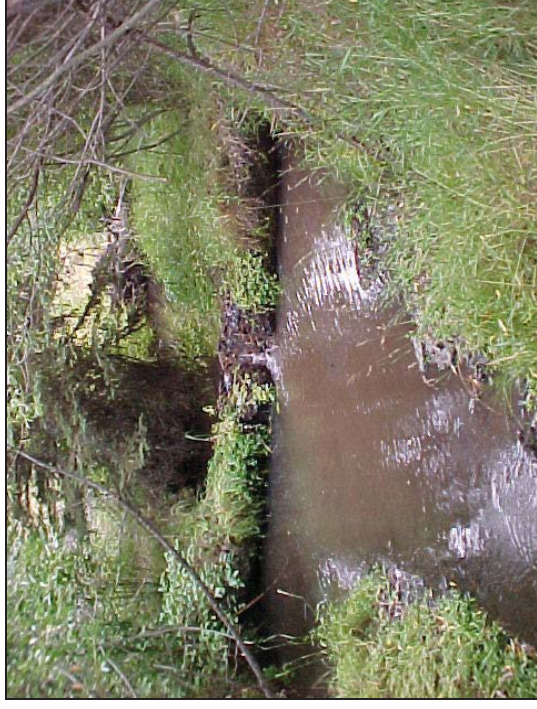
Elk structure #61, post-2003 modification by hand

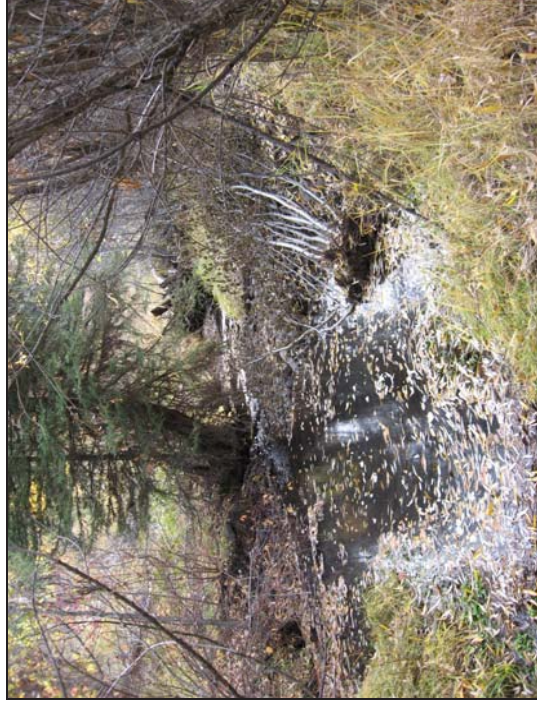
Elk structure #61, post-modification by machine; Oct 2007

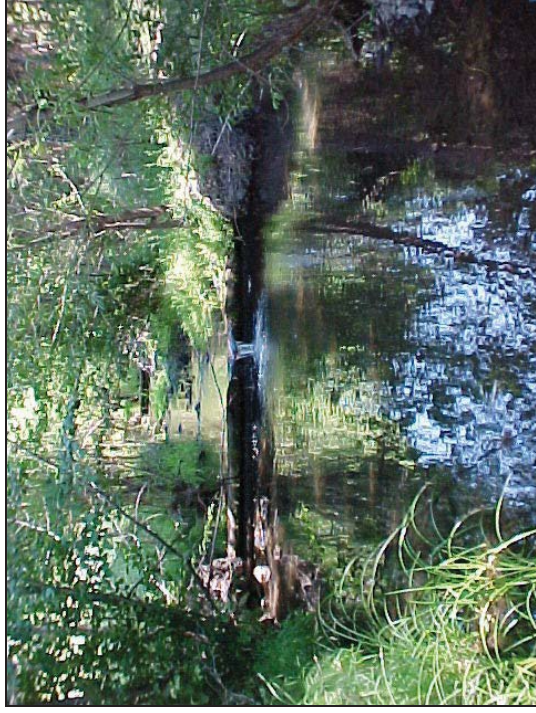
Elk structure #85, log weir pre-hand modification; Jul 2003

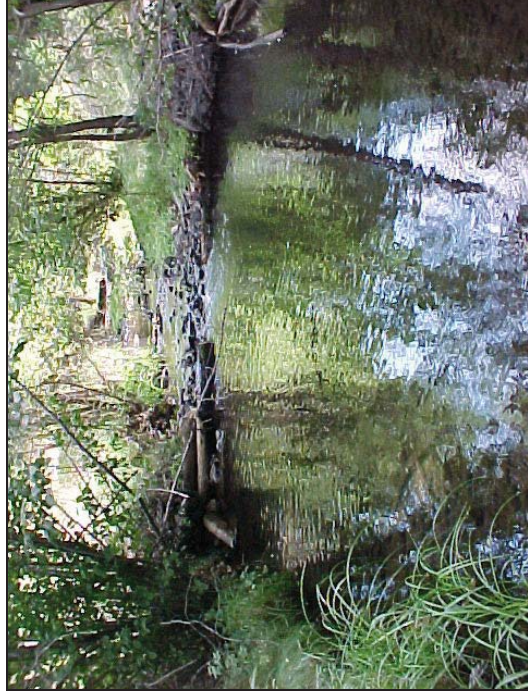
Elk structure #85, post-hand modification; Jul 2003

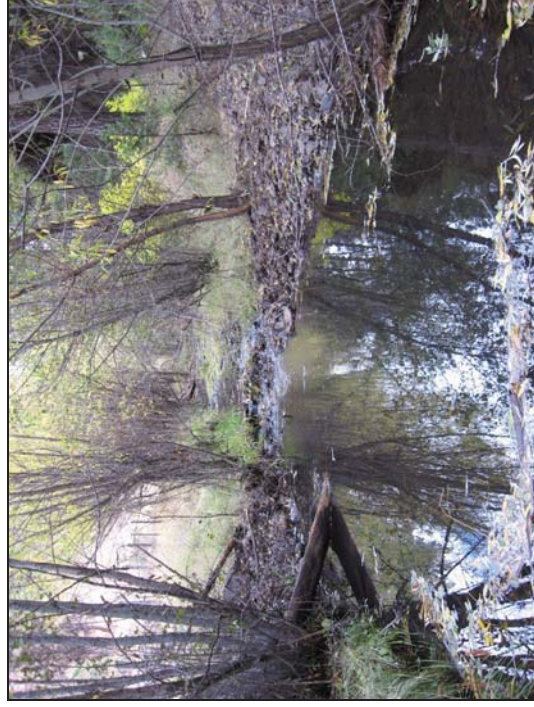
Elk structure #85, post-modification by machine; Oct 2007

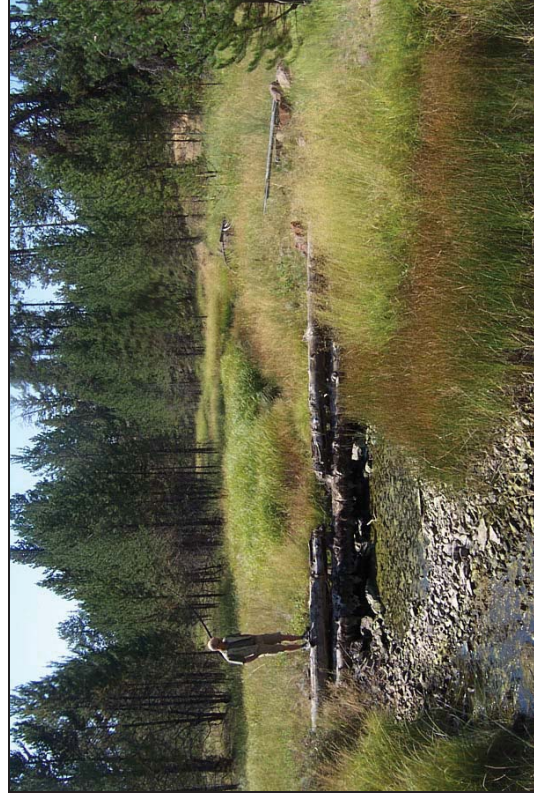
Ches seg F str #52, log weir pre-modification; Aug 2006

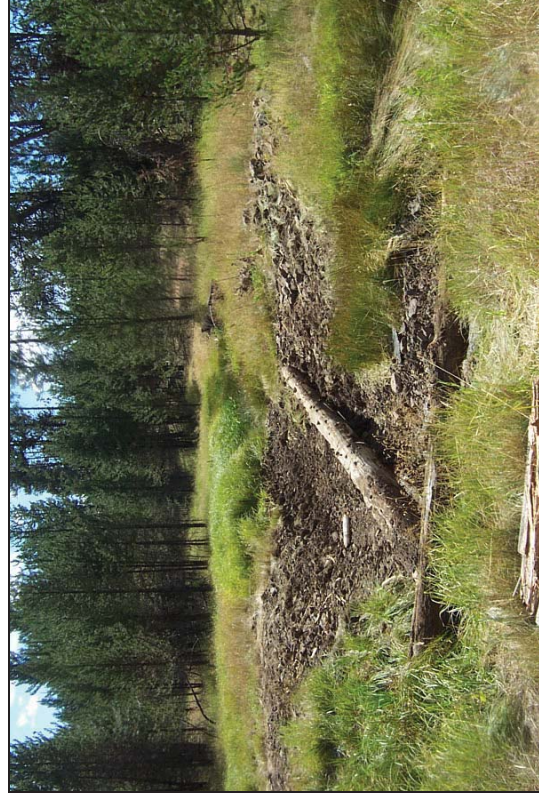
Ches seg F str #52, log weir post-modification; Aug 2007

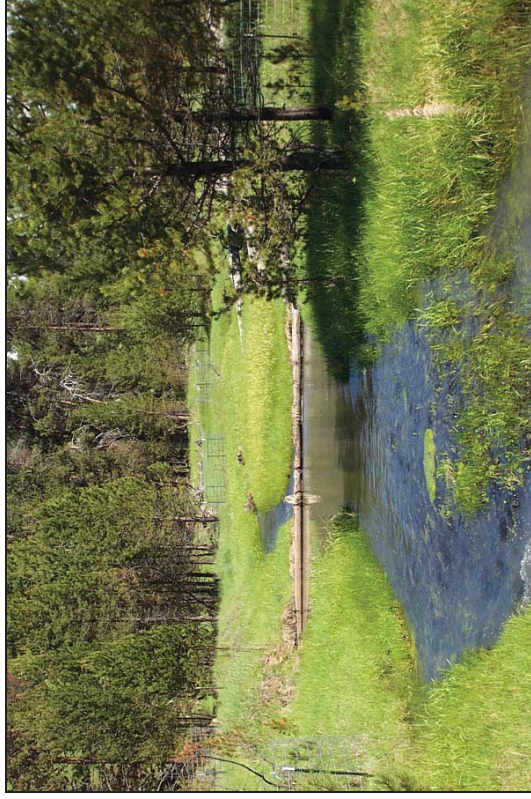
Ches seg F str #46, log weir pre-modification; Jun 2007

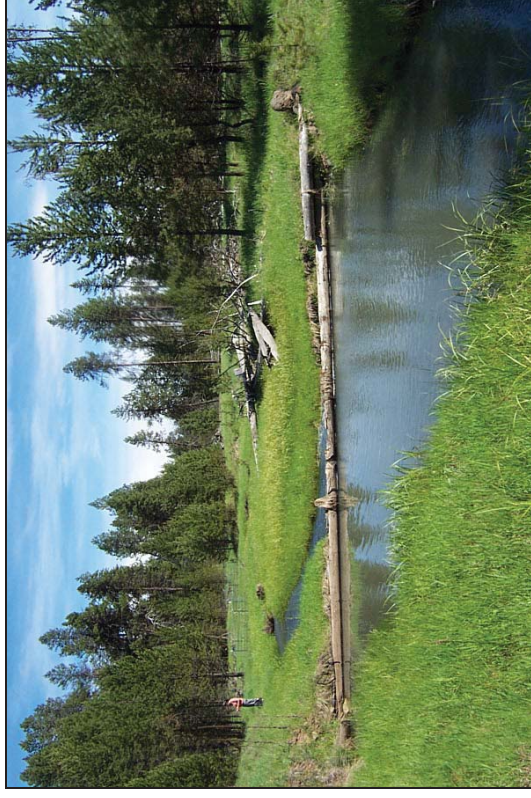
Ches seg F str #46, close-up view showing downstream scour

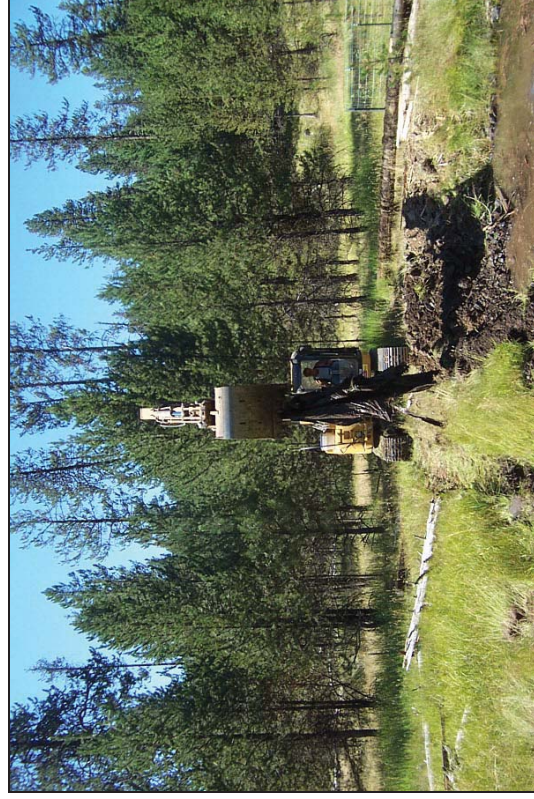
Ches seg F str #46, geo-textile removal during modification

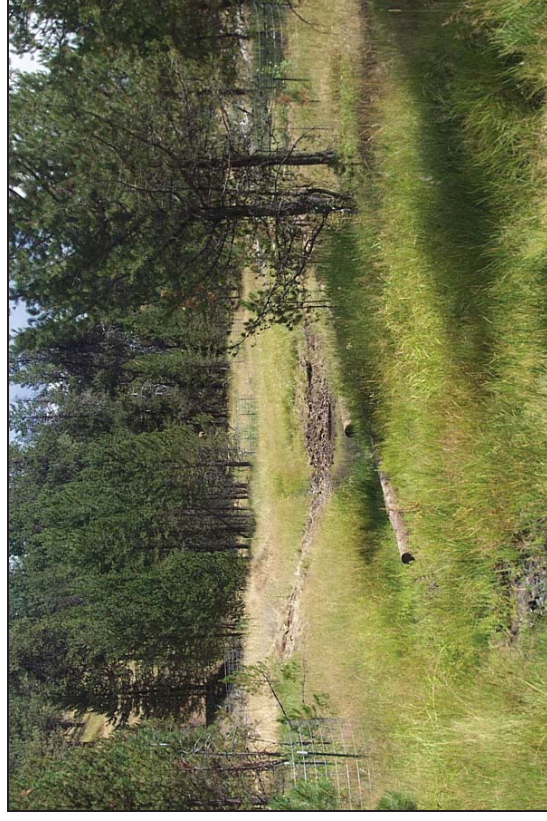
Ches seg F str #46, post-modification; Aug 2007

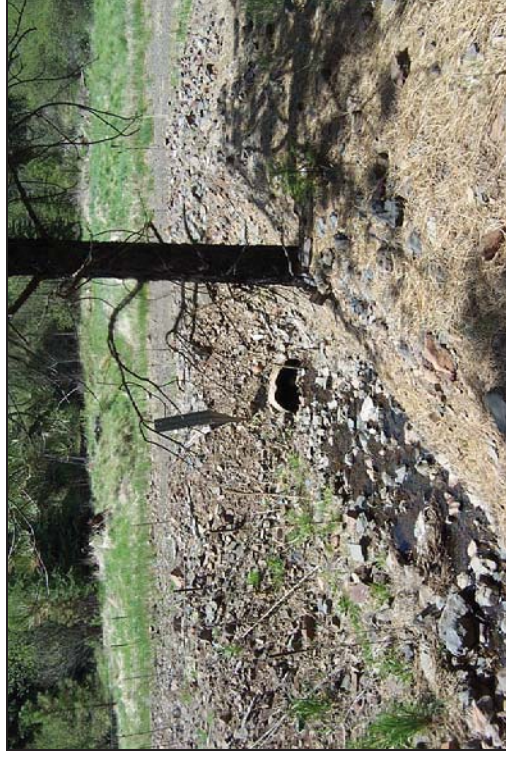
French Gulch culvert before decommissioning; May 2006

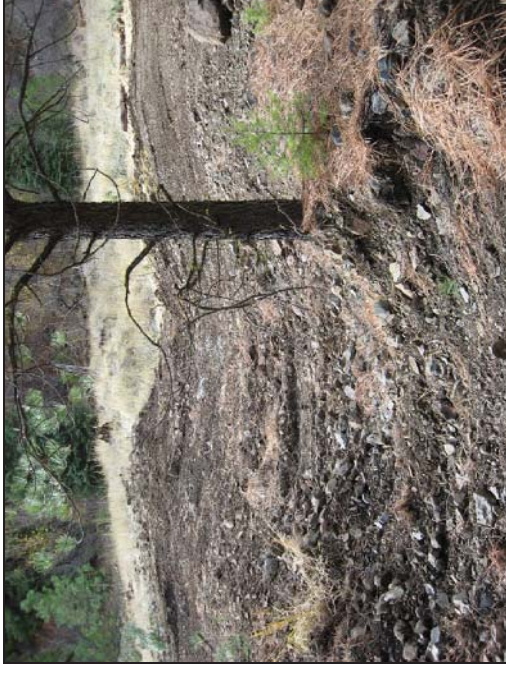
French Gulch after removal, but before rocking; Oct 2007

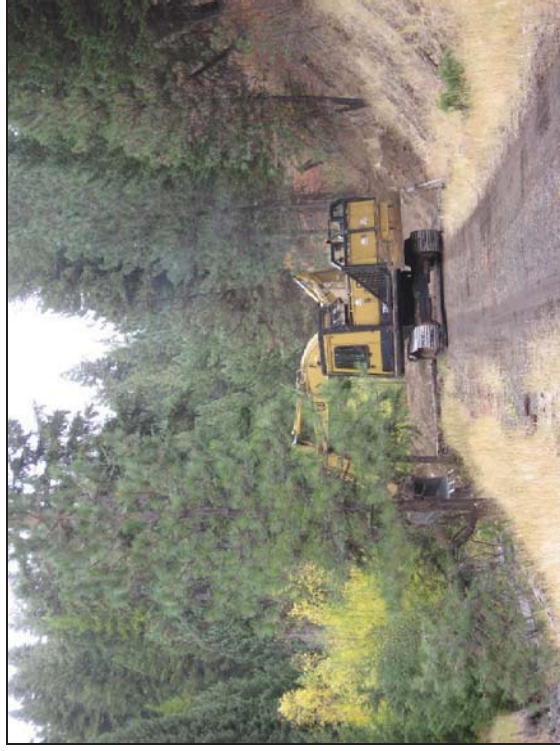
Peavine Trail narrowing in progress; Oct 2007

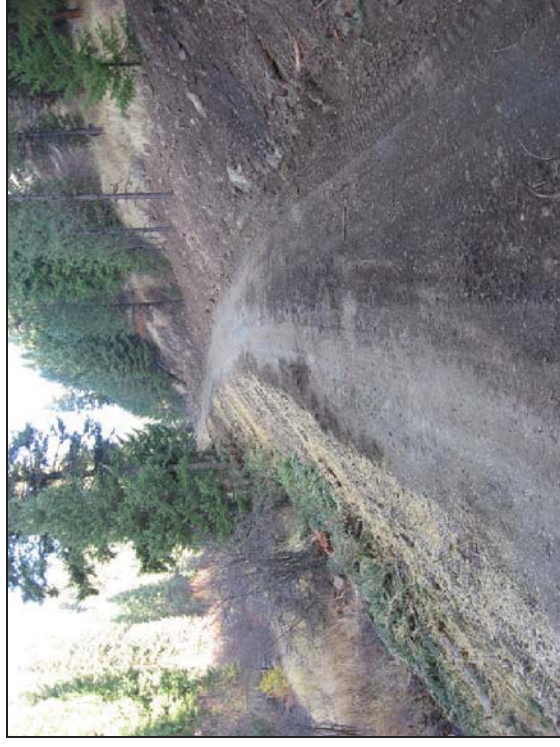
Peavine Trail narrowed with windrows (L) and filled inside ditch (R)
