UPPER JOSEPH CREEK RESTORATION PROJECT

BPA Contract #00022523

BPA Project #1992-026-01

Completion Report September 2006

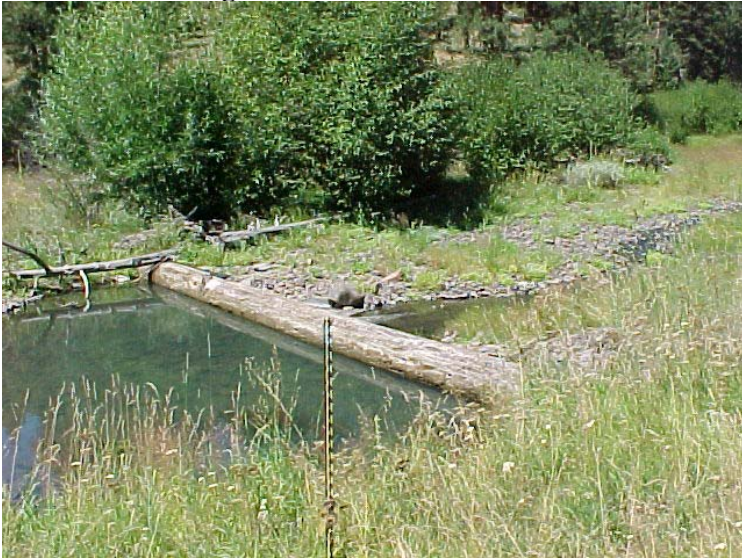
Instream Structure Modification Thirty-nine instream structures were modified along 2.5 miles of Chesnimnus Creek in July 2005. Nine log boles were left in place when they did not promote bank-edge scour downstream, were in an abandoned channel, were not a juvenile fish passage barrier, or had shifted or blown out since installation. Seven boles were removed and reburied in the bank at an upstream angle. Eight boles were removed and placed on the bank angling down into the stream at an upstream or downstream angle. Fifteen boles were removed and reburied in the bank or placed on the bank and had a tree or 2 placed on top of them to create a foundation for miniature log jam development.

Every structure modification involved removing the gabion baskets (with the exception of a basket or two that were hard to get and were completely covered with vegetation) and as much geo-textile material and wire mesh that could be recovered. Some geo-textile was left buried in a few banks when the removal of the material was deemed secondary to preserving the integrity of the bank. Much of the wire mesh was rusty and broke apart easily, thus making it difficult to remove. High turbidity at each site during modification prevented visual identification of lost pieces of wire or fabric. Because of this, some geo-textile material and wire mesh pieces were undoubtedly missed at each site and will be left there to decompose or rust.

PP#1: Chesnimnus segment A, structure #8, pre-work; 2005.

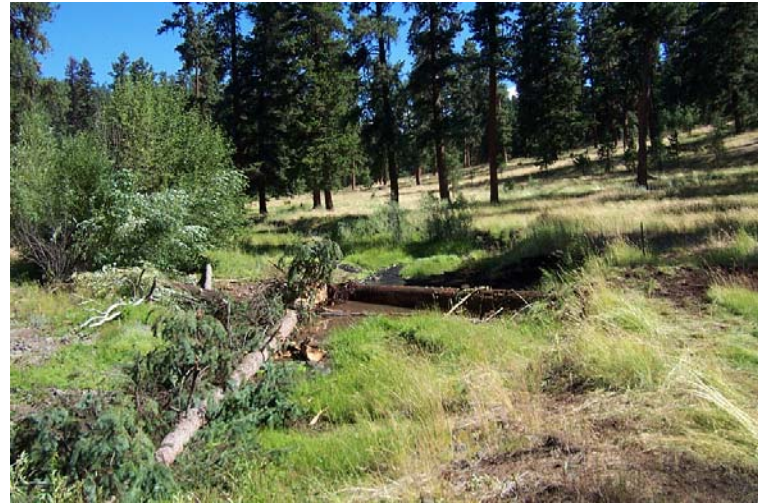
PP#1: Chesnimnus segment A, structure #8, post-work; 2005.

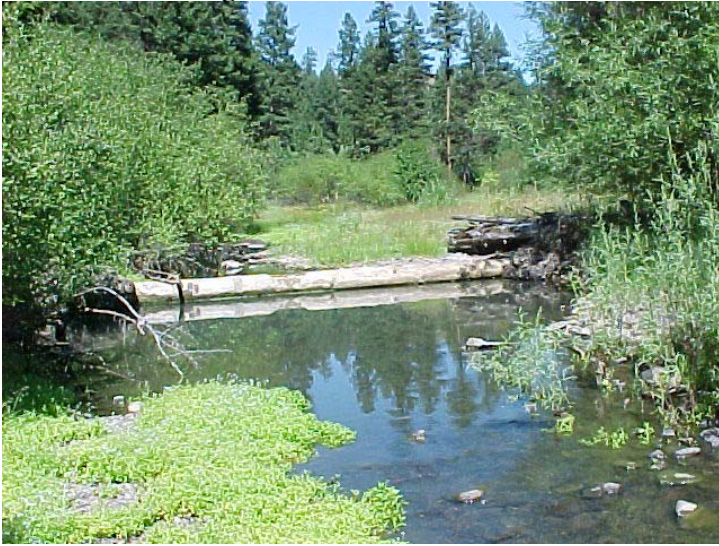
PP#2: Chesnimnus, segment B, structure #8 pre-work, 2005.

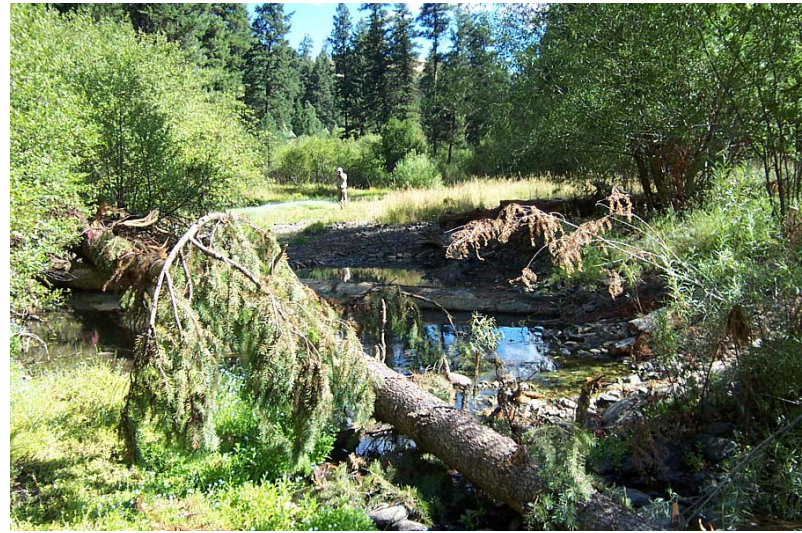
PP#2: Chesnimnus, segment B, structure #8 post-work, 2005.

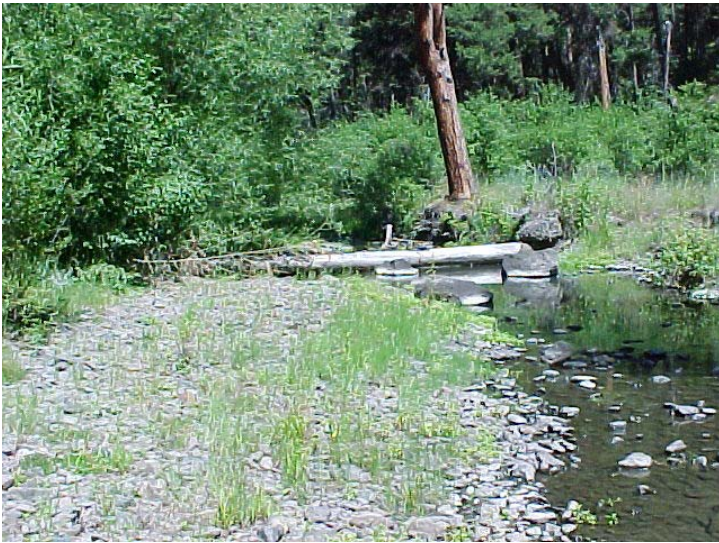
PP#3: Chesnimnus, segment B, structure #6 pre-work, 2005.

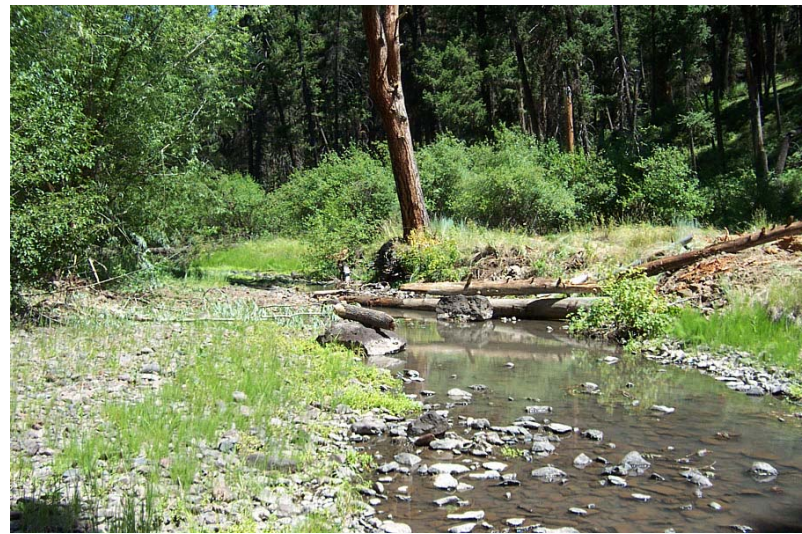
PP#3: Chesnimnus, segment B, structure #6 post-work, 2005.

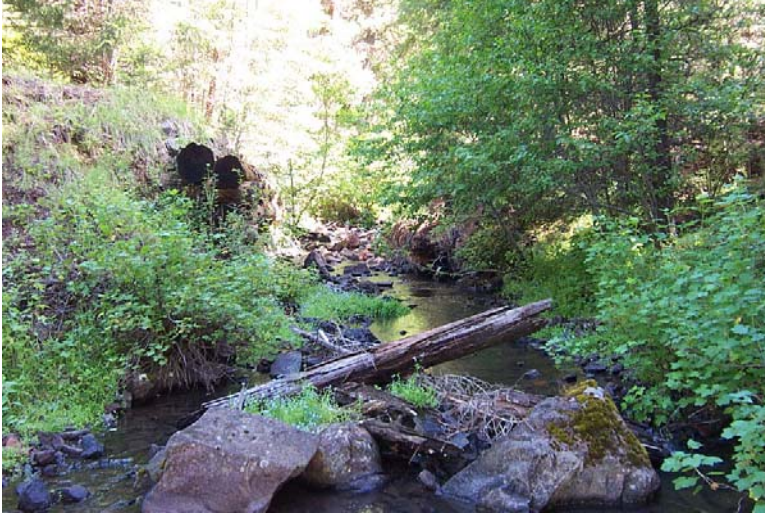
The 4625-550 rd had a bridge that spanned Devils Run Creek. The bridge platform had been decommissioned, but the wood abutments were left in place and were rotting and crumbling into Devils Run. The sediment backfilled behind these abutments had started to slough into the creek. A moderately high flow event had the potential to release a very large plug of sediment into, potentially even damming, this stream which provides spawning and rearing habitat for threatened Steelhead.

PP#1: Devils Run, pre-work view upstream; 2005.

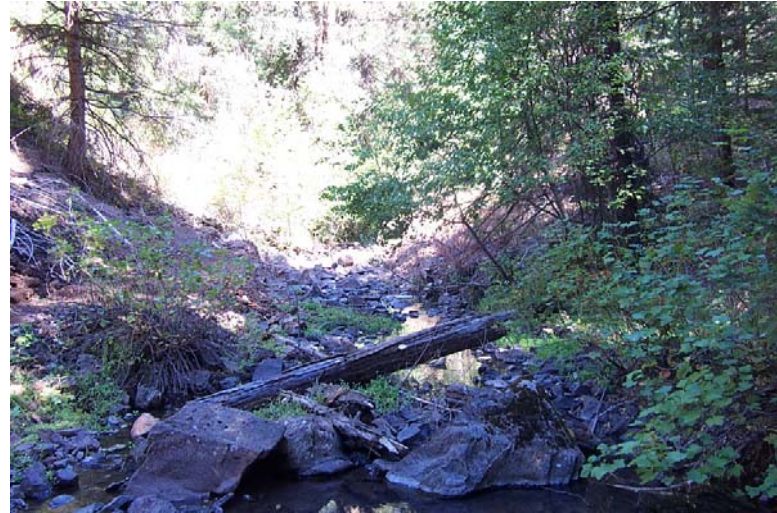
PP#1: Devils Run, post-work view upstream; 2005.

Bridge Abutment Removal Road fill was pulled back from behind both bridge abutments to match the contour of the canyon on both sides of Devils Run at that point. A small floodplain was created on both sides of Devils Run Creek as well. Fill was piled on old roadbeds on both sides of Devils Run and contoured to match local topography. The rotting abutment logs were removed and strewn about adjacent hill slopes and floodplain. Protruding metal spikes in some logs were cut flush with the log and the metal trash removed from the site. The bottom-most log on either side of the creek was left to help protect the new banks from scour. Disturbed ground was seeded following deconstruction.

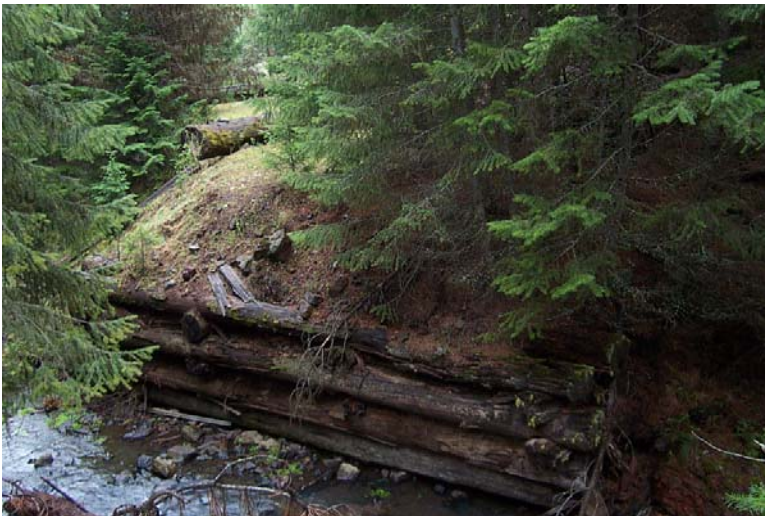
PP#2: Devils Run right abutment, pre-work; 2005.

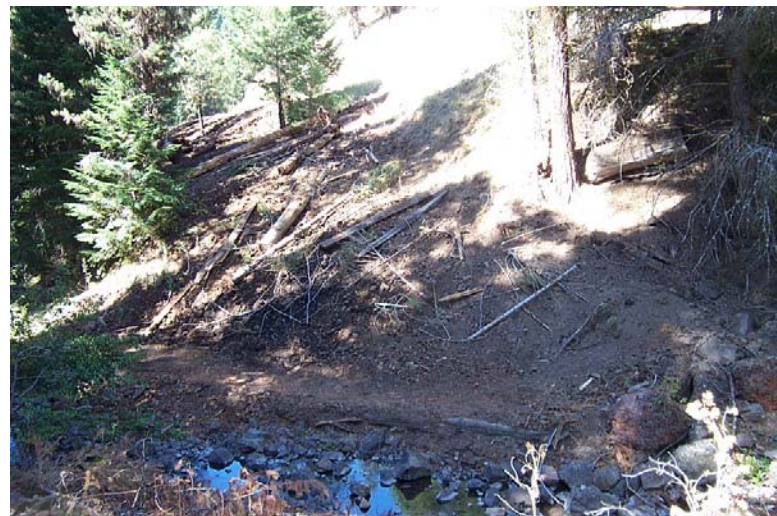
PP#2: Devils Run right abutment, post-work; 2005.

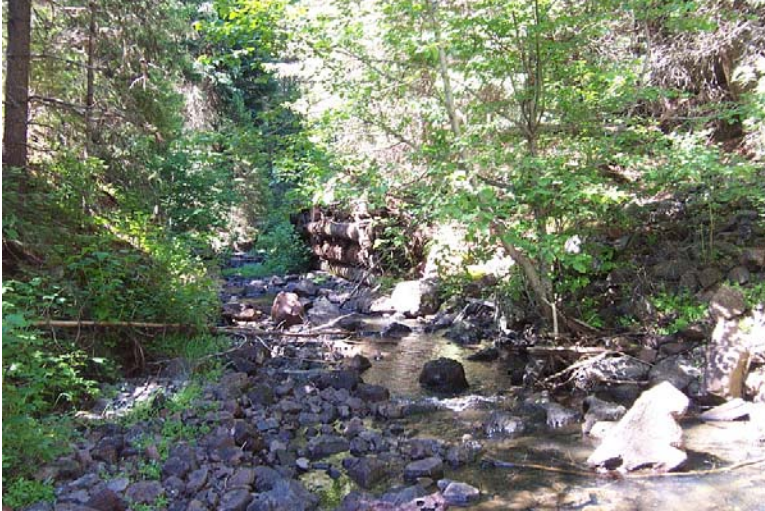
PP#3: Devils Run, pre-work view downstream at R bank; 2005.

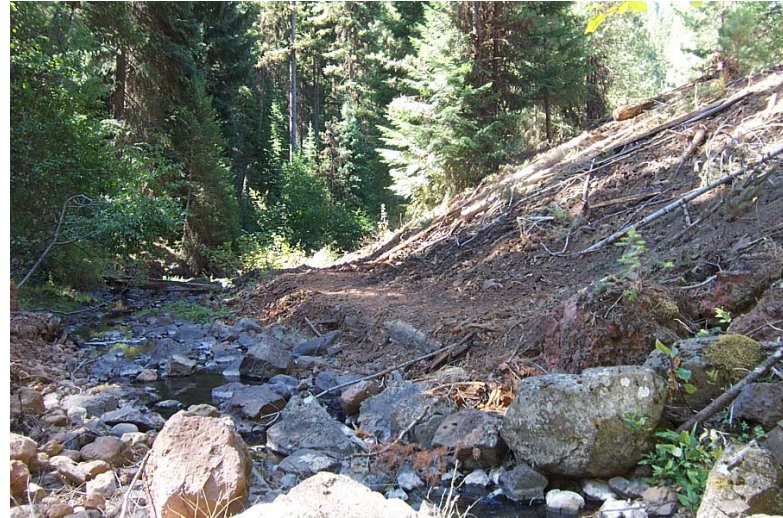
PP#3: Devils Run, post-work view downstream at R bank; 2005.

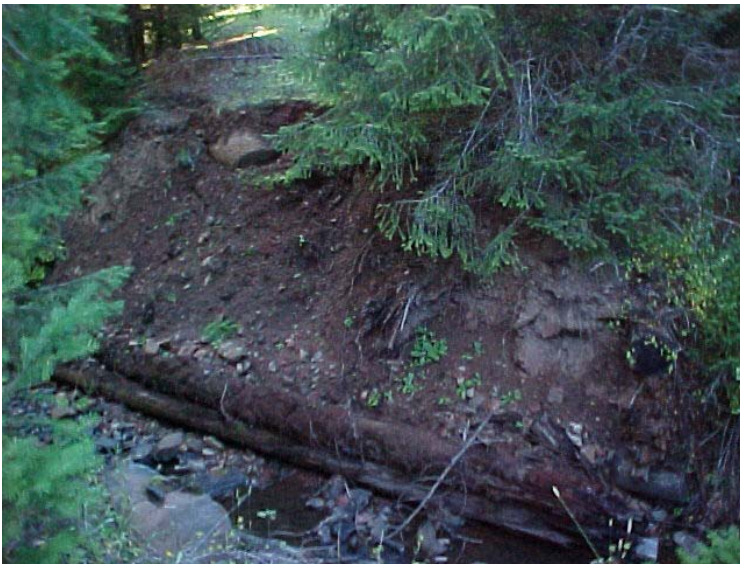
PP#4: Devils Run left abutment, pre-work; 2005.

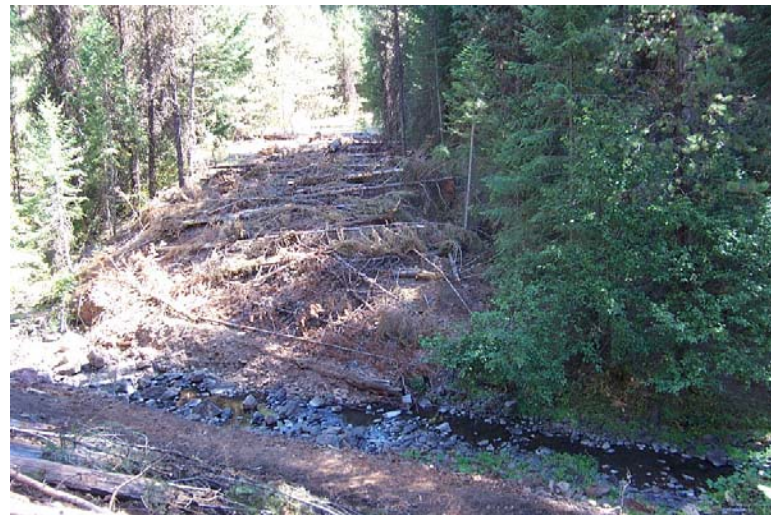
PP#4: Devils Run left abutment, post-work; 2005.
