FY2006 Project Completion Report

Mahogany Creek Culvert Replacement Project

Contract #: 27255
BPA Project #: 1992-026-01

**Nez Perce Tribe Department of Fisheries Resource Management
- Watershed Division**

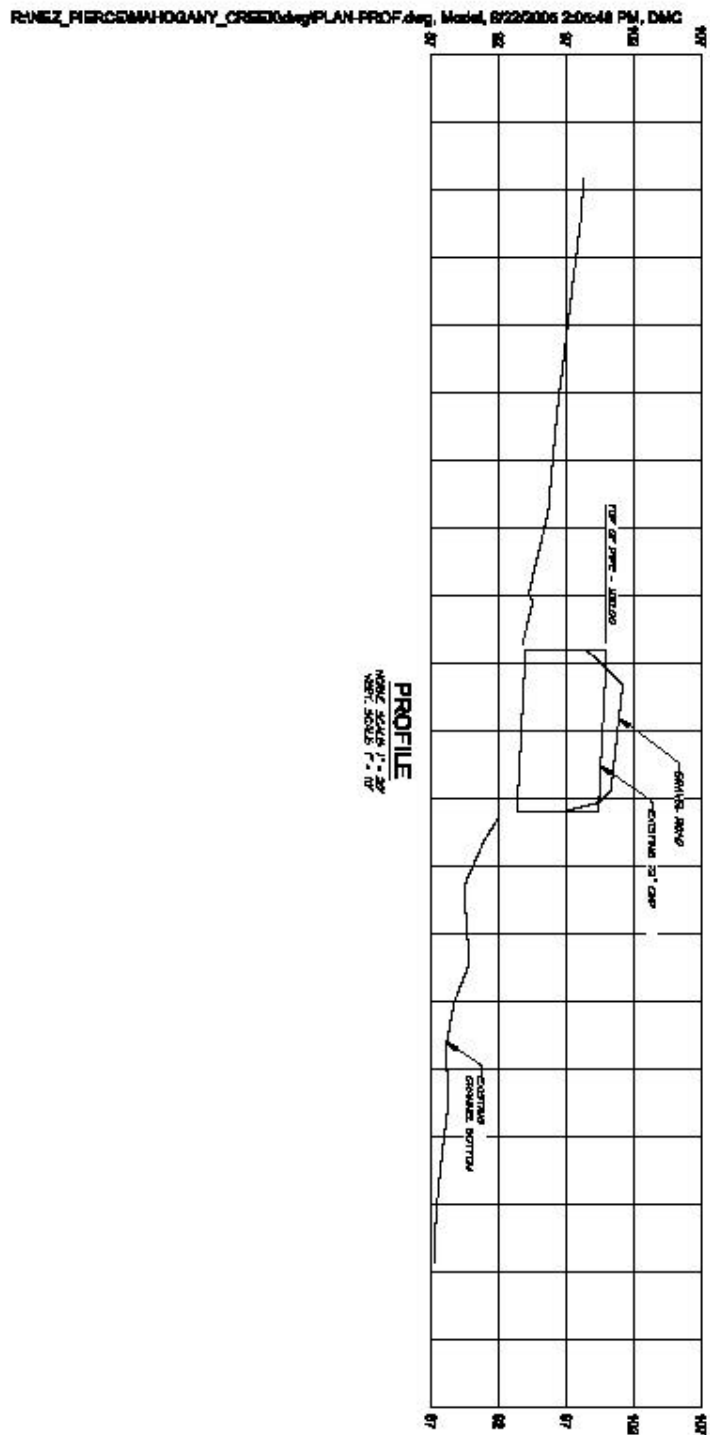
Figure 3. Original longitudinal profile for Mahogany Creek.

A cursory look at the longitudinal profiles obtained pre- and post-construction indicates that the new channel construction matched the existing channel profile. This would indicate that this aspect of the objective to simulate natural channel conditions was met.

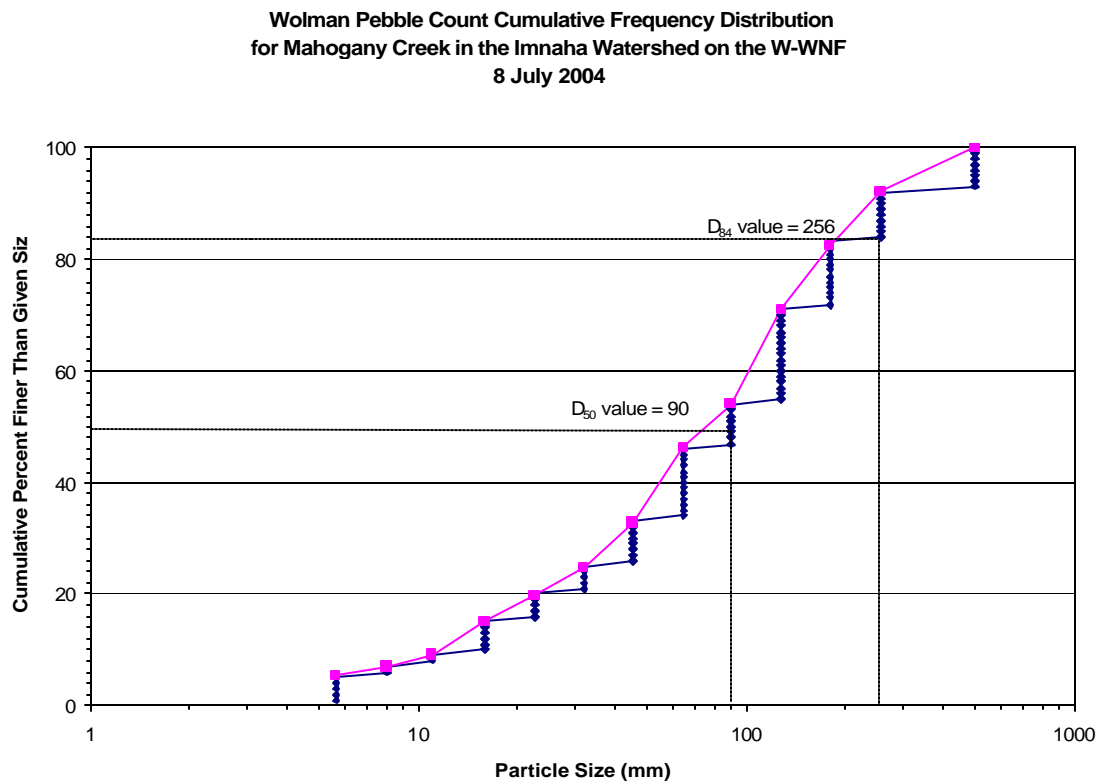
Figure 5. Pebble Count data collected prior to construction.

One of the seeming differences between the two pebble counts is that it appears as though the substrate particle size located within the new structure contains less of the larger material than that located in the undisturbed stream. It is expected that with higher flow events, some of the fine sediment that is now located within the culvert will be redistributed downstream. There is an ample larger substrate gradation located within the natural channel simulation material that was used within the new structure. This aspect was discussed with the contractor multiple times with site visits to appropriate rock

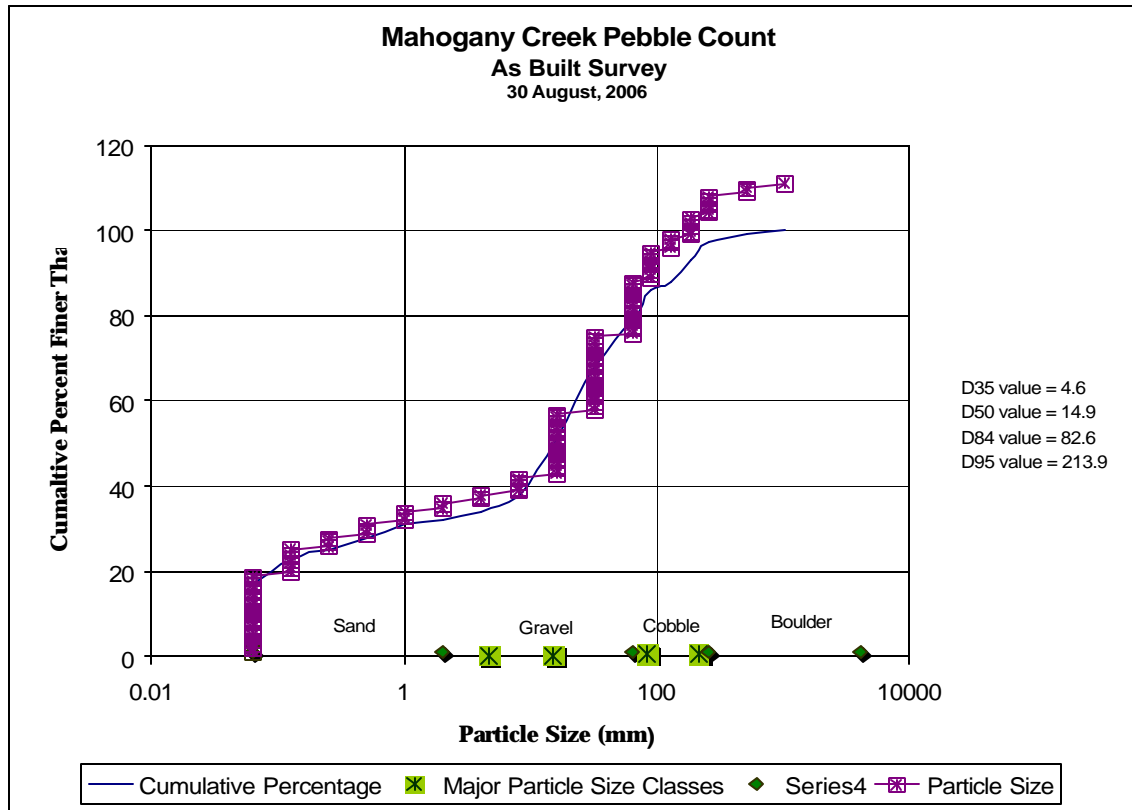
Figure 6. Pebble count data collected inside the newly installed culvert.

sources. In addition, this component was monitored during the inspection phase of contract implementation. Some of this will be exposed during the next spring high water event. As previously mentioned, this will be closely monitored over time to insure that the particle size inside the culvert does simulate the channel particle size outside the culvert.

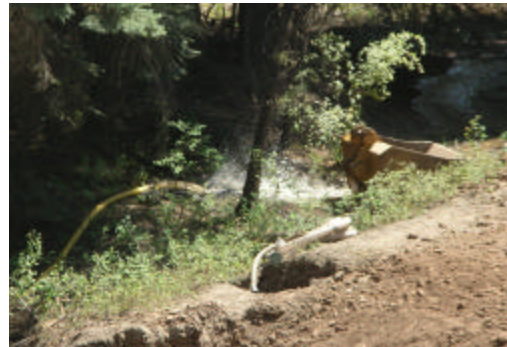
was used to pump the sediment laden water onto the forest floor, shown in the second photograph to the right of this text. This “dirty” water was allowed to filter through the forest floor. Careful attention was needed to insure that this water did not return to the stream.

The channel was dewatered using a pumping system. There were two pumps on site. One pump was used to send fresh water to the undisturbed section of stream below the project site, which is shown in the first photograph. This was done to maintain enough flow in the stream below the project work area to sustain the aquatic life that was present in that section, which was not electroshocked to remove these species. The other pump

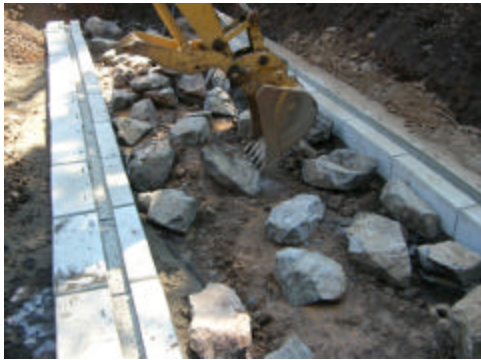
Then, the large boulders were placed within the channel and up to the inside edge of the footings, as per the designs. This photograph shows the latter part of this process.

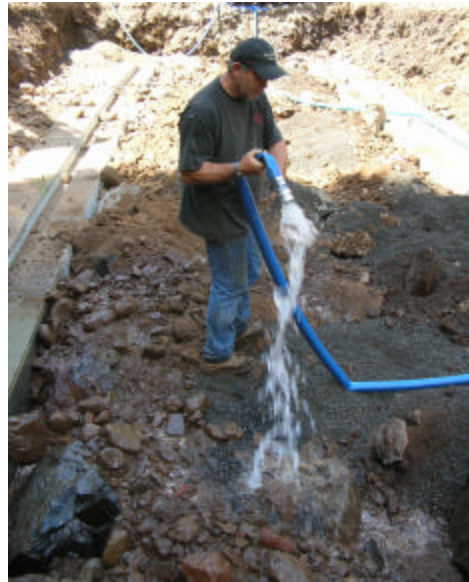
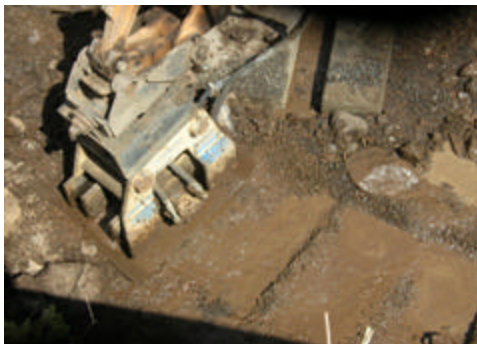
Natural channel simulation material was then placed around the large boulders, washed and compacted into place, which is depicted in the following two pictures. This material filled the entire width between the culvert footings to a level of the top of the footings. The washing and compacting of this material was essential in sealing the channel bottom.

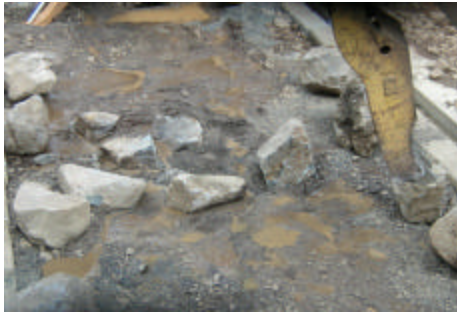
At that time, the 2 foot rock was placed on top of the footer rocks and overlapped the footings. This provided additional scour protection and created the stabilization of the banks within the structure. This is shown in the photograph on the right. Additionally, the steps were finished at this point by placing the 2 foot diameter rocks

in the appropriate positions, which is shown in the picture on the left. The steps were approximately 6 feet long along the longitudinal stream axis. The critical

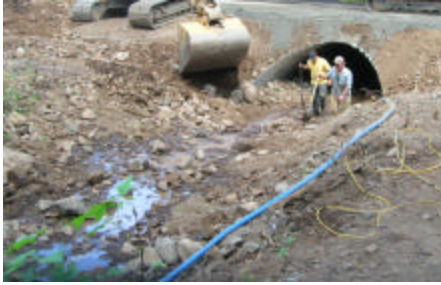
At this time, the new channel was washed until the water was contained no more fine sediment, shown in the photograph to the left. This picture shows the water right after some of it was allowed to flow back into the newly created channel, and thus, it still

contains a lot of fine sediment. After the water was running clear through the newly constructed channel, the bypass pumps were shut off completely, allowing all of the water in the stream to flow through the construction site. At this time, the erosion control dam that was constructed downstream of the work area was removed.

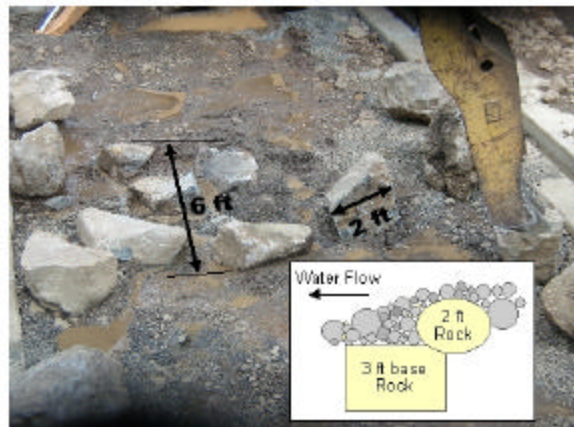
The two grade control structures that were constructed within the new pipe also require some additional discussion. They were installed at different lengths along the longitudinal profile of the culvert to more closely approximate natural conditions and minimize an “artificial” look. The contract administrator desired to have them installed at “about” this distance to make the outcome a little more stream-like. It was also decided that these step

pools should contain rock of varying sizes along their longitudinal axis with the main part of them being the larger boulders, as per the designs. The actual step is depicted in the picture. In addition, this photo contains a depiction of the cross sectional view of each step. The smaller grey rocks shown in the diagram represent the natural channel simulation material that has been mentioned numerous times previously. Over time, a portion of the step might be exposed by scour; however, the addition of the natural channel simulation material will prevent all of the steps from being exposed. Of course, there were also many fines contained within this material that are not shown in this diagram.
