Service experience with
2020-compliant fuels

SL2022-726/KNB
July 2022

Owners and operators of MAN B&W
two-stroke marine combustion engines.
Type: All MAN B&W engines.

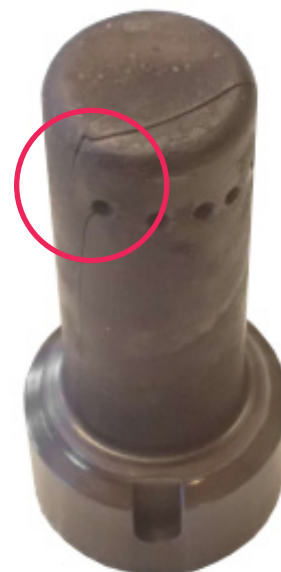
Some vessels have reported cracks in fuel nozzles after switching to a 2020-compliant fuel. Fig. 1 shows a nozzle tip with a crack. This is most dominant for engines of

The reason why this has become an issue is related to the higher delta temperature between the max. temperature for the nozzle during combustion and the cooling effect from the injected fuel.

In some cases, this increased temperature difference may challenge the lifetime of the nozzle and thus reduce the specified time between overhaul (TBO).

Fig. 1: Crack found on the tip of a nozzle

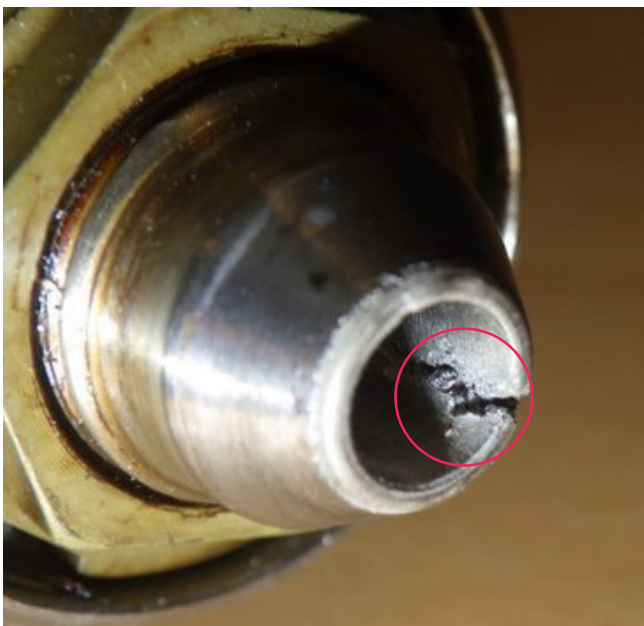
If the high-pressure pipe cone suffers severe cavitation damage that leads to a high-pressure fuel oil leakage and, therefore, erosion damage, this may ultimately lead to damage on the top cover mating surface between the top cover and the high-pressure pipe.

Fig. 2: Inspection of the high-pressure pipe end/seat reveals a crack – no special equipment required

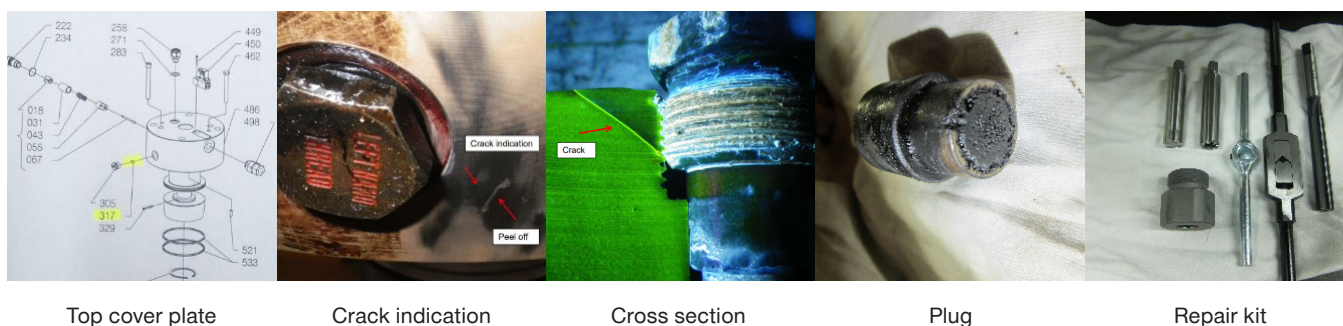
Crack formation around the plug screw in the top cover has been reported in a few cases. The root cause has been identified to be a loose plug behind the plug screw.

The loose plug would “hammer” against the plug screw at every injection, and thus stress the threads in the top cover and initiate a crack at the thread in the top cover. Cavitation on the plug may lead to loose plugs.

Fig. 5: Crack indication around the plug screw in the top cover, top cover plate and repair kit

A repair kit consisting of new plugs and tools for overhauling the mating seat in the top cover can be ordered from PrimeServ, see Fig. 5.

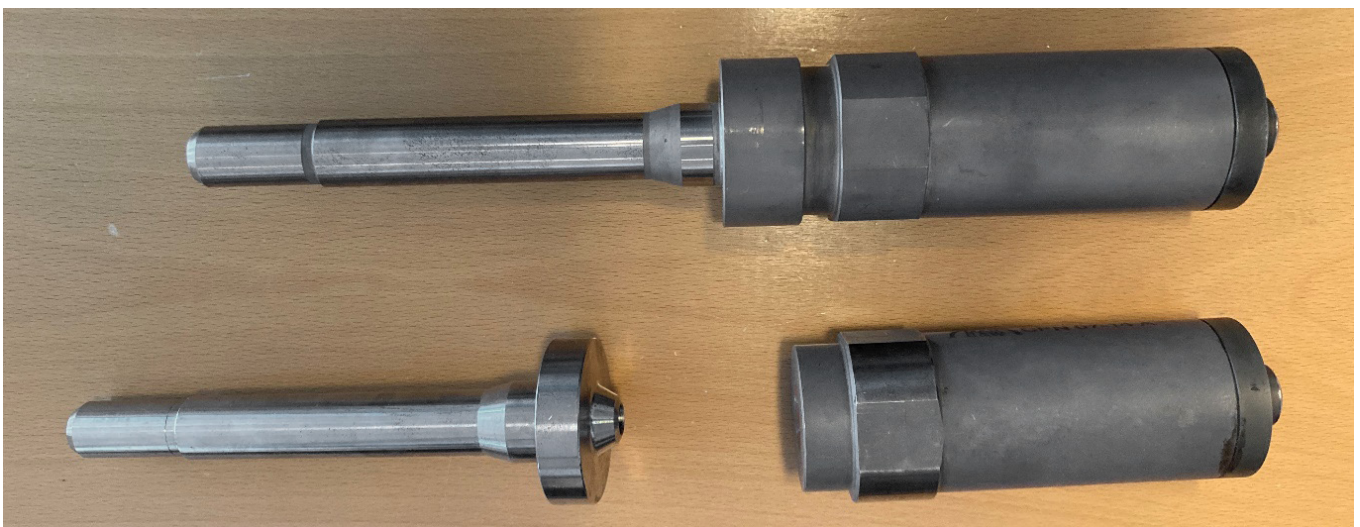
For quite some years now, the standard design on our medium and small-bore engines (50, 60 and 70 bores) has been a type where the non-return valve and thrust spindle pipe are designed as one unit. This design has shown clear superiority over the two-part design used on our large-bore engines. For this reason, we have introduced a similar one-unit type and tested it for 8,000 hours of service on a G95ME-C engine, and the results were very promising, see Fig. 9.

Fig. 9: Non-return valve and thrust spindle pipe vs. combined non-return valve and thrust spindle pipe

As a countermeasure, the new combined non-return valve with integrated spindle pipe will soon be introduced as a standard spare part for 80, 90 and 95-bore engines with conventional fuel valves (interchangeable with the existing two-part design of the non-return valve and thrust spindle pipe).

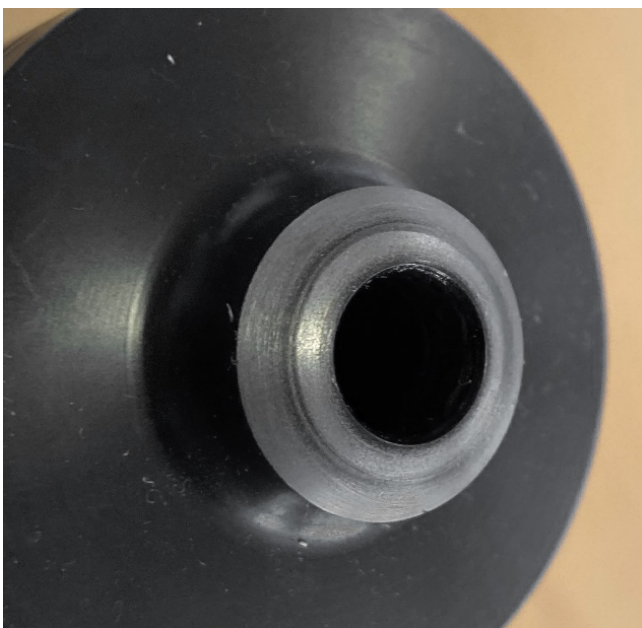
Whereas cavitation is rarely found on the upper end of the non-return valve (Fig. 10), cavitation has been found on the lower end (Fig. 11).

Fig. 10: Cavitation is rarely found at upper end of the non-return valve – towards the fuel valve head – here found in fully functional condition without cavitation

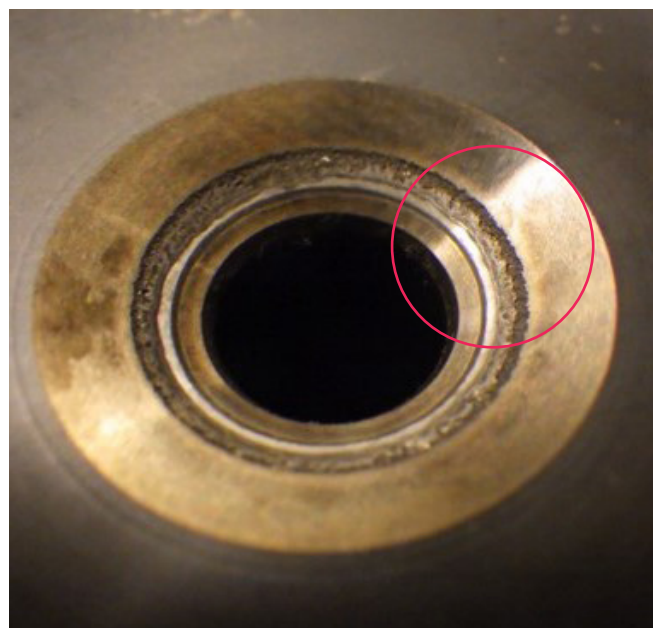
Fig. 11: Close-up of cavitation damage found at lower end of non-return valve – towards thrust spindle pipe

Introduction of the combined one-unit non-return valve for the 80, 90 and 95-bore engines. Cavitation is avoided by omitting of the mating sealing surfaces.

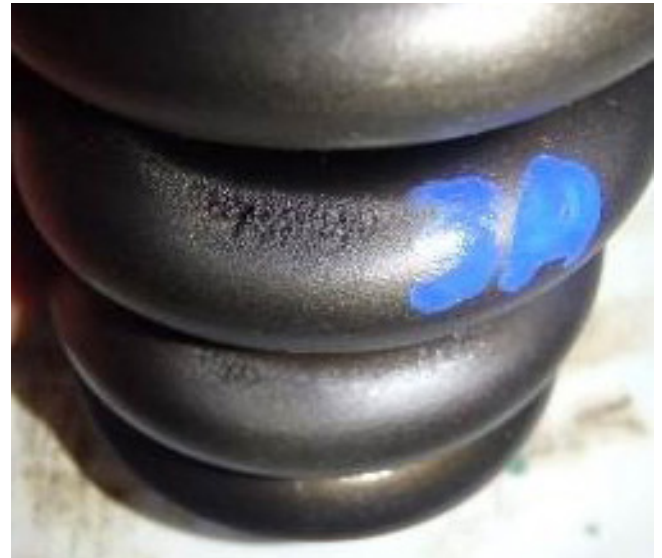
In a few cases, cavitation has been found on the inner diameter of the spring coils, see Fig. 14. Cavitation marks might also be found on the thrust spindle pipe, see Fig. 15.

This type of cavitation occurs when the circulation pressure is too low for the fuel circulating loop, and it is mainly related to an incorrect pressure setting or a worn out “pressure holding valve”.

Fig. 14: Cavitation found on spring

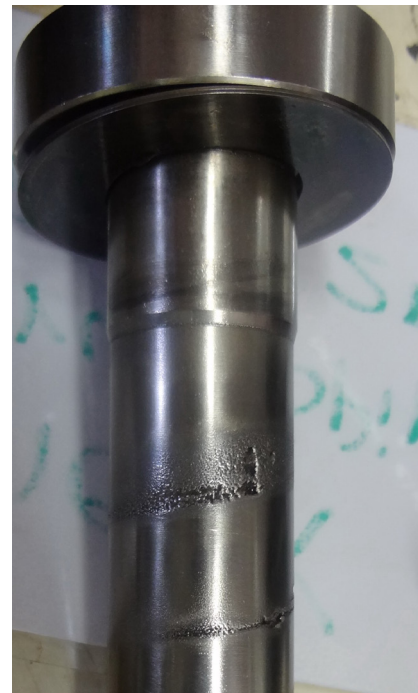
Fig. 15: Cavitation found similarly on cylindrical part of thrust spindle pipe
