Read Jones Christoffersen
Consulting Engineers

April 23, 2012

RE: Cypress Point Unit 329/332 Building C - Structural Assessment
Strata Plan 2050 - 7651 Minoru Blvd., Richmond, BC

RJC No.: VAN.037207.0017

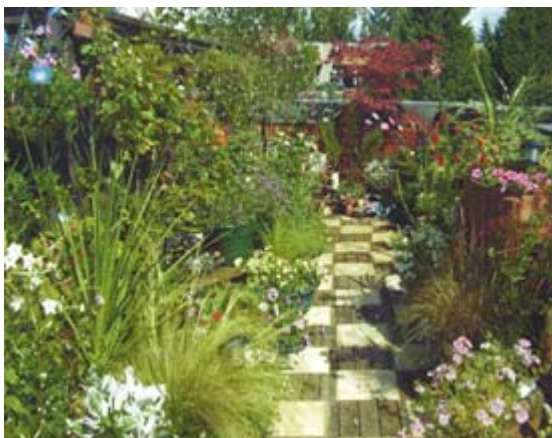
Photo 1: Roof Deck (October 2008)

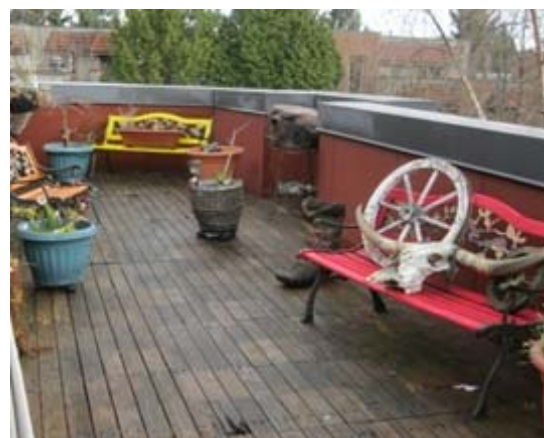
Photo 2: Roof Deck (April 2012)

- a) Roof top deck loading (unit 329/332) - A substantial amount of the landscaping on the roof deck has been removed; the remaining planters have been evenly spread out over the roof deck as recommended in the previous load review report. The current loading condition appears to be within the design loading of the roof deck.

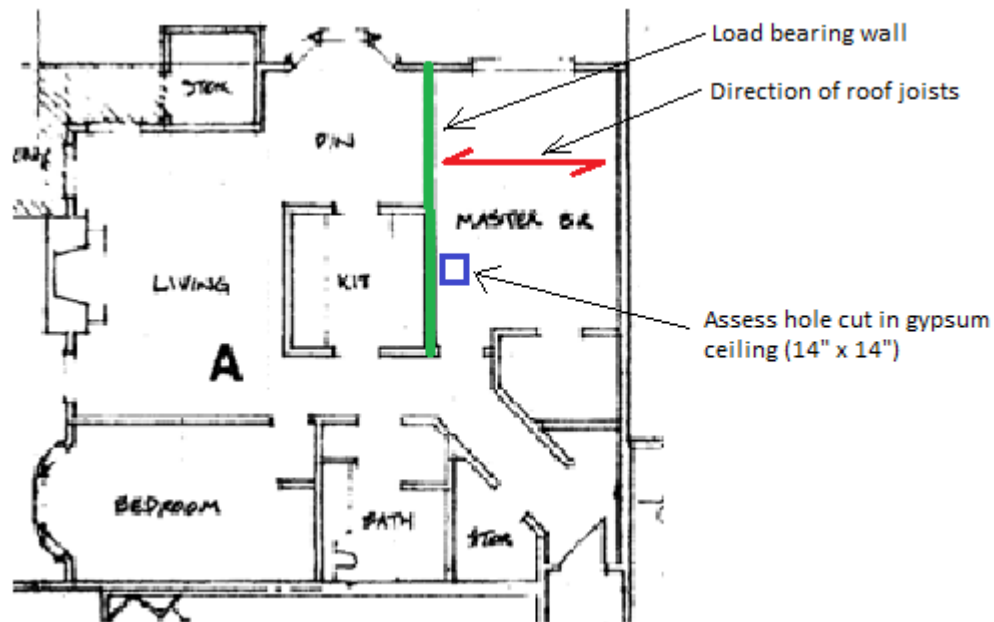
On Wednesday April 4, Jesse Pauls and Crystal Wegner of Read Jones Christoffersen were on-site to review the existing structural framing and review the revised loading on the roof top deck. A contractor was retained to cut an assess hole in the existing gypsum board ceiling within suite 229 to allow access to visually review the condition of the existing roof joists. The access hole was cut within the master bedroom beside the load bearing wall, as shown in Figure 1. This location corresponded to one of the regions previously loaded with landscaping.

Figure 1: Suite 229 Layout - Location of access hole

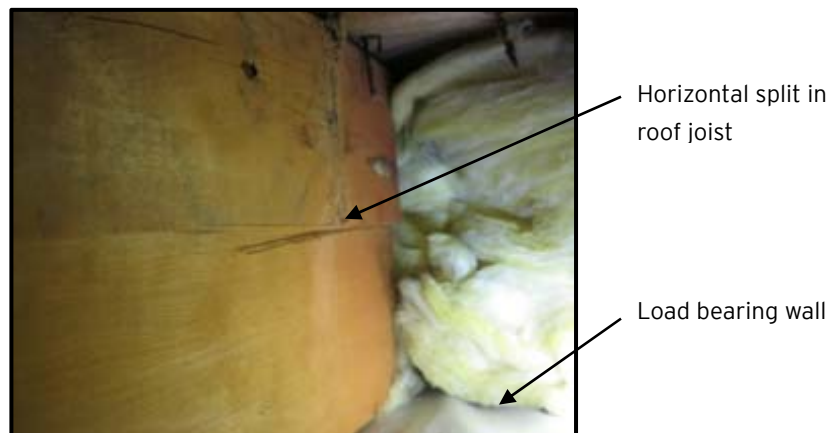
Conditions within the access hole appeared "dry" and both joists within the hole appeared to be the correct size. A horizontal split was observed through one of the joists above the bearing wall. The split was located at bearing end, near mid-height of the joist, and extended approximately 3ft along the joist (refer to photo 3). The split was observed to run through a knot in the wood.

Photo 3: Split in Roof Joist

The observed split in the roof joist can be a result of several different issues. Such splits could represent a horizontal shear failure, a defect in roof joist at time of installation, and/or shrinkage cracking. Horizontal shear failures tend to occur when beams or joist are heavily loaded near their supports and the shear resistance of the joist is surpassed. The shear resistance of wood is highly variable, design codes account for this variability by applying resistance factors. Based on the current wood design provisions contained within the Canadian Wood Council CSA 086-09 *Engineering Design in Wood* we conservatively estimate the shear resistance of the 2x10 roof joists to be 13.2kN. For this shear resistance to be reached or exceeded the landscaping load applied on the roof joist would have needed to be extensive and would have likely caused visual cracking in the gypsum ceiling elsewhere.

The split in the wood could also represent an initial defect in the joist. Initial defects in the joist can over time propagate into large cracks/splits as the wood continues to dry.

Nevertheless; the cause of the existing split, the splits represents a significant reduction in the strength and stiffness of the joist and should be repaired.

Based on the two roof joists reviewed from the one ceiling opening a conclusive cause for the split in the roof joists cannot be determined. We would recommend removing a strip of the gypsum ceiling adjacent to the load bearing wall or alternatively removal of the roof assembly (membrane and plywood from the topside), to visually review the end condition of all the joists within this region. If other joists show signs of splits near the support a larger remedial scheme should be considered. However, if the remaining joists within this region appear okay, the one damaged joist should be repaired and the ceiling can be replaced. When the ceiling or roof is removed we would recommend installing rigid blocking between each joist over top of the load bearing wall to increase the stability of the roof assembly.

To repair the split joist we would recommend splicing a Microlam joist beside the existing joist and screwing the two joists together. The Microlam joist should extend a minimum of 24" past the end-point of the split to ensure adequate load transfer.
