# **CONE 650: CONSTRUCTION LABOR PRODUCTIVITY**

## **FIELD STUDY 4: Complexity/Difficulty Analysis**

### **1. Operation Analysis**

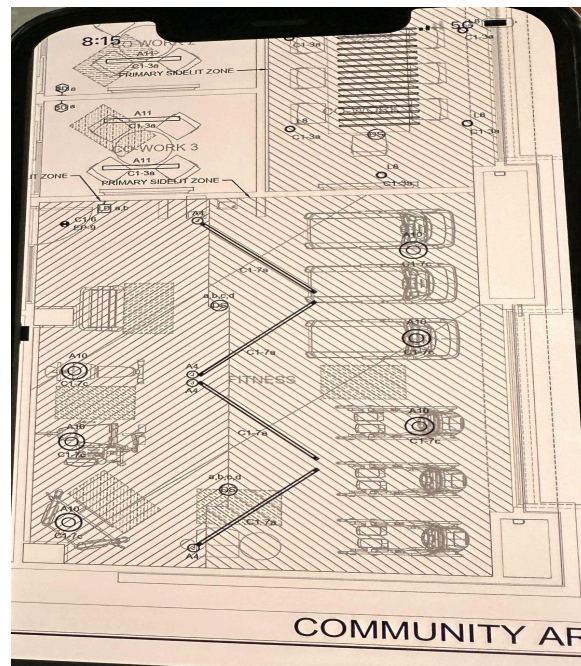
#### 1. Installed Wrong box cover:

Round white color box covers, which have two holes, one for aircraft cable support and second for power line delivered 6 similar types in one pack. Which is going to be installed 4 at the fitness room and remaining two at another unit. The same day when installing box covers workers installed all 6 of them in the fitness room, because he thought all came in one box so it was supposed to be installed in one unit. But later when he was going to install the light fixture he got to know that he installed 2 wrong covers, he was supposed to install steel one's which are smaller in size. So he needed to remove them and detach the aircraft cable from cover. and again he needs to make a steel box cover ready and attach aircraft cable to that cover, which causes a time and effort to the process.

The installation of the wrong box covers also led to non-productive time, as the crew had to remove the incorrect covers and replace them with the right ones. This idle time was a direct result of the difficulty in correctly identifying and installing the appropriate box cover type.

The installation of the wrong box covers resulted in three defects, as the incorrect covers had to be removed and replaced with the right ones.

To reduce the difficulty and prevent the installation of the wrong box covers, the following changes can be implemented:

- **Improved Material Organization:** Clearly label and segregate the different types of box covers (steel vs. round white) to avoid confusion during the installation process. This can be done by using color-coded labels or storing them in separate designated areas.

- **Enhanced Communication:** Ensure clear communication between the crew members about the specific box cover requirements for each installation location. This can be achieved through detailed work instructions, checklists, or regular team meetings to discuss the installation plan.

- **Verification Checks:** Implement a quality control step where the crew members cross-check the box cover type against the installation plan before proceeding with the installation. This will help identify any discrepancies and prevent the installation of the wrong covers.

- **Training and Supervision:** Provide thorough training to the crew members on the proper identification and installation of the different box cover types. Additionally, have a more experienced crew member closely supervise the installation process to catch any mistakes early on.

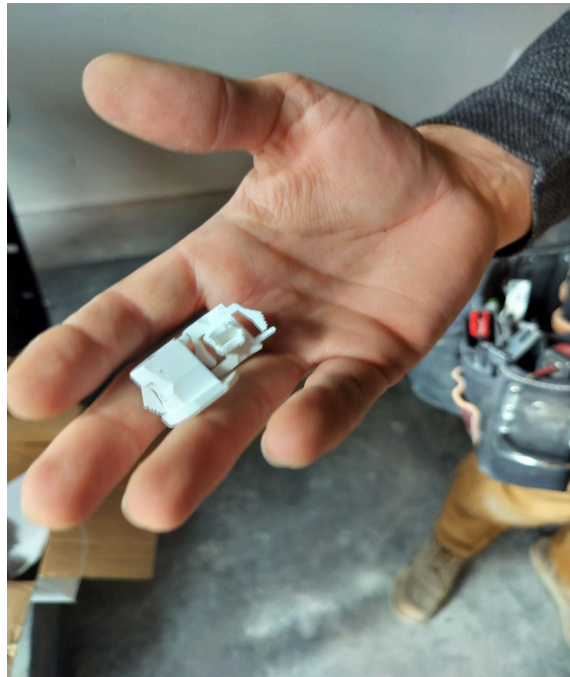
2. Wire attachment part/ Stinger clip size issue: During the final stages of installation, when attempting to tight the wires to the light box, the crew encountered an issue where the provided stinger clips were smaller than the size of the wires themselves. making it challenging to securely fasten the wires to the box. Because there were two different sizes of wires or cables and only one size of stringer clip was provided, which was a smaller size, which didn't fit properly. That caused a lot of time and struggle. So now work stops, and they need to order a bigger size of stringer clip which takes a few days of time.

The mismatch between the wire/cable size and the provided stinger clip size caused a significant delay, as the work had to be stopped to order the correct size clips. This idle time could have been avoided if the appropriate stinger clip size had been procured and available on-site.

The mismatch between the wire/cable size and stinger clip size led to one defect, as the crew struggled to securely fasten the wires to the light boxes.

To address the stinger clip size issue and ensure a secure wire attachment, the following changes can be implemented:

- **Material Procurement:** Ensure that the correct size of stinger clips is ordered and available on-site before the installation begins. This may require better coordination with the material supplier or a review of the material specifications.

- **Material Inspection:** Implement a quality check process where the crew members inspect the stinger clips upon delivery to verify that they match the size of the wires being used. This will help identify any discrepancies before the installation starts.

- **Inventory Management:** Maintain a well-organized inventory of various stinger clip sizes to have the appropriate ones readily available on-site. This will prevent delays in obtaining the correct parts during the installation process.

- **Standardization:** Consider standardizing the wire and cable sizes used throughout the project to minimize the need for different stinger clip sizes. This can simplify the material procurement and installation process.
