PORTFOLIO OF WORKS

TONIMA FERDOUS

PERFORMANCE AUDIT OF A TOWNHOUSE DEVELOPMENT

RESERVE FUND STUDY OF MIDRISE AND TOWNHOUSE DEDEVELOPMENT

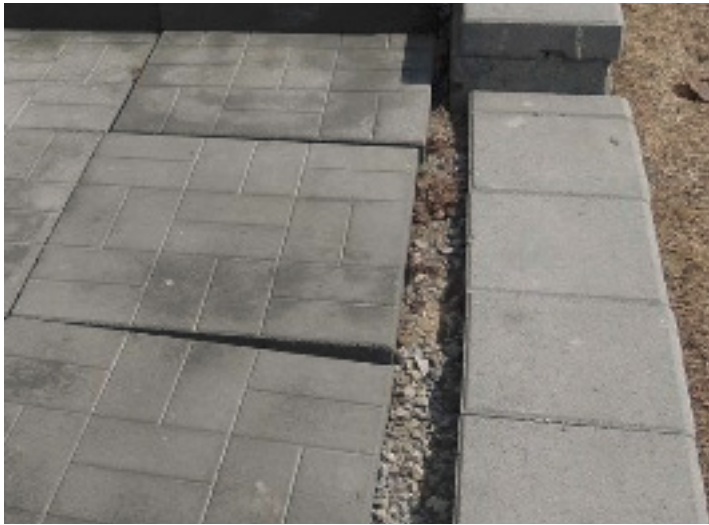
Unit paver walkways are exhibiting noticeable movement and settling which is anticipated to continue unless addressed

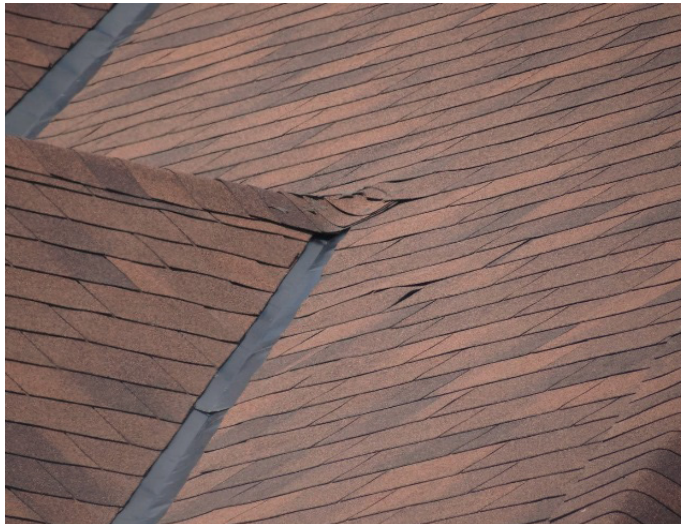
Lifting or asphalt shingles on the roof

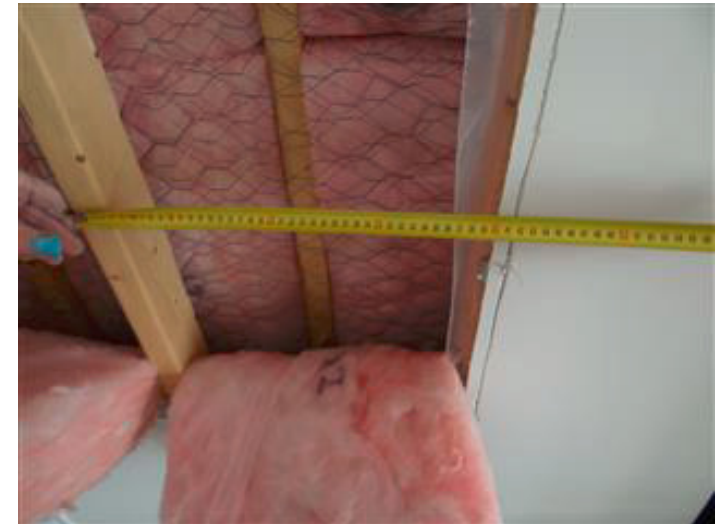
The spacing of the wood studs was consistently greater than the maximum specified spacing requirement. Wood studs spaced beyond the maximum design spacing of 400 mm O.C.

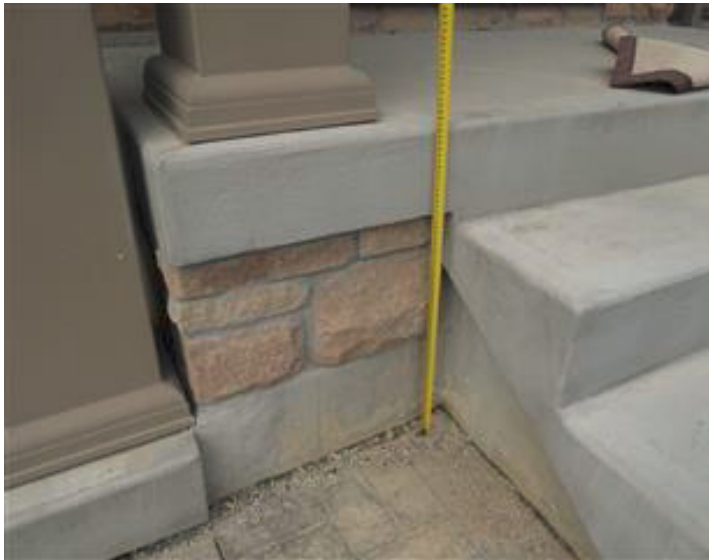
Lack of railings along porches and pre-cast block retaining walls result in building code violations and potential safety concerns

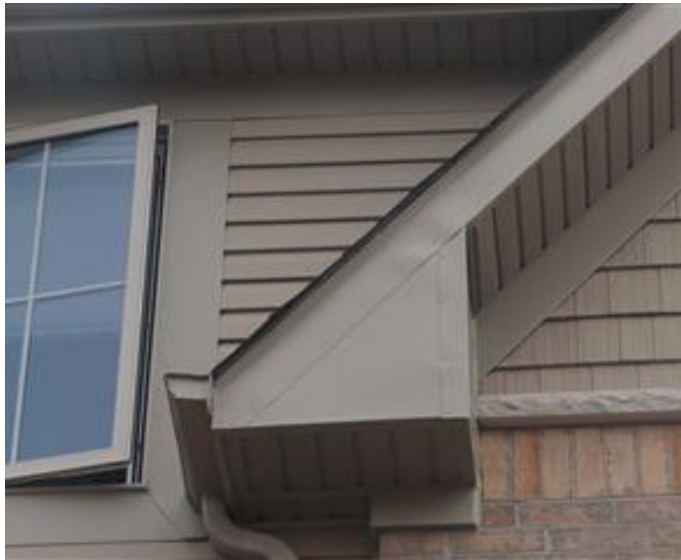
Unrestricted window openings on the 2nd and 3rd levels represent potential safety concerns

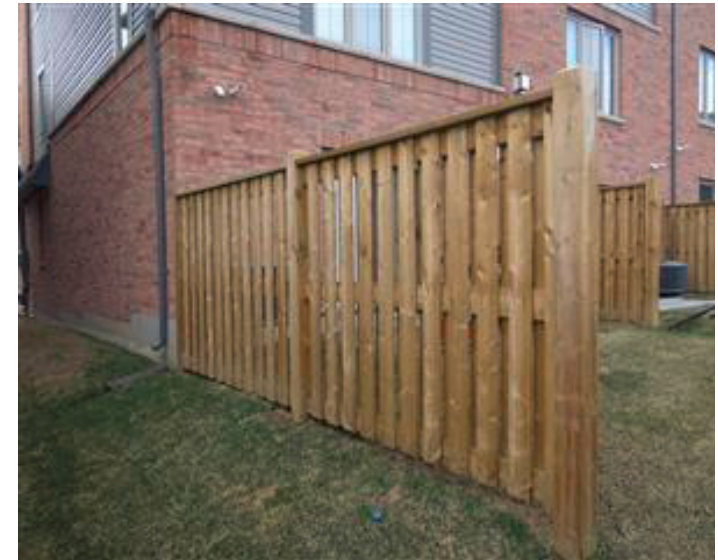
Unpainted wood fencing is subject to accelerated deterioration
