TECHNICAL REPORT

Record No (get by EIC program): 4-Pr-007-4-Fo-0006-4-RC-0269			Date: 16-Aug-2024
Report title: Report Cross section for Trillian FAU -cap Assy_Pre-build (PNJHE-1321-25-09B)			
Prepared by: DienDC

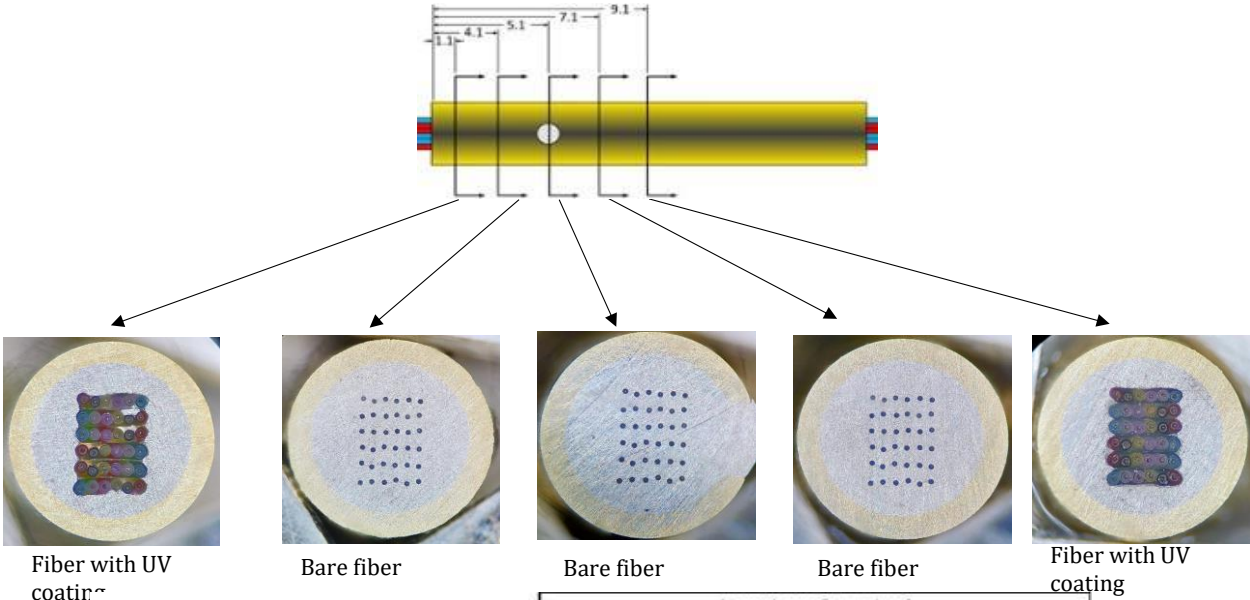
1) Cross section cerrocast 1

Location of required				
		1.1 (mm)	4.1 (mm)	5.1 (mm)	7.1 (mm)	9.1 (mm)
Evaluation items	Stripping position	OK	OK	OK	OK	OK
	Fiber misalignment /crowding	None	None	None	None	None
	Micro cracks	None	None	None	None	None
	Edge voiding	None	None	None	None	None
	Judgment (OK/NG)	OK	OK	OK	OK	OK

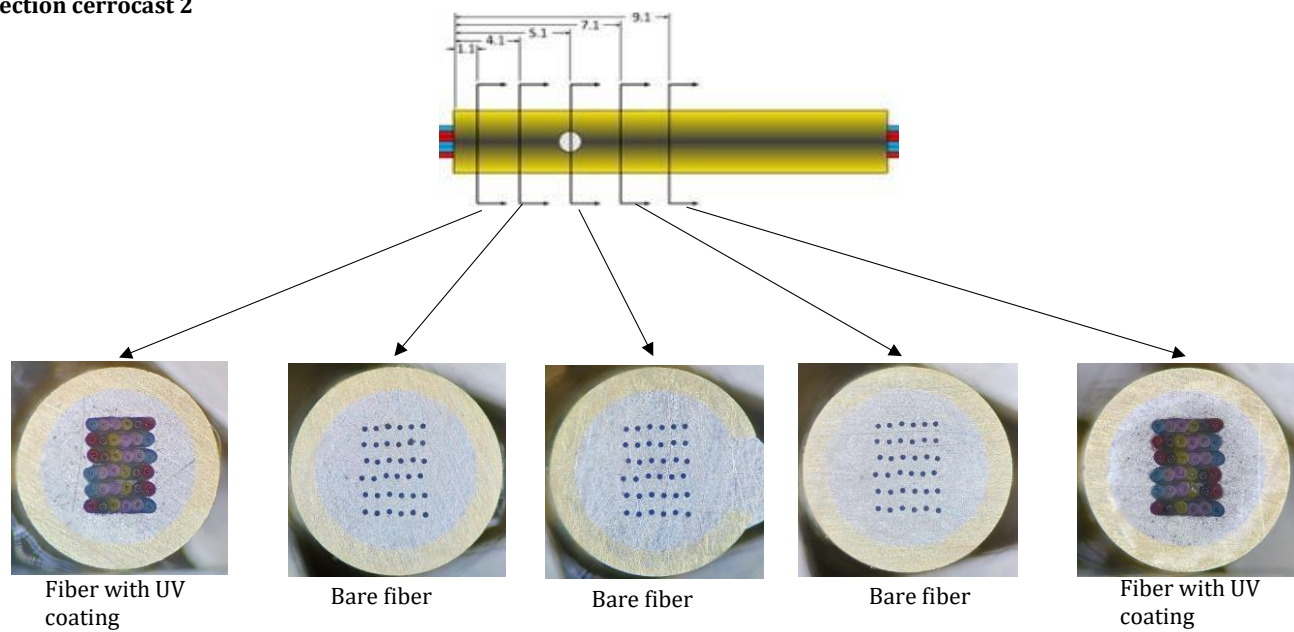
2) Cross section cerrocast 2

Location of required				
		1.1 (mm)	4.1 (mm)	5.1 (mm)	7.1 (mm)	9.1 (mm)
Evaluation items	Stripping position	OK	OK	OK	OK	OK
	Fiber misalignment /crowding	None	None	None	None	None
	Micro cracks	None	None	None	None	None
	Edge voiding	None	None	None	None	None
	Judgment (OK/NG)	OK	OK	OK	OK	OK
