TECHNICAL REPORT

Report title: Report Cross section for Trillian FAU -cap Assy_Pre-build (PNJHE-1321-25-09B)_MACHINE 2_SEP-24

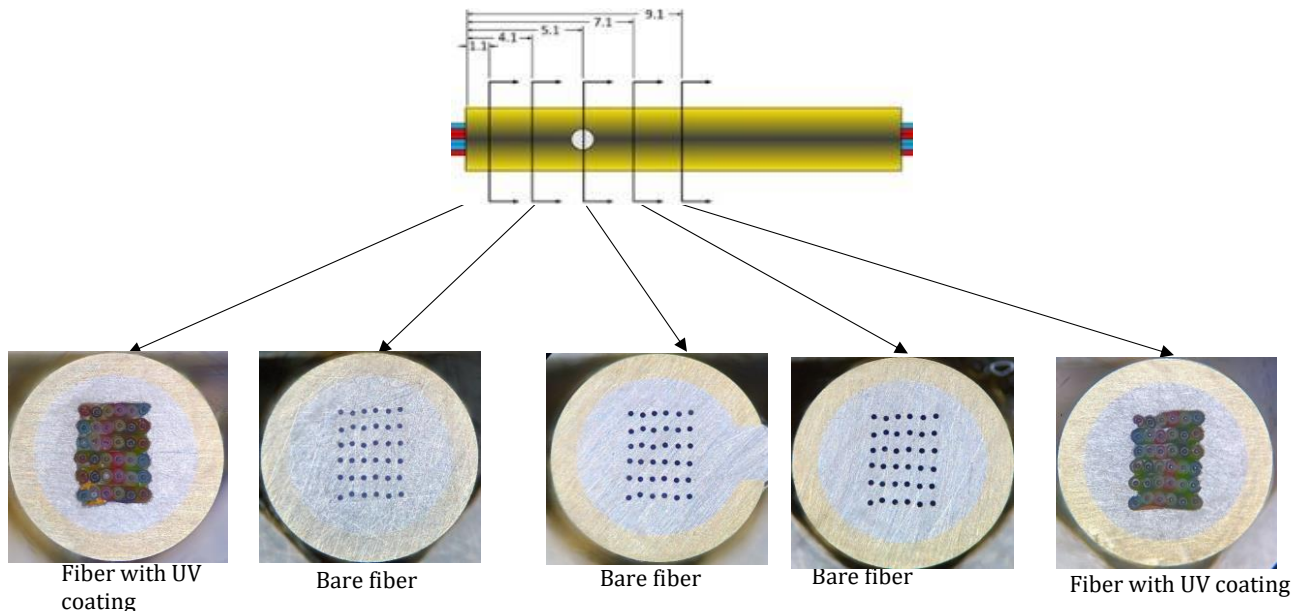
1) Cross section cerrocast 1

Location of required				
		1.1 (mm)	4.1 (mm)	5.1 (mm)	7.1 (mm)	9.1 (mm)
Evaluation items	Stripping position	OK	OK	OK	OK	OK
	Fiber misalignment /crowding	None	None	None	None	None
	Micro cracks	None	None	None	None	None
	Edge voiding	None	None	None	None	None
	Judgment (OK/NG)	OK	OK	OK	OK	OK

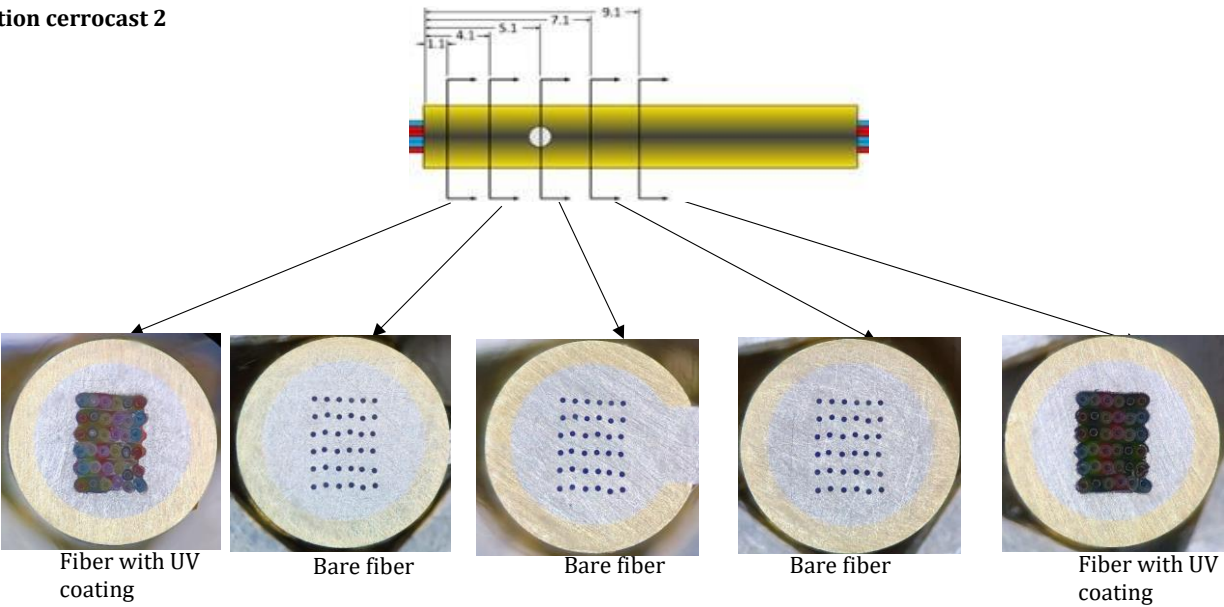
2) Cross section cerrocast 2

Location of required				
		1.1 (mm)	4.1 (mm)	5.1 (mm)	7.1 (mm)	9.1 (mm)
Evaluation items	Stripping position	OK	OK	OK	OK	OK
	Fiber misalignment /crowding	None	None	None	None	None
	Micro cracks	None	None	None	None	None
	Edge voiding	None	None	None	None	None
	Judgment (OK/NG)	OK	OK	OK	OK	OK
