TECHNICAL REPORT

Date: 16-Aug-2024

Report title: Report Cross section for Trillian FAU -cap Assy_Pre-build (PNJHE-1321-25-09B)_MACHINE 2_AUG-24

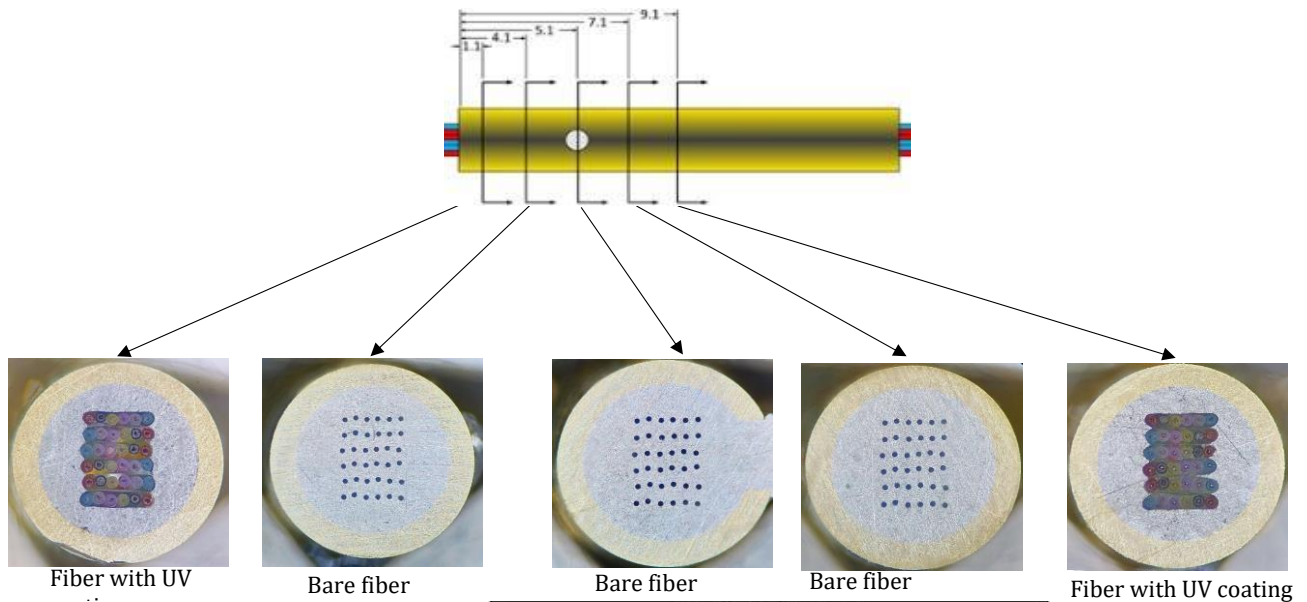
1) Cross section cerrocast 1

Location of required				
		1.1 (mm)	4.1 (mm)	5.1 (mm)	7.1 (mm)	9.1 (mm)
Evaluation items	Stripping position	OK	OK	OK	OK	OK
	Fiber misalignment /crowding	None	None	None	None	None
	Micro cracks	None	None	None	None	None
	Edge voiding	None	None	None	None	None
	Judgment (OK/NG)	OK	OK	OK	OK	OK

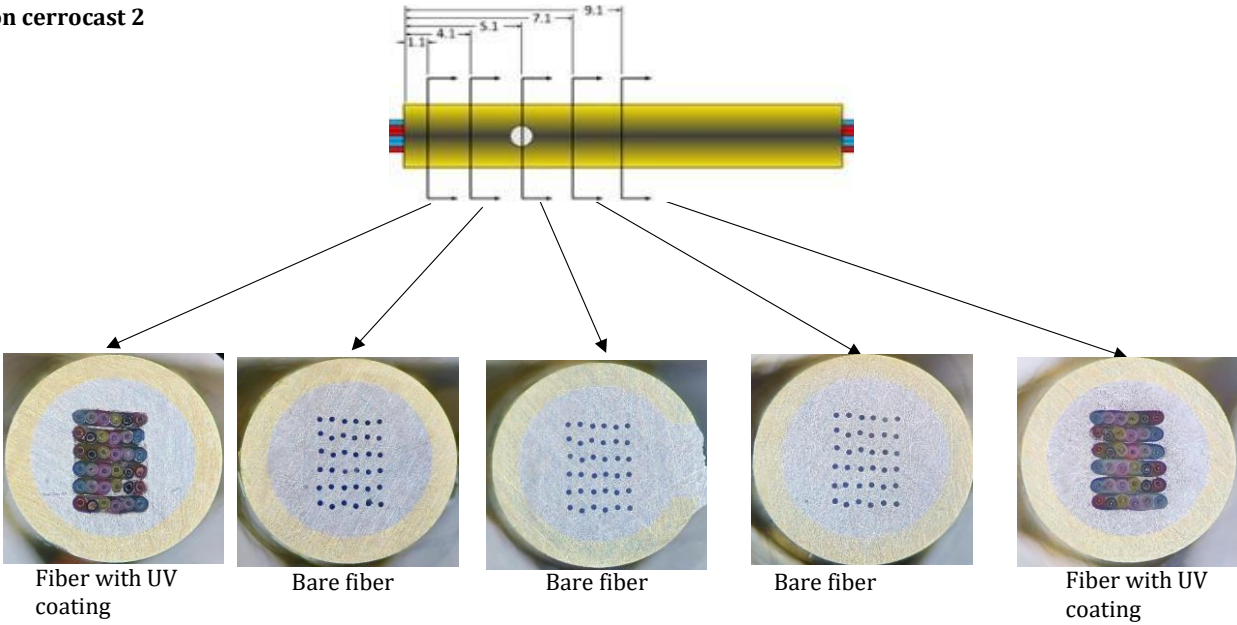
2) Cross section cerrocast 2

Location of required				
		1.1 (mm)	4.1 (mm)	5.1 (mm)	7.1 (mm)	9.1 (mm)
Evaluation items	Stripping position	OK	OK	OK	OK	OK
	Fiber misalignment /crowding	None	None	None	None	None
	Micro cracks	None	None	None	None	None
	Edge voiding	None	None	None	None	None
	Judgment (OK/NG)	OK	OK	OK	OK	OK
