Technical Memo

Sitka Hydro Science LLC

April 24, 2020

Recent Streambank Erosion Observations

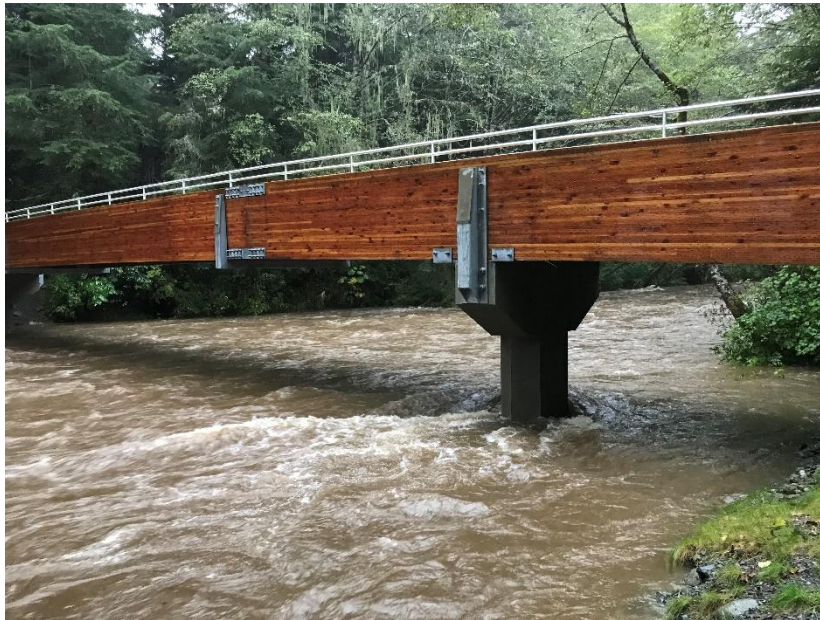
A major flood peak of 3,800 cfs (fig. 1) was recorded at the Indian River stream gage on September 20, 2019. An additional 6 channel forming high flow events (1,000 to 1,500 cfs) were observed between October 2019 and April 2020 in Indian River. The magnitude and

Figure 1 Indian River NP Reach flood stage September 2019,(3,800 cfs).

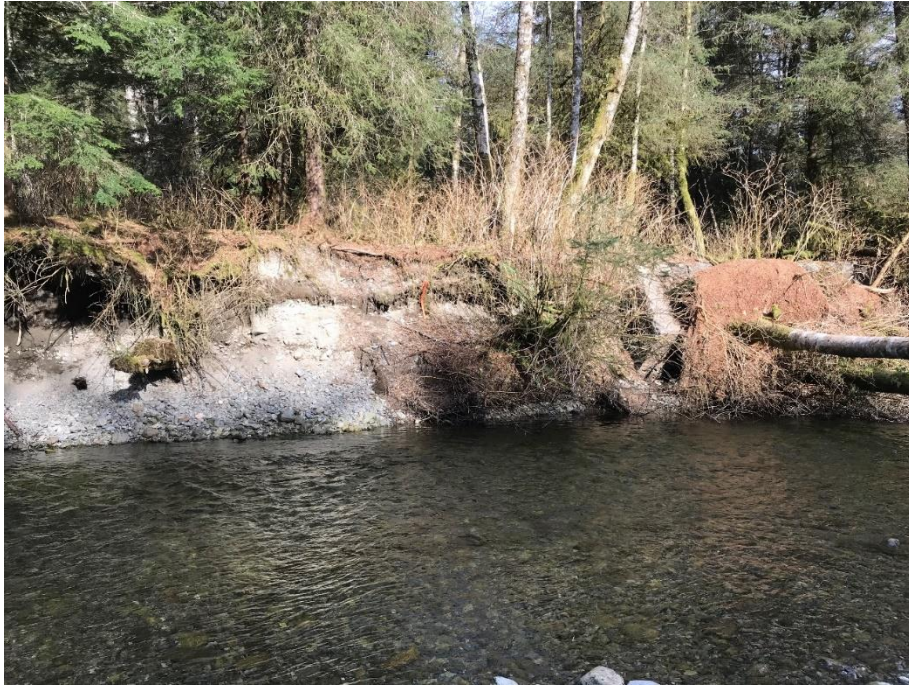
Figure 2. Transect 4, Left Bank

Significant bank slumping occurred at Transect 4 (left bank) in 2019-2020 (fig 2). This site is 130 m downstream of the new Pedestrian Bridge. It was the location of an early bridge crossing (note concrete bridge abutment in the middle right of the photo). Three large alder that were on top of the old bridge abutment have tipped into the channel.

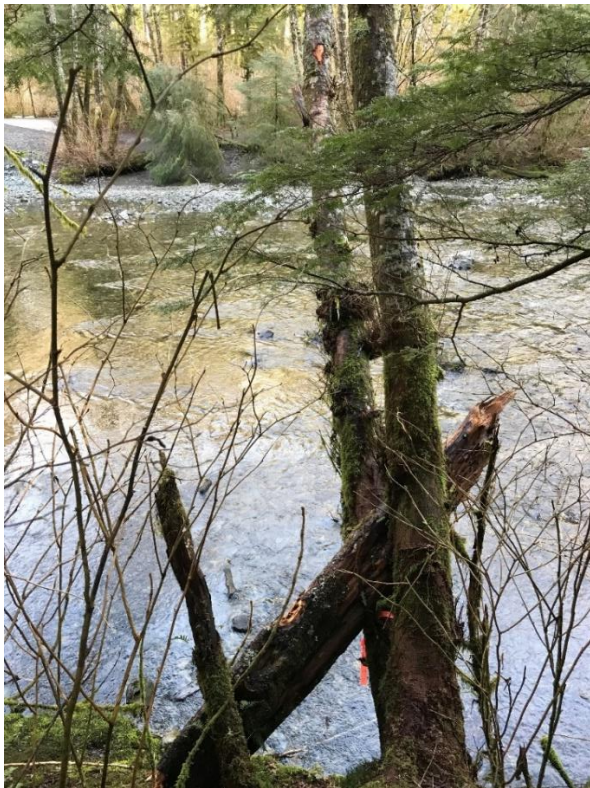
Figure 3. Transect 5, Left Bank

Some channel widening was also observed at Transect 5 (fig 3). This site is located 20 m below the new Pedestrian Bridge. A small conifer has been undermined by recent erosion along the left bank at this site.

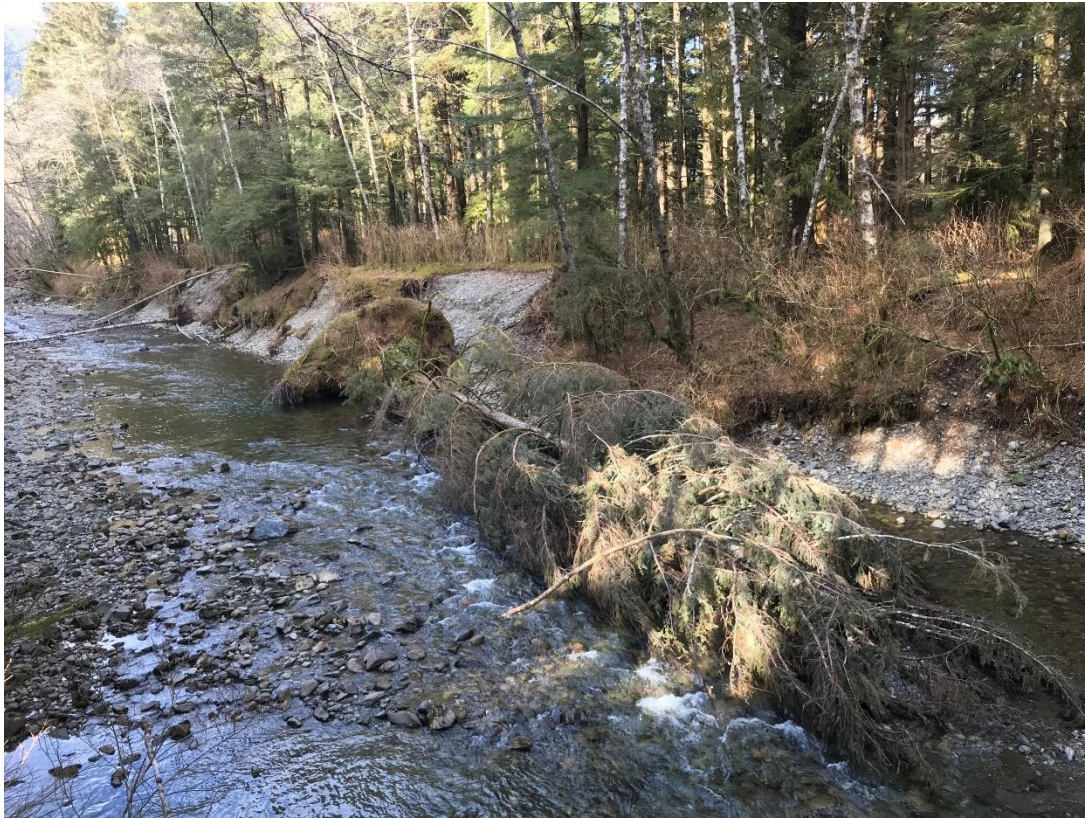
Figure 4. Left Bank between Transects 7-8

Extensive streambank sluffing is evident along the river left bank between Transects 7 and 8 (fig 4). This channel segment is 60 to 90 m upstream of the Pedestrian Bridge. A large conifer stem with root wad entered the active channel this winter. This woody debris structure should afford some protection to the adjacent stream bank. This structure will also provide beneficial aquatic habitat complexing. It is well anchored in the stream bed and should not be an imminent risk to the downstream bridge structure.

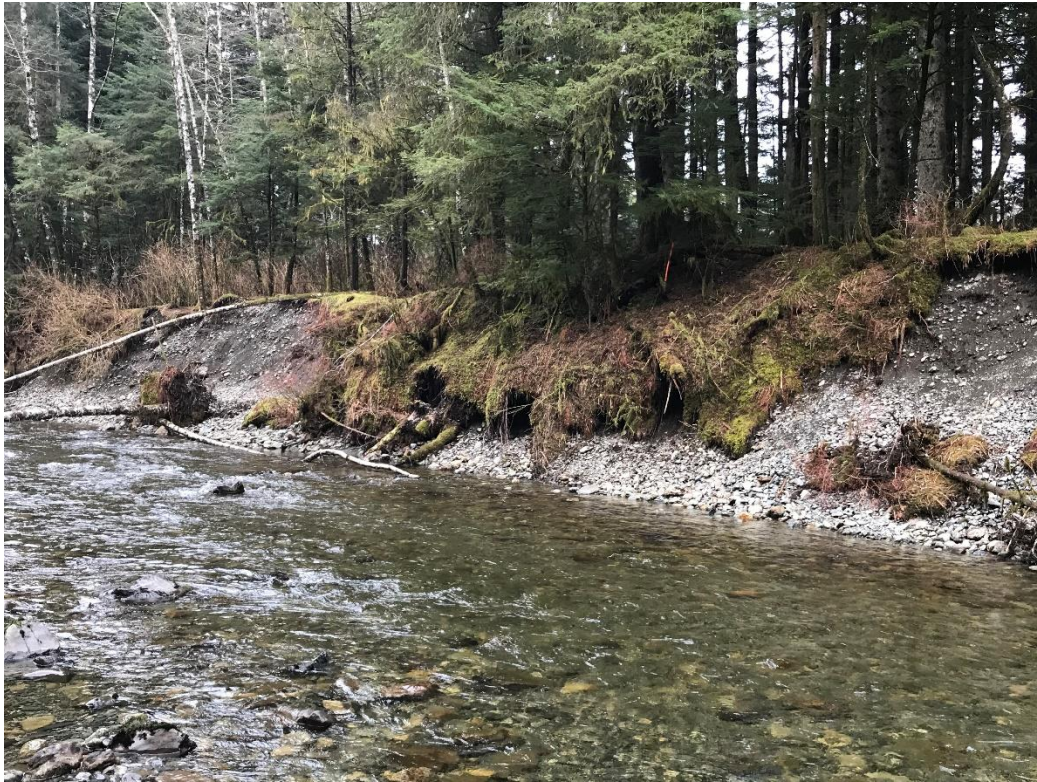
Another large conifer and vegetation root mat at Transect 8 is being undermined (fig 5). This section of streambank will likely slump into the river during one of the next flood / wind storm events.

Figure 5. Left Bank erosion near Transect 8.

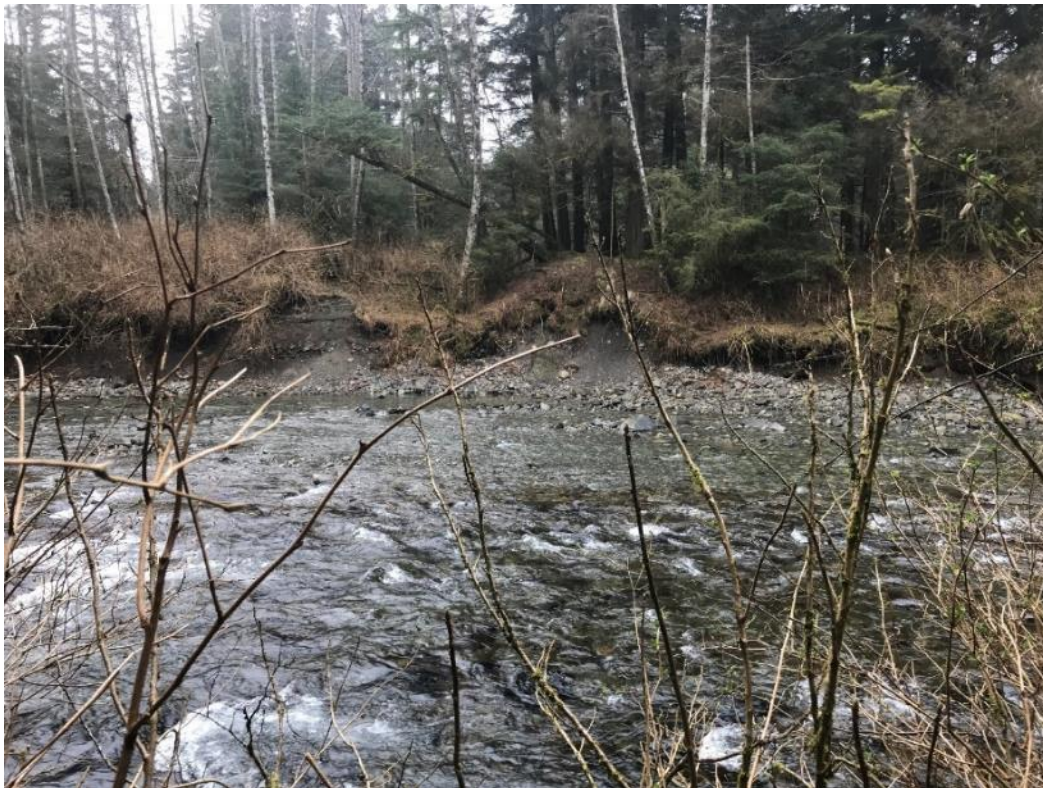
Figure 6. Transect 9, Left Bank

Streambank conditions are similar at Transect 9 close to the Sawmill Creek Road bridge crossing (fig 6). However no large trees are likely to enter channel at this location in the near term.
