Diving Department		Project No.:	5/894	Activity No.:	002:001
Underwater Inspection Report		Date:	22-08-23	Prepared By:	DANNI
Location/Vessel:	801 / GLOBE PEGASUS		Page 1 of 29

**MV "GLOBE PEGASUS"**

**UWILD**

**22-08-2023**

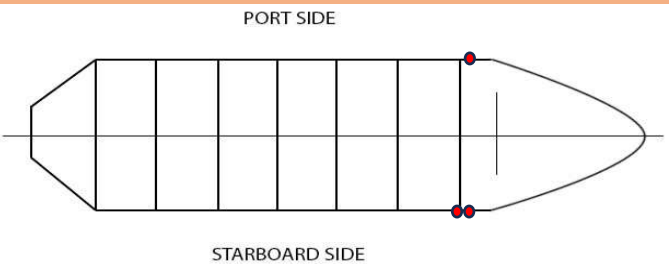
<input type="checkbox"/> Other									
<b>Port Side</b>					<b>Starboard Side</b>				
<input type="checkbox"/> Area Bent Up					<input checked="" type="checkbox"/> Area Bent Up		20mm x 200mm		
<input checked="" type="checkbox"/> Area Bent Down		20mm x 200mm			<input checked="" type="checkbox"/> Area Bent Down		20mm x 400mm

<b>PORT SIDE</b> <ul style="list-style-type: none"> <li>- Most forward bilge keel 500mm from leading edge.</li> <li>- Bent down 20mm by 200mm long.</li> <li>- No cracks or damages noted to welds.</li> </ul> <b>STARBOARD SIDE</b> <ul style="list-style-type: none"> <li>- Most forward bilge keel 500mm from leading edge.</li> <li>- Bent up 20mm by 200mm long.</li> <li>- 1m from leading edge bent down 20mm by 400mm.</li> </ul>

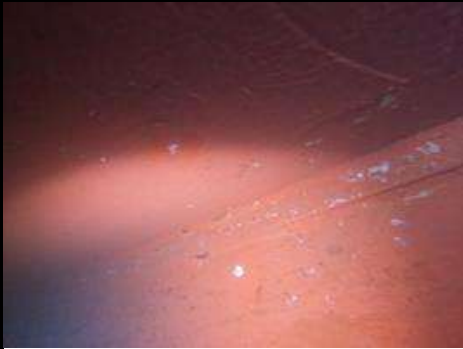
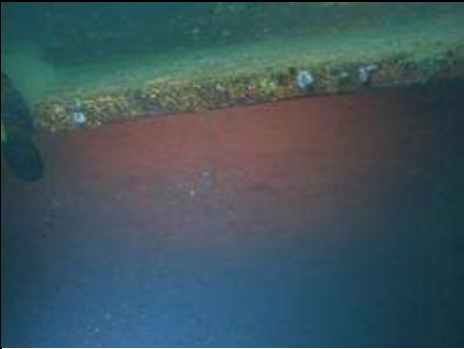
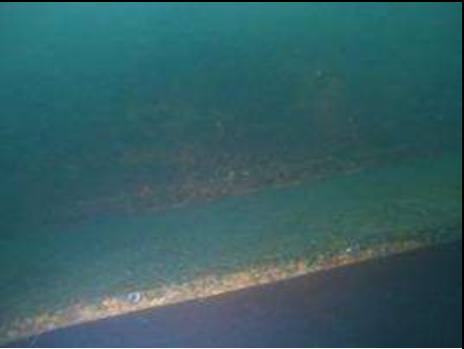
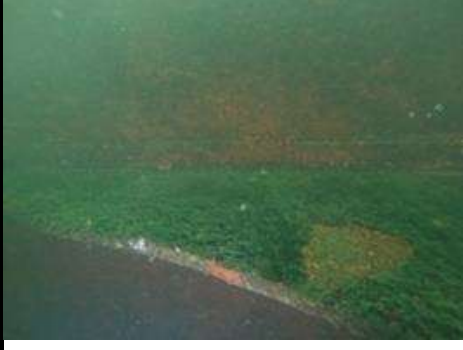
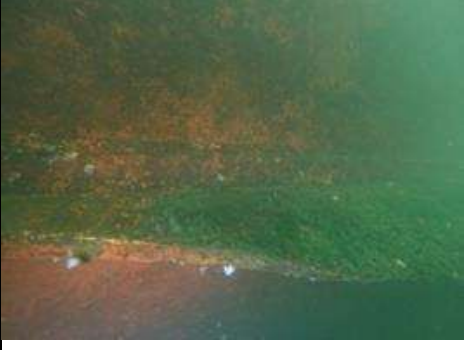
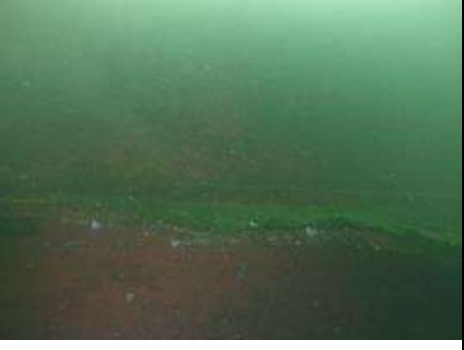
13.4 Bilge keels photos

✓ Last six photos are of the damages noted to the bilge keels.
