DIVING REPORT

Vessel:	GLOBE PEGASUS
IMO No:	9403188
Flag:	MARSHALL ISLANDS
Work Scope:	BILGE KEEL, RUDDER, FLAT BOTTOM, SEA CHEST CLEANING & PROPELLER POLISHING
Performed Date:	July 21 – July 22, 2022
Location:	Thieng Lieng Anchorage, Viet Nam

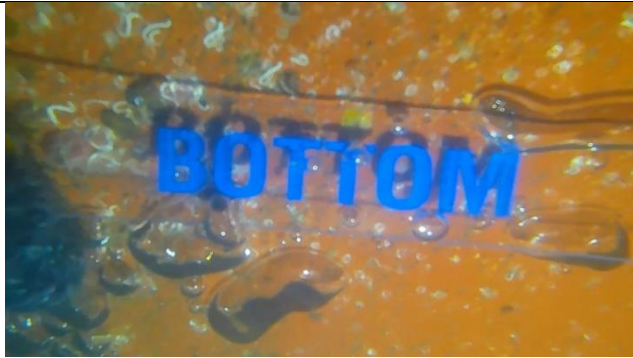
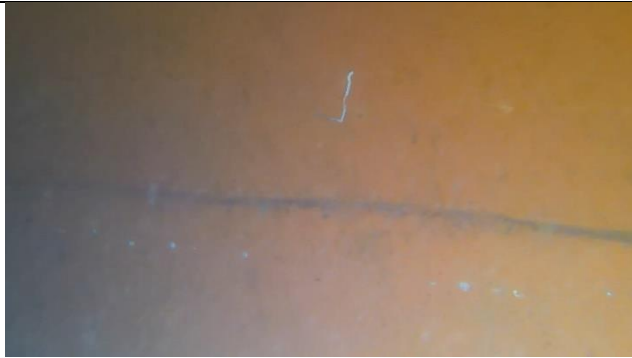
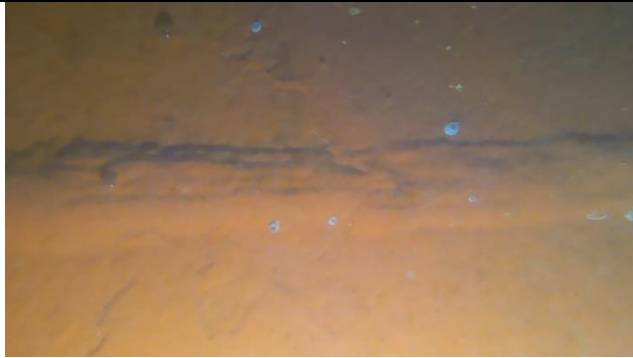
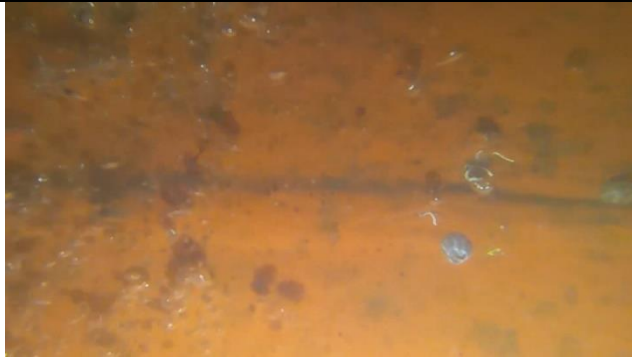
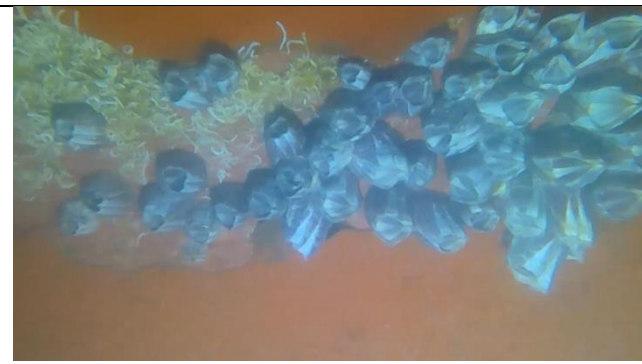
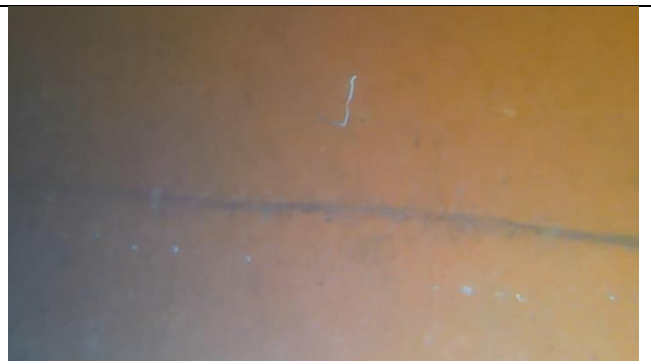
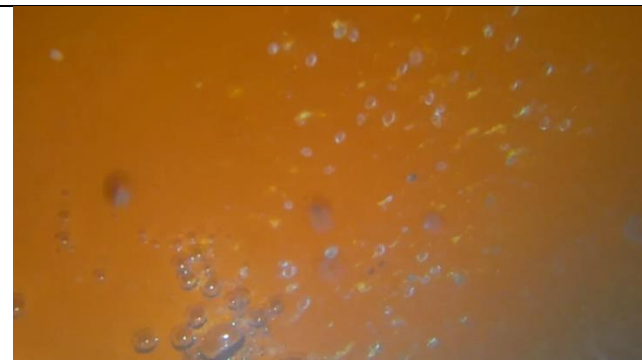
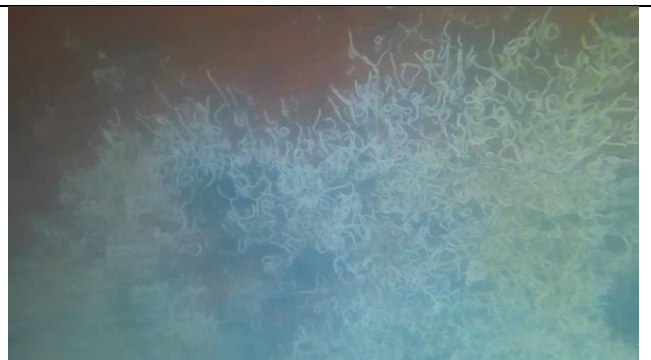
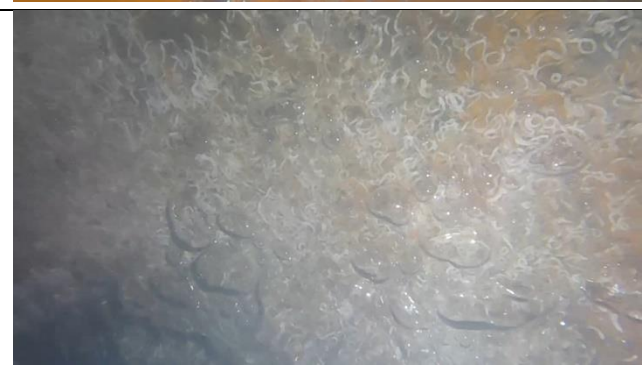
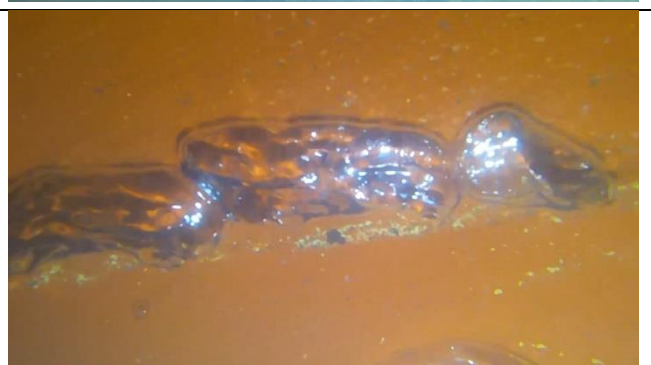
Hull Flat Bottom	
General Condition	<input type="checkbox"/> Good <input checked="" type="checkbox"/> Normal <input type="checkbox"/> Poor
Mechanical Damage	No
Plate Indentation	No
Weld Seams	In normal condition
Coating	In normal condition
Fouling	Cover 15% Barnacles & Tubeworm
Before Cleaning

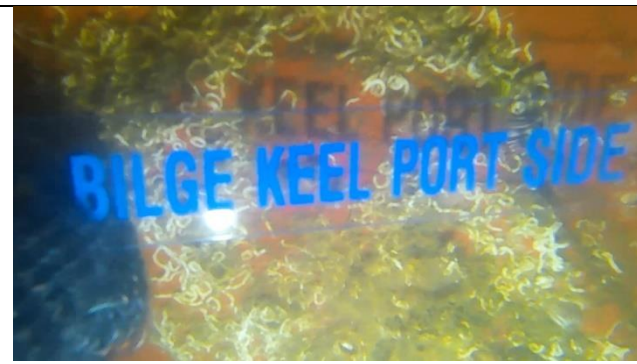
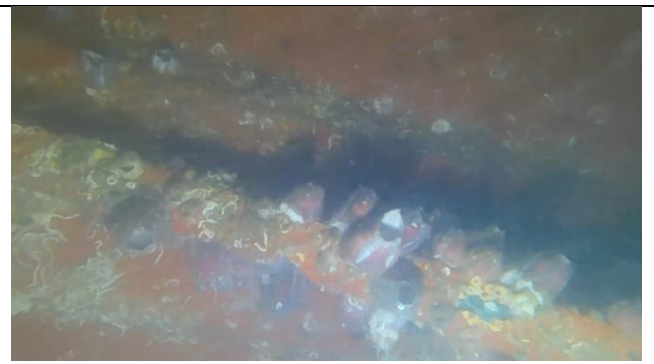
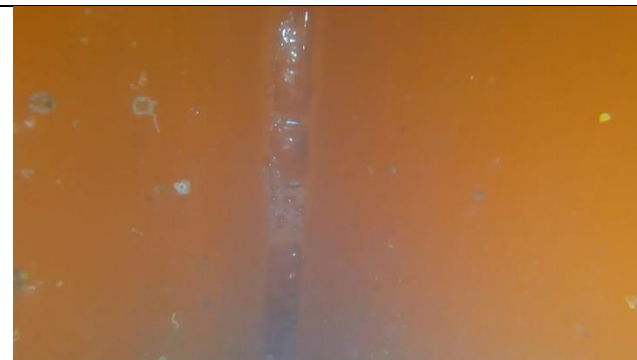
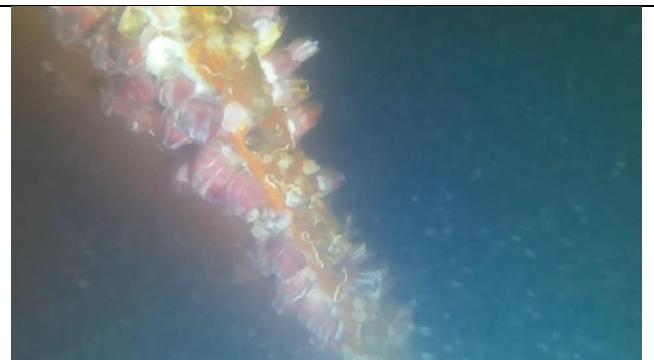
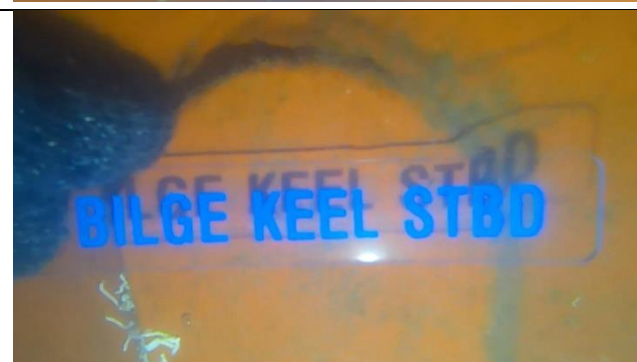
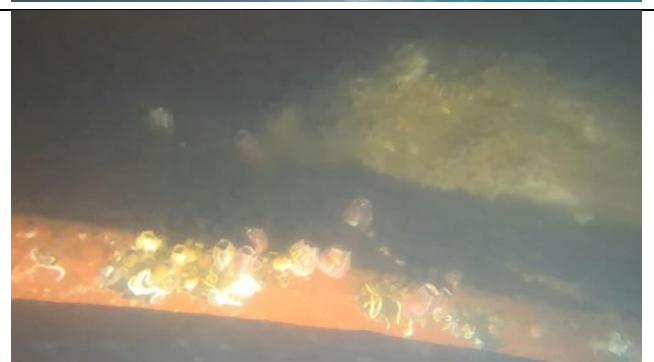
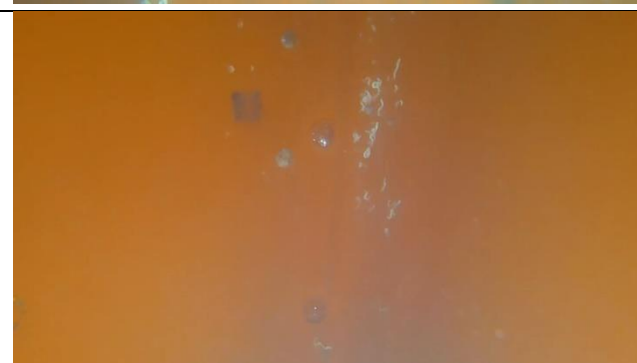
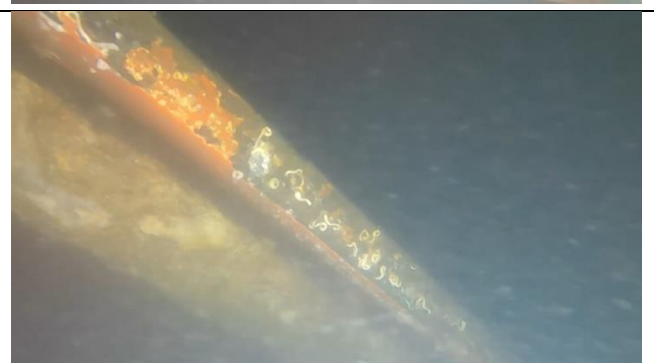
General Condition	<input type="checkbox"/> Good	<input checked="" type="checkbox"/> Normal	<input type="checkbox"/> Poor
Mechanical Damage	No		
Weld Seams	In good condition		
Coating	In normal condition		
Fouling	Cover 30% Barnacles & Tubeworm		
Before Cleaning

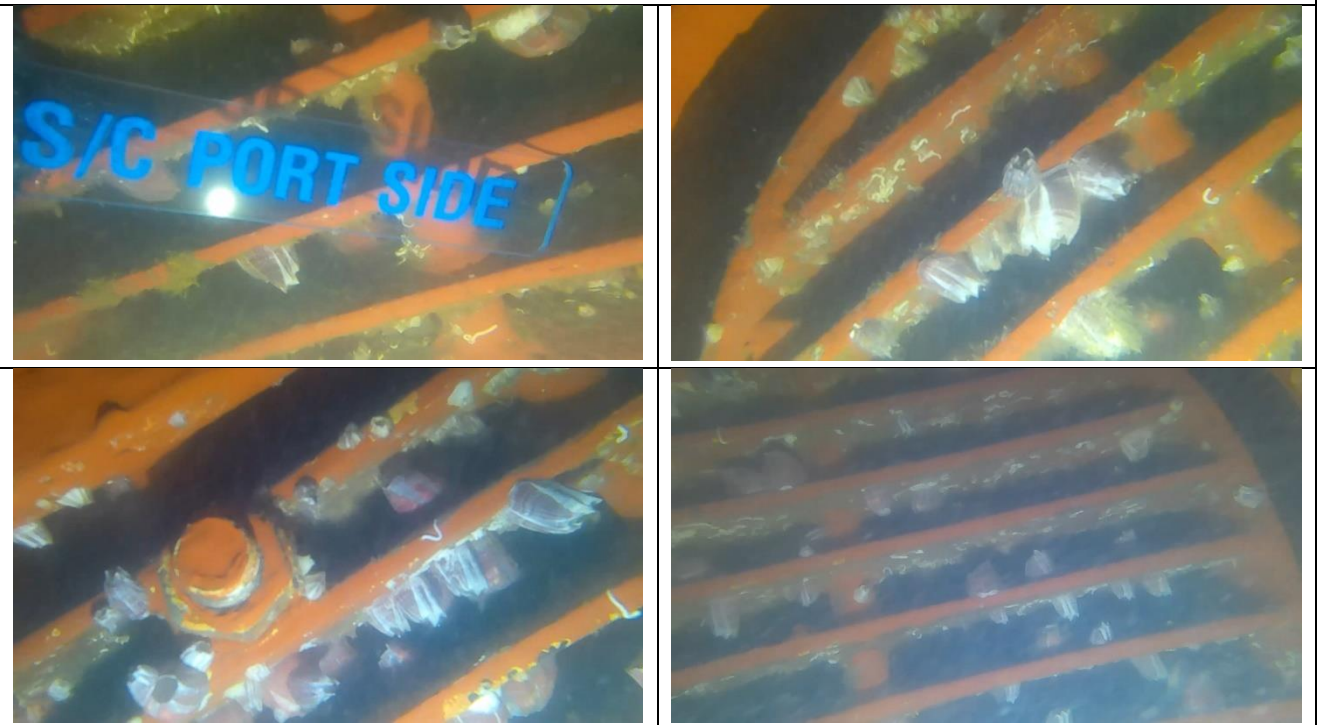
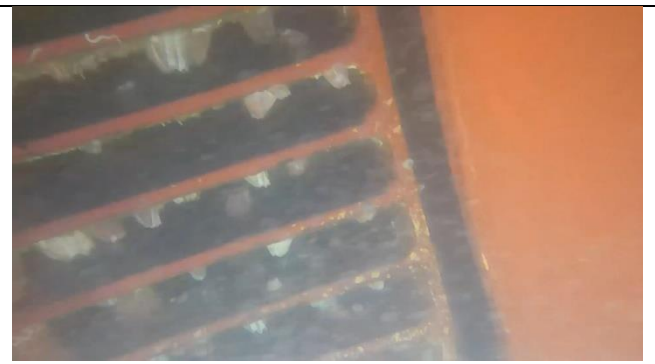
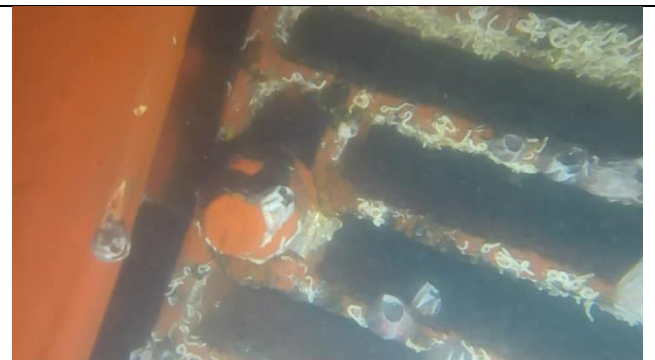
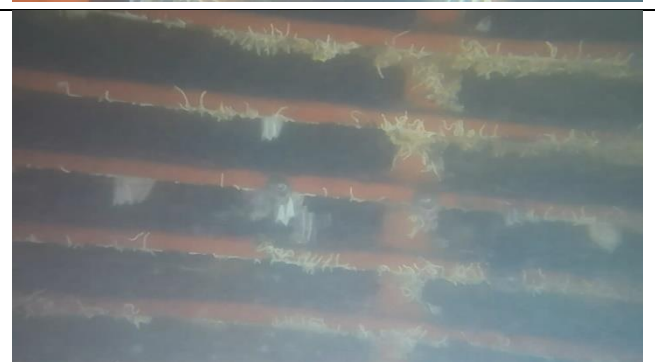
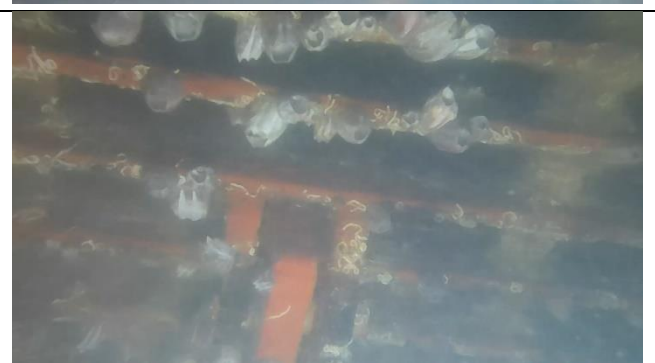
Before Cleaning

Grating Condition	<input type="checkbox"/> Good	<input checked="" type="checkbox"/> Normal	<input type="checkbox"/> Poor
Mechanical Damage	No		
Securing Type	Bolted		
Bolts Condition	Intact		
Fouling in Grating	Cover 80% Barnacles Sea Chest – Port side & 50% Barnacles Sea Chest – Starboard side

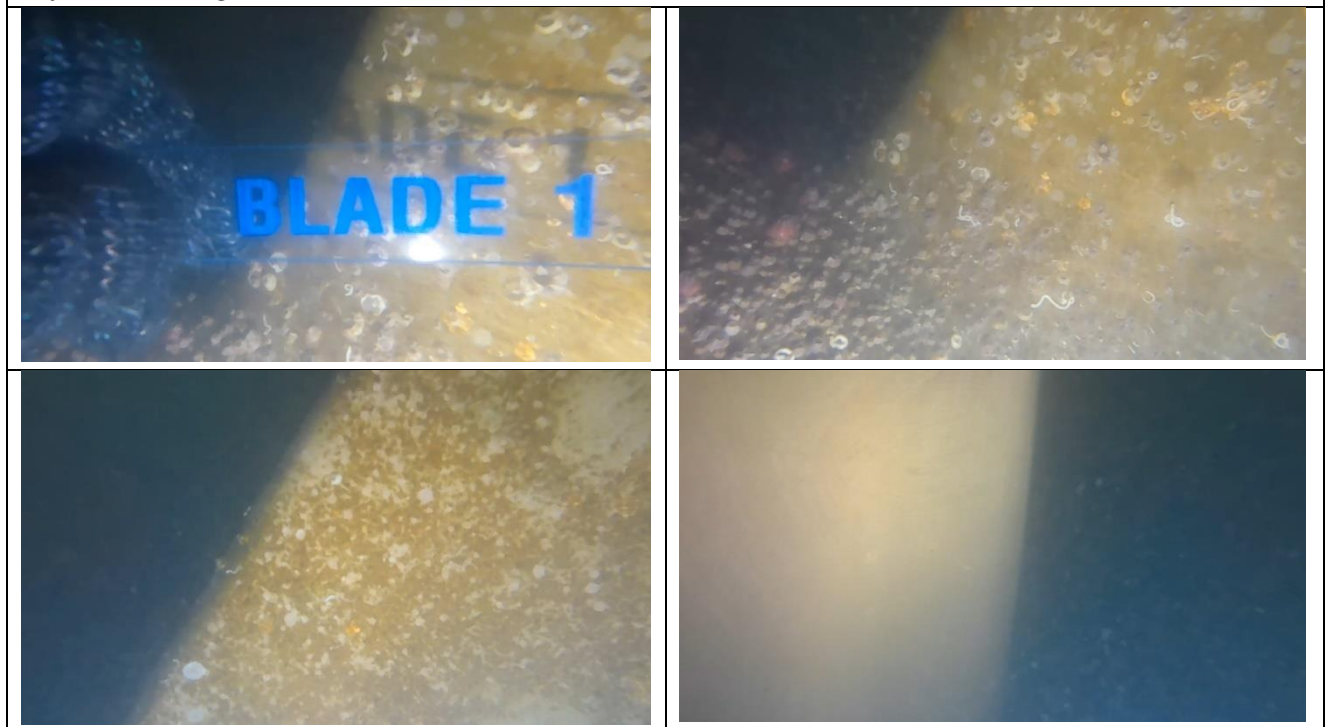
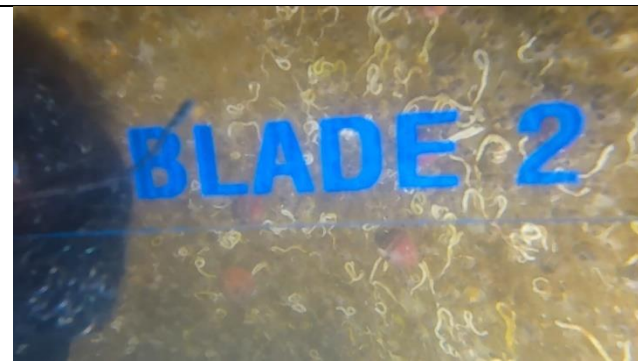
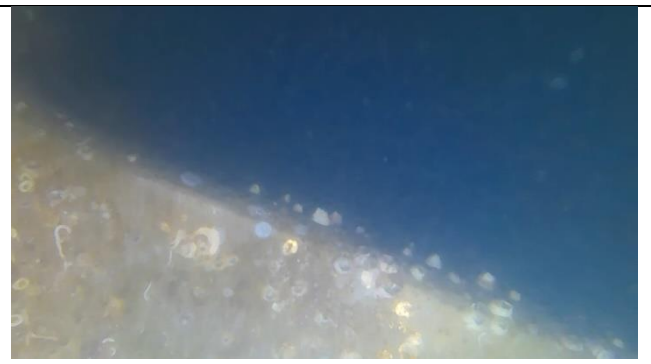
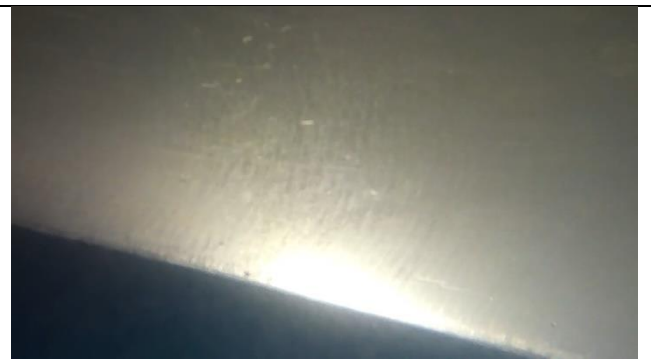
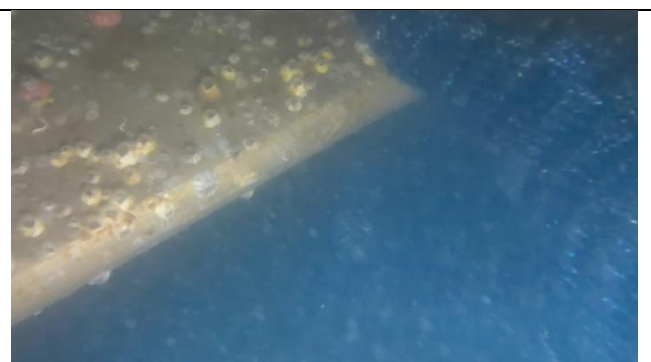
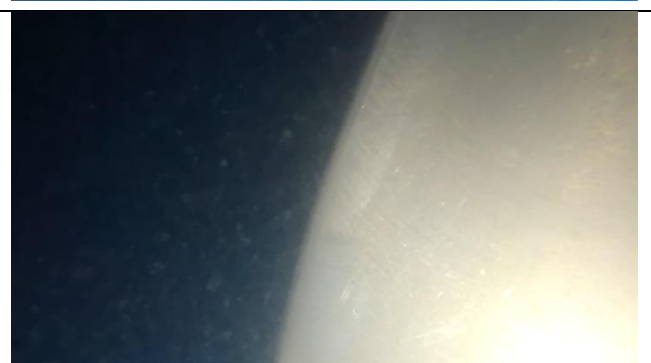
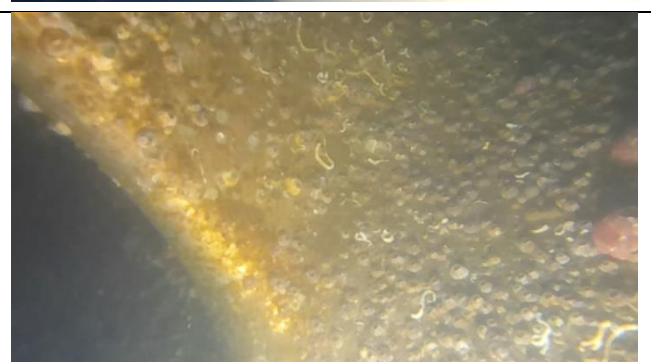
Before Cleaning

Location	<input checked="" type="checkbox"/> Center Line	<input type="checkbox"/> Twin Propellers	
Blades	<input type="checkbox"/> Good	<input checked="" type="checkbox"/> Normal	<input type="checkbox"/> Defective
Rope Guard Cover	Plate condition: In normal condition		
	Securing Type: Welded		
	Oil Leaking: No		
	Rope/ Cable/ Net: No		
	Rope cutter: Intact		
Boss Cone	In normal condition		
Fouling	Cover 10% Barnacles & Tubeworm

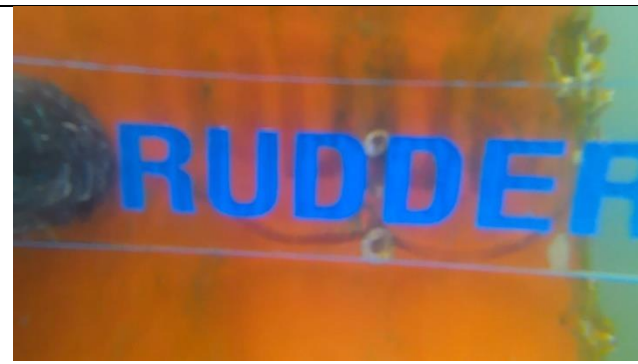
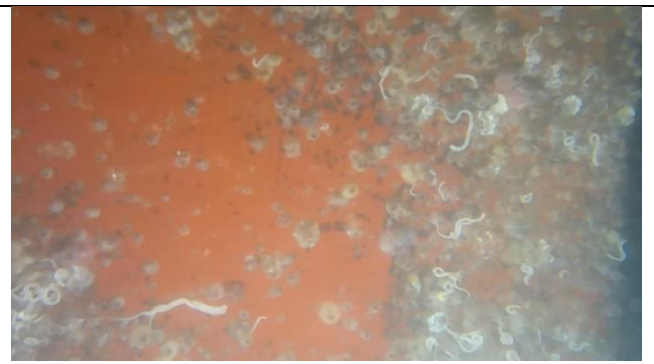
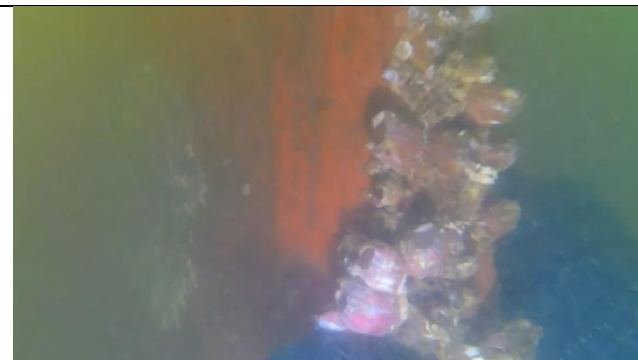
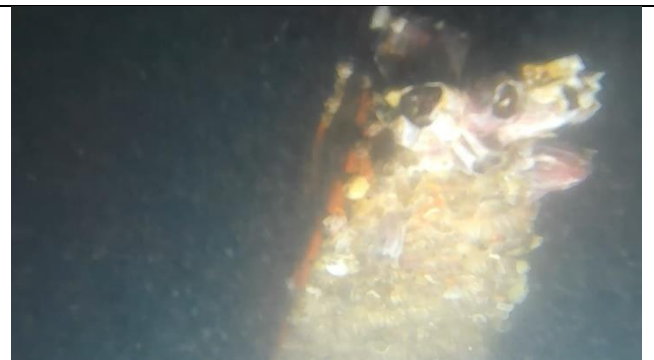
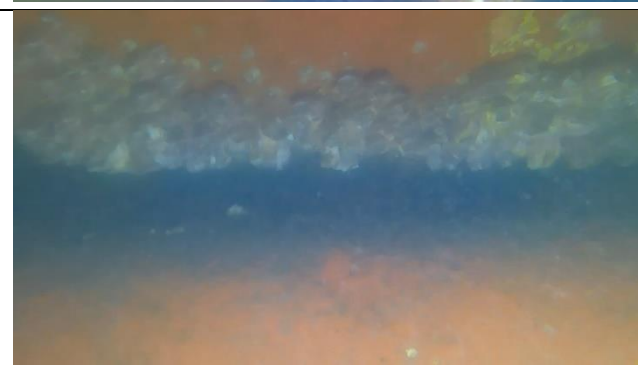
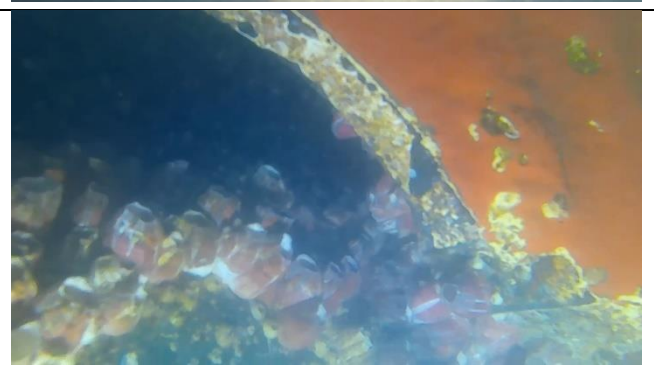
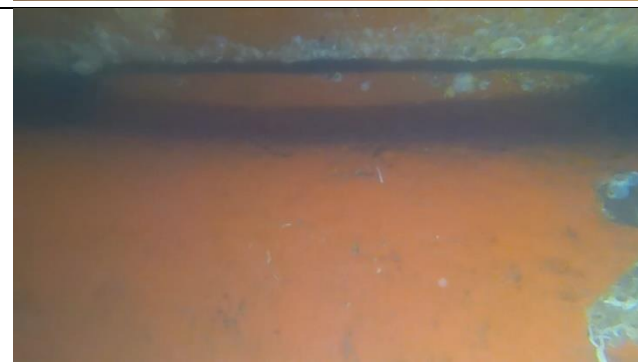
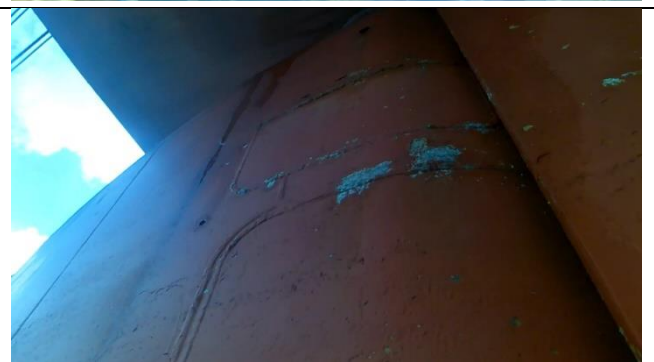
General Condition	<input type="checkbox"/> Good <input checked="" type="checkbox"/> Normal <input type="checkbox"/> Poor
Mechanical Damage	No
Plate Indentation	No
Weld Seams	In normal condition
Bottom Rudder	In normal condition
Corner Plates	In normal condition
Coating	In normal condition
Fouling	10% Barnacles
<i>Before Cleaning</i>
