### STM32F446xC/xE device errata

This document applies to the part numbers of STM32F446xC/xE devices and the device variants as stated in this page. It gives a summary and a description of the device errata, with respect to the device datasheet and reference manual RM00390. Deviation of the real device behavior from the intended device behavior is considered to be a device limitation. Deviation of the description in the reference manual or the datasheet from the intended device behavior is considered to be a documentation erratum. The term “*errata*” applies both to limitations and documentation errata.

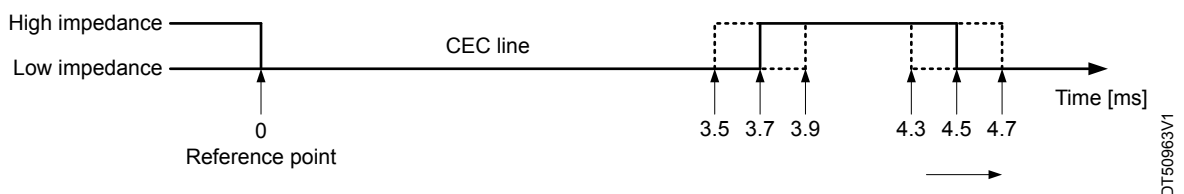
**Figure 2. CEC start bit format with tolerances**

The start bit timing standard tolerances are shown in Figure 2. The start bit is initiated by the device by driving the CEC line low (reference point). After 3.7 ms, the device releases the CEC line and starts checking its level. The following conditions must be met for the start bit to be valid:

If one of these conditions is not met, the transmission is aborted and never automatically retried. No error flag is set and the TXSOM (Tx Start Of Message) bit is not cleared.

The only way to detect this error is for the application software to start a timeout when setting the TXSOM bit, restart it upon ARBLST or any RX event (as the transmission can be delayed by interleaved reception), and stop it upon TXBR (proof that the start bit was transmitted successfully) or TXEND event, or upon any TX error (which clears TXSOM). If the timeout expires (because none of those events occurred), the application software must restart the CEC peripheral and retransmit the message.
