Sparkline							Doc No:	QD/06
							Rev No:	00
							Date:	17.05.17
Problem Statement		Part Number	461 UFA	Date	Issue No.	Responsible dept	Responsible	Issue observed at : DICV Line
Bottom attachment beam fitment issue		Part Name :	9T UFA	10.03.18	-	SEPL Quality & Production	Praveenkumar	07-02-2018
		Supplier Name :	Spark line Equipments					
Problem Description		Defect Photo		Cause validation symbols for results: O= no direct cause X= direct cause Δ= inexplicit cause				
Bottom attachment beam distance from 8th cross member to bkt unersize by 20mm

Sparkline							Doc No:	QD/06
							Rev No:	00
							Date:	17.05.17
Problem Statement		Part Number	4.2 tons B3	Date	Issue No.	Responsible dept	Responsible	Issue observed at : Saint gobain
Base frame and side frame II fitment issue at customer end.		Part Name :	Collier	26.10.17	-	SEPL Quality	Praveenkumar.s	24.10.17
		Supplier Name :	Spark line Equipments Pvt. LTD					
Problem Description		Defect Photo		Cause validation symbols for results: O= no direct cause X= direct cause Δ= inexplicit cause				
Base frame and side frame II locking hole offset which leads to fitment issue at customer end.

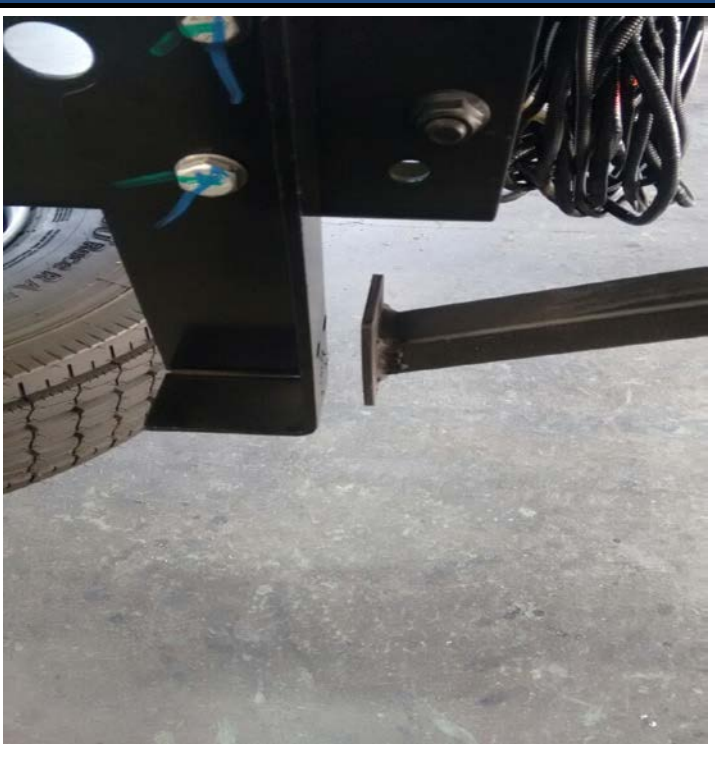
No.	Investigation method	Weightage	WHY?	
				1-	Unawre of the dimension and criticality of the dimension.	O	Bottom attachment beam distance from 8th cross member to bkt unersize by 20mm	
Inspection Lot: 3				2-	Part was wrongly fixed at the time of part fixing.	X	WHY?	
Affected / Blocked Quantity : 1				3-	Attachment beam lenght inspection missed by the quality inspector on the fixture.	O	WHY?

4-	UFA is Inproperly mounted on the levelling fixture during levelling	O	WHY?	
				5	Operator skill is not enough to fix the parts.	X	WHY?	
Probable root cause:								Root cause
1-Unawre of the dimension and criticality of the dimension.								1-Part was wrongly fixed at the time of part fixing.
2-Part was wrongly fixed at the time of part fixing.								3- Attachment beam lenght inspection missed by the quality inspector on the fixture.
3- Attachment beam lenght inspection missed by the quality inspector on the fixture.								
4- UFA is Inproperly mounted on the levelling fixture during levelling								
5-Operator skill is not enough to fix the parts.								
Interim containment action								
When(Date)	Containment Action By Whom	OK Quantity	Rejected Quantity					
At DICV :	SEPL Representative	2	1					
At SEPL :	Quality inspector	3	3					
Cause & Effect

Corrective action					
No.	Countermeasures	Who	When	Status	Validation
1	All attachment beam distance must be inspected	SEPL	8.02.18	Started	Continuously followed
2	Poke-yoke is provided to control attachment beam lenght within limit	SEPL	10-02-2018	Completed	After implementing no issues found on the further dispatches.
Horizontal deployment process - Preventive action					
Will be applicable for all models of 9T Under frames

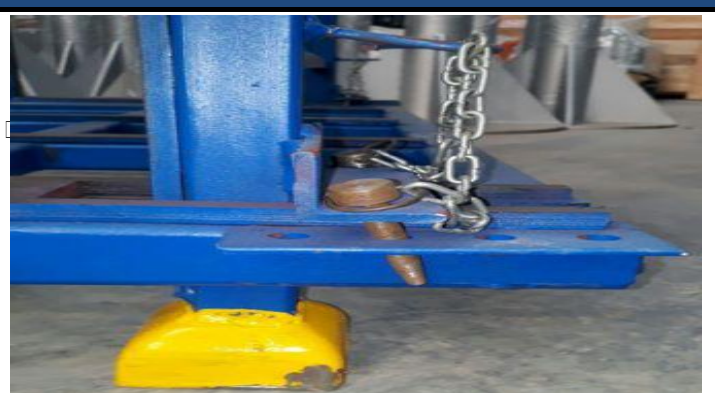
No.	Investigation method	Weightage	WHY?	
				1	Base frame locking angle fixed at wrong location by Fitter.	X	Base frame and side frame II fitment issue at customer end.	
Inspection Lot: 15				2	Unaware of criticality of the issue.	O	WHY?	
Affected / Blocked Quantity : 1				3	Locking angle fixed by manual	X	WHY?

WHY?	
							WHY?	
Probable root cause:								Root cause
1- Base frame locking hole offset at LH side due to wrong fitment.								Locking angle fixed by manual
2-Locking angle fixed at wrong location by Fitter.								
3-Unaware of criticality of the issue.								
4-Locking angle fixed by manual								
Interim containment action								
When(Date)	Containment Action By	OK Quantity	Rejected Quantity					
At Saint gobain:	SEPL Representative	14	1					
At SEPL :	Quality inspector	20	-					
Cause & Effect

Corrective action					
No.	Countermeasures	Who	When	Status	Validation
1	Base frame locking angle fixed on the fixture	SEPL	From next dispatch	Completed	After implementing no issues found on the further dispatches.
Horizontal deployment process - Preventive action					
Same procedure will be followed for J1 collier.
