PROBLEM & COUNTERMEASURE SHEET (PCM)								COORDINATOR Bhavesh shirode		
TEAM Members	Josan,Sai krishna,Nirmal,Parthiban,Praveenkumar, soundhar ,Mohanbabu,Alaguraja,selvam								DATE 22-02-2018		
DESCRIPTION	MAIN ASSEMBLY	DATE RAISED	SKETCH	CAUSE	Action	RESP.	DEPARTMENT	FOLLOW-UP DATE	Result RAG Status	Date DATE	STATUS
5th to 6th cross member centet tube missing	UFA 461	22-02-2018

PROBLEM & COUNTERMEASURE SHEET (PCM)

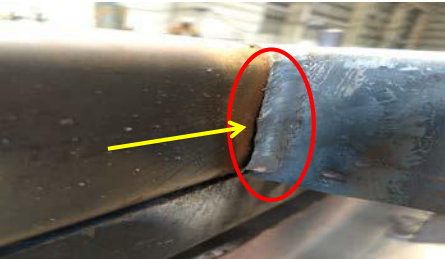
PROBLEM & COUNTERMEASURE SHEET (PCM)										COORDINATOR Bhavesh shirode	
TEAM Members	Josan,Sai krishna,Nirmal,Parthiban,Praveenkumar, soundhar ,Mohanbabu,Alaguraja,selvam,prakesh								DATE		19-03-2018	
DESCRIPTION	MAIN ASSEMBLY	DATE RAISED	SKETCH	CAUSE	Action	RESP.	DEPARTMENT	FOLLOW-UP DATE	Result Date		STATUS	
Floor support angle weld crack	UFA 618	19-03-2018

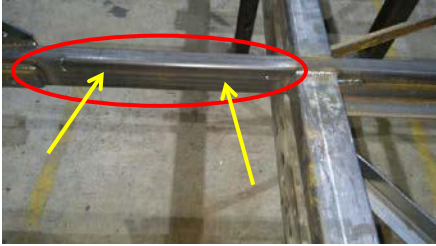
PROBLEM & COUNTERMEASURE SHEET (PCM)								COORDINATOR Bhavesh shirode		
TEAM Members	Josan,Sai krishna,Nirmal,Parthiban,Praveenkumar, soundhar ,Mohanbabu,Alaguraja,selvam							DATE		09-02-2018	
DESCRIPTION	MAIN ASSEMBLY	DATE RAISED	SKETCH	CAUSE	Action	RESP.	DEPARTMENT	FOLLOW-UP DATE	Result Date		
									RAG Status	DATE	STATUS
5th cross member Floor support angle miss	UFA 461	09-02-2018
