Problem Statement		Part Number :	620 UFA	Date	Issue No.	Responsible dept	Responsible Manager	Date:	17.03.17
Bracket Dimension NG and found oversize by 40mm	Part Name :	9T UFA	21.03.18	-	SEPL Quality & Production	Sai krishna	Issue observed at : DICV Line		20.03.18
	Supplier Name :	Spark line Equipments

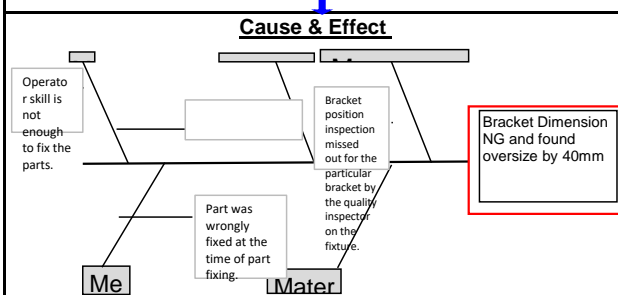
Problem Description		Defect Photo
<p>ocket Dimension NG and found oversize by 40r</p>

Bracket Dimension NG and found oversize by 40mm

Part fixing was done wrongly.

1-Part was wrongly fixed at the

2-Bracket position inspection missed out for the particular

No.	Countermeasures	Who	When	Status	Validation
1	Training program is conducted and	SEPL	20.03.18	Completed	Will be monitored for next 10
2	All brackets must be inspected and	SEPL	21.03.18	Started	Continuously followed
