CORRECTION INDEX - MECANOGRAM

Correction Index - Mecanogram No. 1005 includes those Series C Mecanogram items which may be considered as having current value that were previously announced in Mecanogram through No. 597.

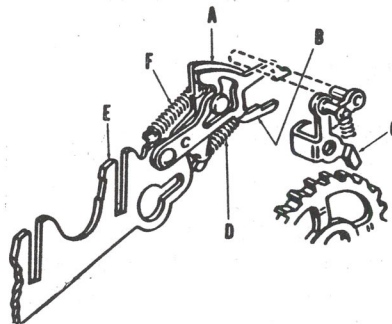
CONDITION: Over addition.

CAUSE: Failure of latch M (Plate 4, Series C Symbol Book) to remain locked on the tie strip when a key is flicked and only partially depressed. Should the drive pawl make contact on the high point of a tooth in the drive gear it will allow latch M to raise prematurely and release the indexed key during the machine operation.

Index slide E contains cam A which is riveted to latch B and held in its raised position by springs F and D. Cam A when depressed by actuation of the drive pawl, increases the spring tension on latch B sufficiently to hold the latter fully indexed on the tie strips regardless of the drive pawl's position on the drive gear teeth.

A longer stud has been added to drive pawl C to actuate the cam of the new index slide.

CORRECTION: Replace indexing slide C and drive pawl P with improved drive pawl C (illustrated), index slide E and springs D and F.

Check for safe clearance between the stud and motor brackets AM (Plate 22) when installing.

C	1A-56101	Drive pawl
D	69806	Spring to latch B
E	1A-56115A No. 1	Index slide
F	3480 1/2	Spring to cam A

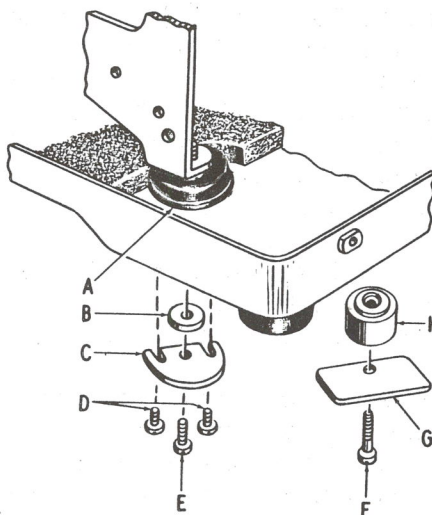
CONDITION: Excessive machine noise.

CAUSE: Machine not insulated from the machine base.

CORRECTION: Rubber shockmounts A (1-50998) are used on all currently manufactured machines except Style C101 to reduce the sound of machine operations. The mounts are held to the machine base by screws D (50558).

To eliminate machine sway and subsequent machine damage during shipment, all styles of currently manufactured machines that include rubber shockmounts A are fitted with solid mounts H when packed. The rubber shockmounts are packed separately, and on receipt of machines, the solid mounts should be removed and the rubber mounts installed and adjusted as follows: (NOTE: Mount H, plate G and screw F should be retained in sufficient quantities for future use.

- a. Remove the machine case.
- b. Disconnect the wires from the motor to the base plug.
- c. Remove the base.
- d. Remove any rubber that may be in the threads of the shockmount screw. Use a 5-44 die Kit 283 No. 4.
- e. Assemble all shockmounts by screwing them to their limits into the threaded hubs of the machine side frames - then back them out approximately two turns.
- f. Reassemble the base.
- g. Reconnect the wires from the motor to the base plug.
- h. Replace the case.
- i. Using a screwdriver in the shockmounts slots (which are accessible through holes in the base) adjust the height of the machine for about .005" clearance between the case and the keyboard panels - always taking the same number of turns in each shockmount.
(Noise will be transmitted if the case and keyboard contact).
- j. Secure the shockmounts to the base with screws D.

When Field machines in use - equipped with rubber shockmounts - are to be shipped, remove the shockmounts and replace with solid mount H, locking plate G and screw F.

Prior to the adoption of solid mounts H for shipping purposes, the rubber shockmounts were originally pulled down tight and retained by plates C, washers B and screws E when being prepared for shipment. In the event a machine is received from stock packed thusly, remove screws E, plates C, and washers B and adjust the rubber shockmounts as explained above.
