Chapter 3

Observations of the Casting Process and the Occurrence of Leakers in the Water Inlet Casting

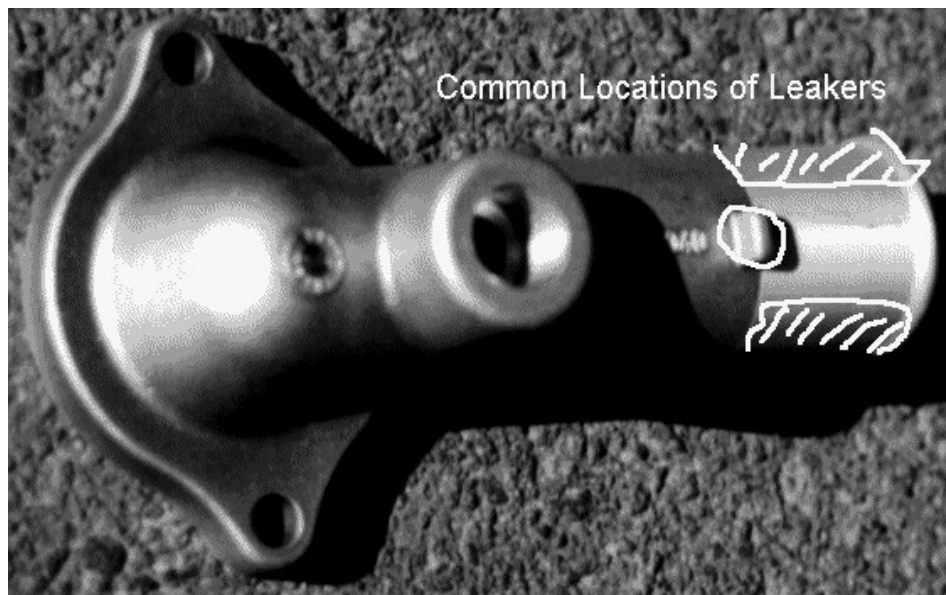
The first clue as to the mechanism of leaker formation is their location. In the case of the water inlet the location of leakers is fairly consistent. Most leakers occur on or near the machined end of the tube. The majority of these leakers occur on or near the parting line of the casting. However, leakers can occur at any point on the circumference of the machined area. A smaller number of leakers occur near the bases of the lugs on the top and bottom of the tube. In this case the leak may occur through the shot blasted surface rather than the machined surface. Figure 3.1 shows these areas.

Figure 3.1 Photograph of Water Inlet Casting Showing Common Sites of Leakers.

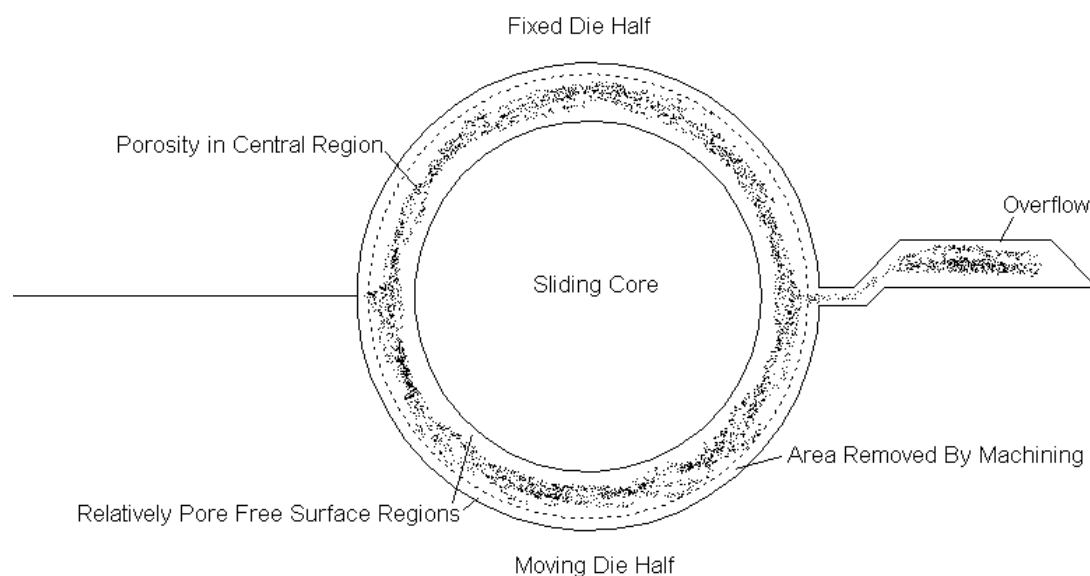
The tendency for many leakers to occur near the parting line may be explained by the presence of the gate to the overflows which provides an area where the internal porosity will be shifted towards the area to be machined. Figure 3.2 shows the likely effect of machining at the tube end. Under certain conditions and within certain regions the process of machining the tube will expose internal porosity. This provides a leak path through the outside surface of the tube.

Figure 3.2 Likely Porosity Distribution at Tube End, Showing Effect of Overflows and Machining.

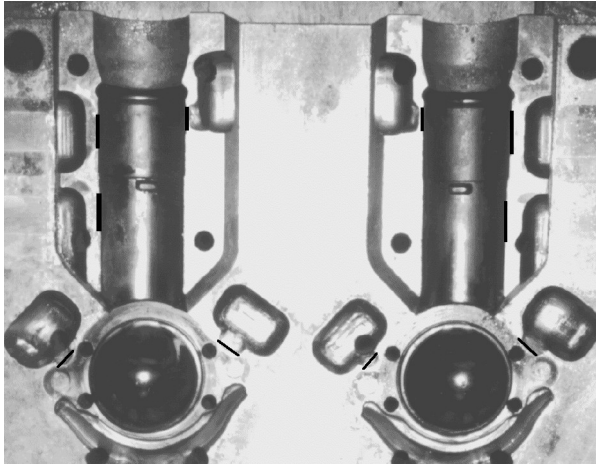
This raises the question of whether a strong correlation exists between the location of overflow gates and the location of leakers. Figure 3.3 shows the location of overflows and the corresponding gates. Gates are present on each side of the tube end. In a small number of cases leakers occurred at locations exactly corresponding to these gates, but in the majority of cases the location of leakers did not match the location of the gates to the overflows.

Figure 3.3 Water Inlet Die Cavity Showing Location of Overflows. The Gates to the Overflows are Marked in Black.

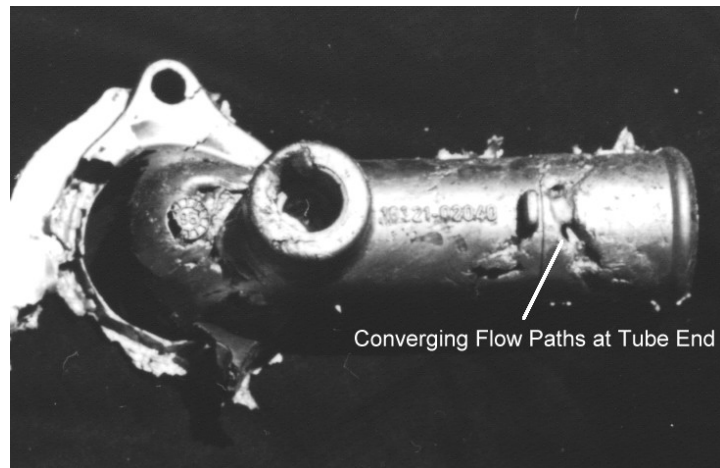
The end of the tube is located at the part of the cavity most remote from the gate. Metal reaching this area will have traversed the rest of the cavity, losing heat along the way. Due to the shape of the cavity and the way it fills this area is also subject to a number of converging flow streams. This flow pattern is confirmed by examination of short shots, see Figure 3.4. Here we see that two flow paths are in the process of coming together at the end of the tube. This makes this area susceptible to the formation of cold shuts when the heat lost by the flowing metal is sufficient to cause premature solidification. We would expect cold shuts to form in some locations at the tube end in preference to others.

Figure 3.4 Short Shot Showing Last Areas to Fill.

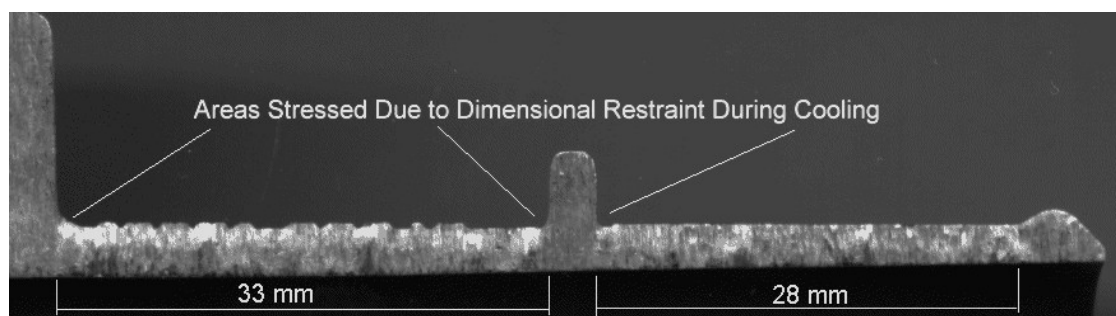
The lugs provide a restriction to the shrinking of the casting. Thus there will be stress applied to the base of the lug as the casting shrinks during cooling. Figure 3.5 shows the locations at the base of the lug where stresses induced by volumetric contraction of the casting during cooling will occur.

Figure 3.5 Restrained Sections Near Tube End.

Comparing this value with a yield strength of 165 MPa and a ultimate tensile strength of 330 MPa [37] we see that yielding and indeed fracture is likely. However, due to the small distances involved, about 30 mm (see Figure 3.5), the amount of yielding necessary to relax the stresses involved will be small. For a strain of 0.0053 m/m over a distance of 0.03 m, the displacement caused by yielding will be:

These calculations are very approximate as they use material properties based on room temperature conditions which will not be the case during casting. Nonetheless, they show that cracking due to solidification stresses is possible, but that due to the small restrained distance, any cracking will be of very small size. Nonetheless, it is possible that the action of solidification stresses will worsen any defects present such as cold shuts and gas porosity.

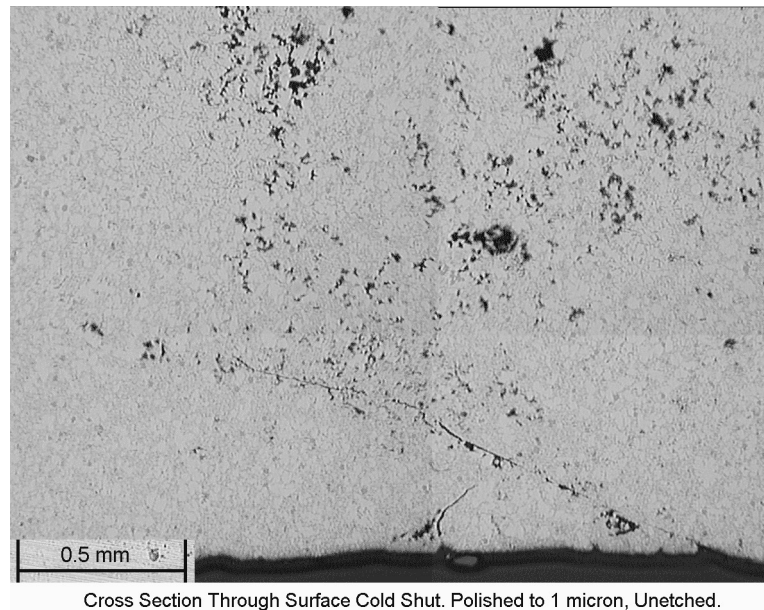
- ★ The cold shuts observed on the internal face of the tube allow a path through the otherwise sound surface layer into the central regions of the casting. This concept is well illustrated by Figure 3.6.

Figure 3.6 Cold Shut at Surface of Leaking Casting Leading to Porous Inner Region.

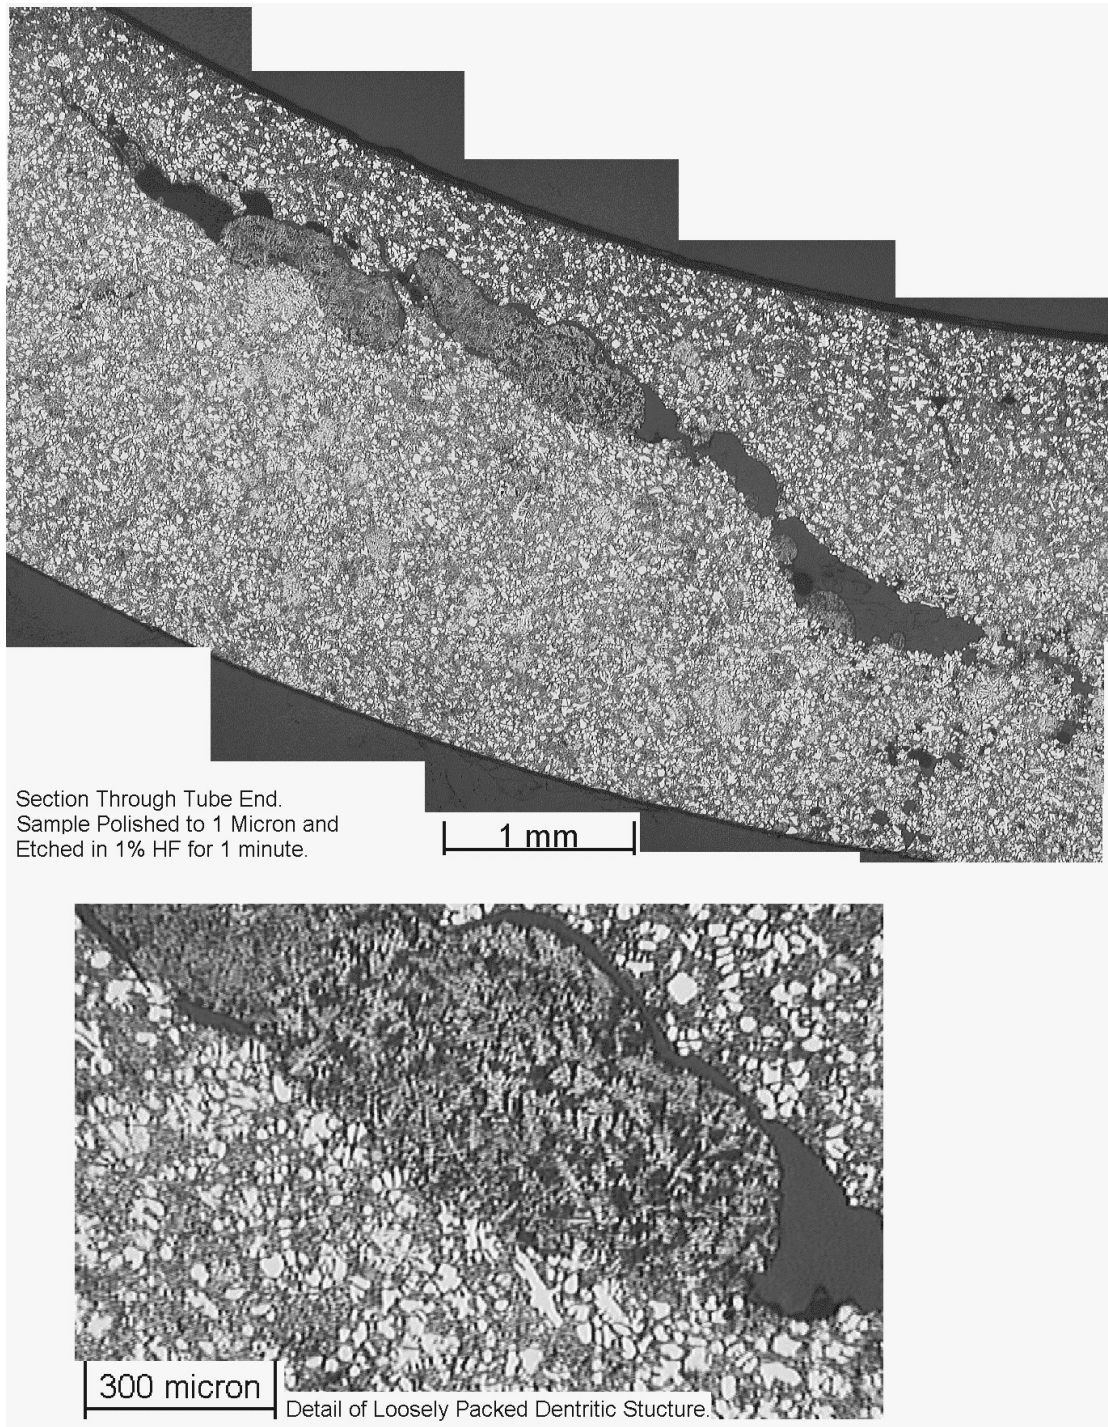
- ★ In some cases the cold shuts visible on the surface are indicative of larger defects present within the casting. Such larger defects may provide a leakage path through the body of the casting. Such a case is illustrated in Figure 3.7. In this case a number of small cold shuts were visible on the casting as well as porosity on the external tube face. Sectioning revealed a very large void associated with a cold shut. Figure 3.7 shows an overall view of the cold shut defect as well as an expansion of an interesting microstructure found within the cold shut.
- ★ The consistent position of cold shuts suggests that they are caused by poor flow patterns within the die coupled with an excessive fill time.

Comparison of actual fill times with calculated ideal fill times shows that the actual fill times are generally less than the calculated maximum fill times, see Appendix B. This suggests that this casting is especially prone to cold shutting due to poor

fill patterns. As such the fill times need to be considerably shorter than the values suggested by calculation. Such fill times are generally achieved in practice as the majority of castings are free from cold shuts. In cases where cold shuts have occurred it is likely that the maximum allowable fill times have been reduced by changes in the heat transfer rate between the metal and die. It is unlikely that the actual fill times would vary significantly.

Figure 3.7 Large Cold Shut Leaving Void Through Casting Centre.

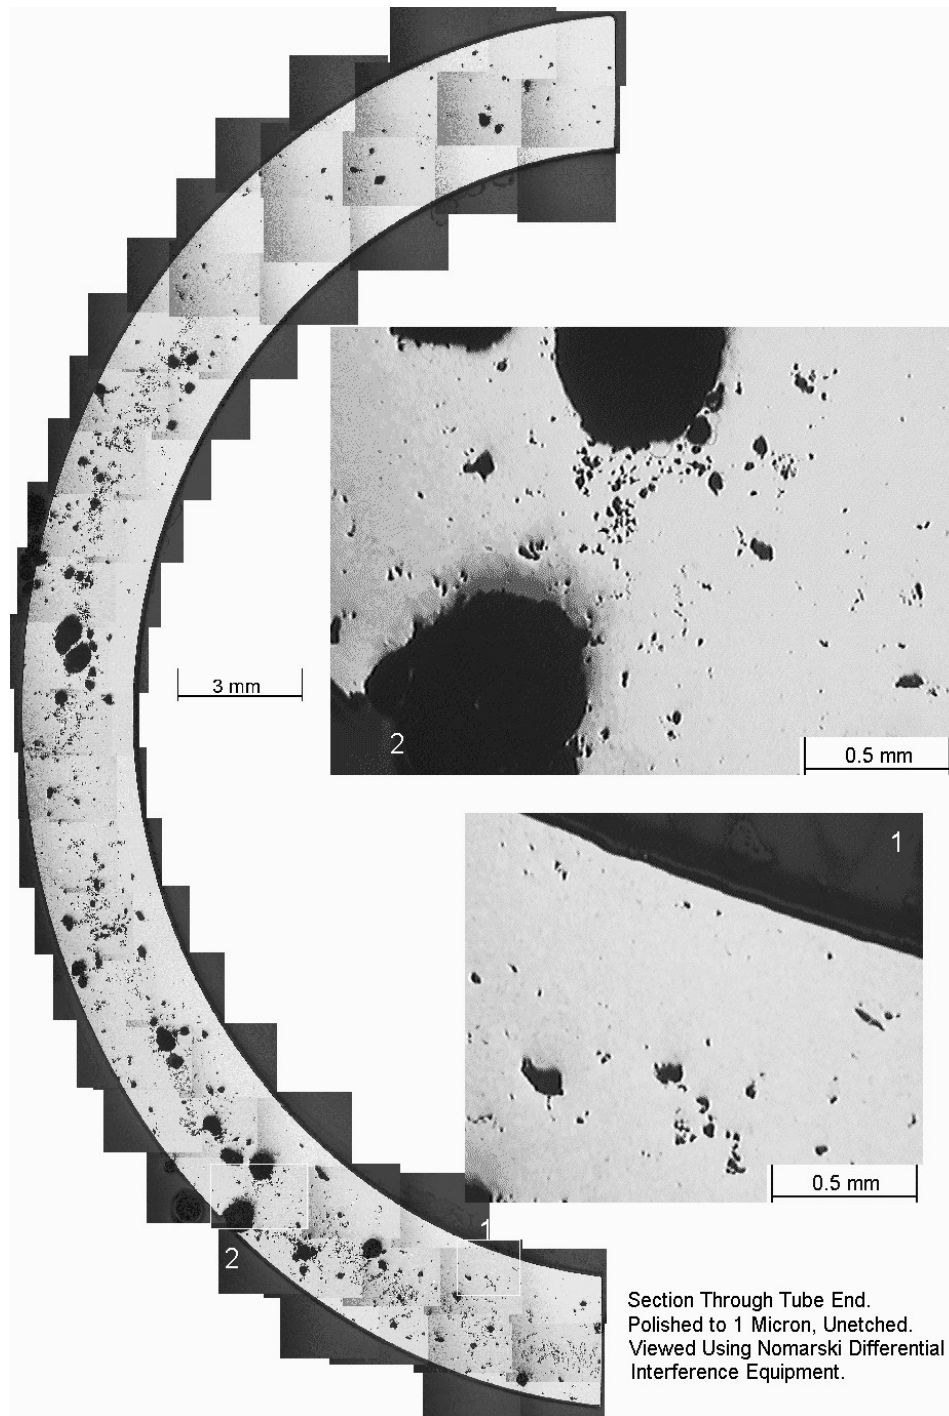
Nonetheless, in many cases exposed pores are noted on leakers. In cases where these exposed pores are due to shrinkage porosity or cold shuts it is easy to conceive how they may be linked to internal paths for leakage. However, this will only occur in the minority of cases. In the majority of cases the exposed pores appear to be the result of gas porosity. In these cases the potential still exists for an interconnected leak path to extend from a gas pore. Figure 3.8 shows a section through a leaking casting that displayed significant exposed porosity on the machined surface. The expansion of Area 2 shows the manner in which an exposed gas pore can be very nearly linked through smaller pores to other pores.¹ As the casting carries on either way in the dimension perpendicular to the page, it is likely that linkage of the pores will occur in this third dimension as well. With this in mind it is apparent that in some cases links may occur further through the casting. This exposed porosity may therefore be linked to the formation of leakers.

In a similar manner, Area 1 shows porosity near the inner surface of the tube. The pores get very close to, but do not actually break the surface. Remembering that the

¹ Interestingly we see what appears to be inter-linked shrinkage porosity in close proximity to the gas pores. Referring to Sections 2.3.4 and 2.3.8 of the literature review we recall the uncertainty surrounding the interaction between gas and shrinkage porosity. Figure 3.8 suggests that the presence of gas porosity may retard shrinkage feeding.

casting continues on in three dimensions it is possible that breakage of the surface occurs in a parallel plane due to small shrinkage porosity or small cold shuts.

Figure 3.8 Extensive Gas Porosity Found Through Section of Tube End.²

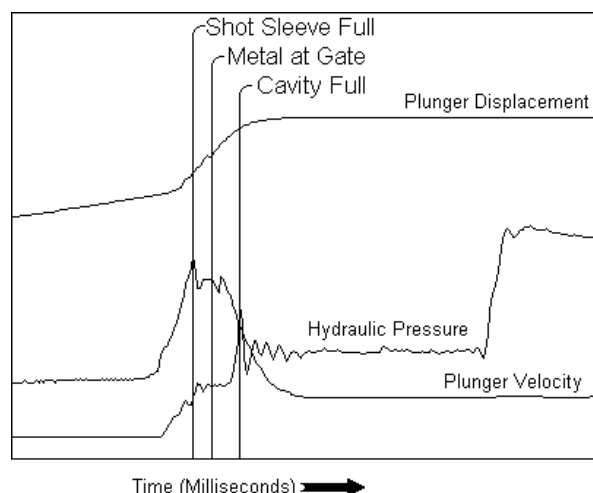
Figure 3.9 Shot Timing for Water Inlet Casting.

thus gas entrapment. If we use the most basic approaches outlined by [9] we find that while the velocities and accelerations used are near the theoretical optimal values, the change-over from the first to second stage occurs significantly earlier than would be expected, see Appendix C. The plunger accelerates to the high velocity second stage while the remaining shot sleeve volume is only 70% full of alloy. The result of this is that a very large proportion of air will

be entrained by the molten alloy as the plunger accelerates to second stage velocity. Figure 3.9 shows an actual shot trace with the “shot-sleeve full” point marked. We can see that the plunger has begun acceleration well before this point.

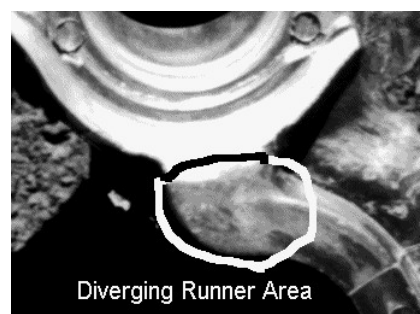
Examination of the runner system indicates that there is a section at which the runner rapidly diverges. This is highlighted in Figure 3.10. Such a section will mean that the rapidly advancing metal front will separate at this point allowing further gas entrapment. Short shots indicate that at this point the momentum of the molten metal causes the metal flow to maintain a reasonably straight trajectory, flowing up and through the outside gate. This effect is shown in Figure

Figure 3.10 Diverging Runner Section of Water Inlet Casting.

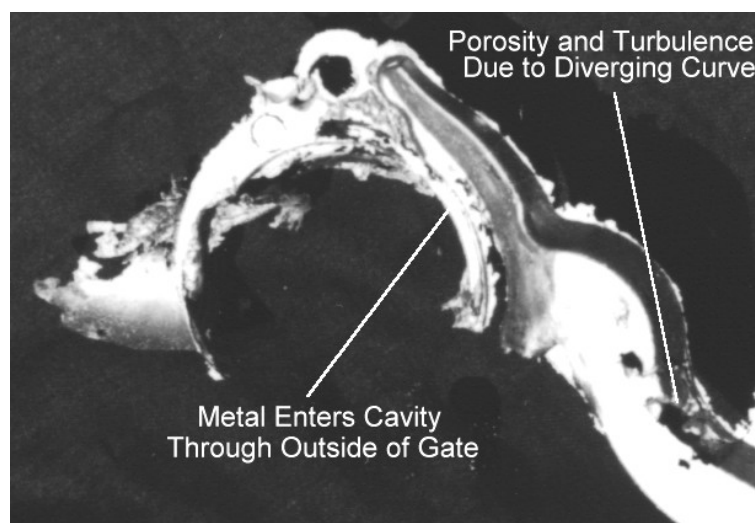
3.11. This results in large areas that will remain unfilled after the die vents have been sealed off. Air in these unfilled areas will remain trapped within the casting.

Figure 3.11 Short Shot Showing Flow Through Runner.

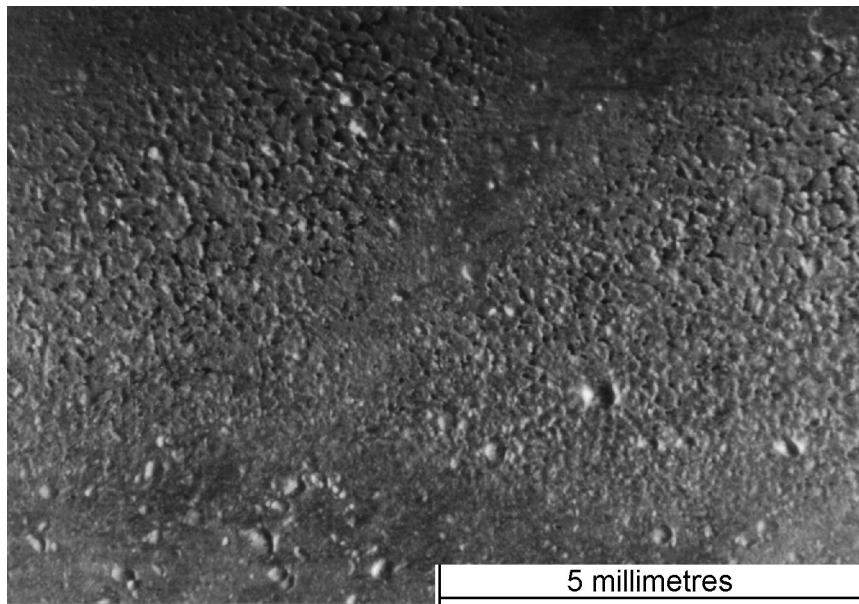
This defect was infrequently observed on the internal surface of leaking castings. Usually its appearance is coupled with excessive cold shutting. Figure 3.12 shows an example of this defect.

Figure 3.12 Surface Porosity on Internal Face of Tube.

The pores' discoloured appearance and pattern of occurrence suggests that they are caused by the volatilisation of die lubricant. As well as the application of die spray every shot there is a periodic application of thick, waxy lubricant to the die. The application of this lubricant slows the cycle slightly allowing the die to cool momentarily. This will increase the likelihood of cold shutting.

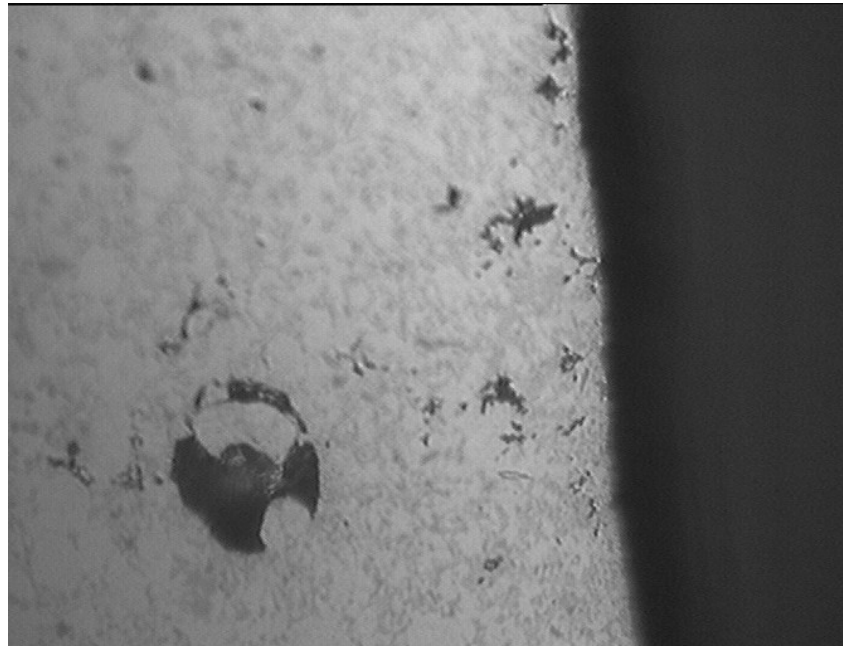
Figure 3.13 shows a case where sectioning through the visible surface porosity revealed a series of interconnected pores leading into the centre of the casting. Figure 3.14, however, shows a case where sectioning through apparently similar surface porosity revealed large pores running parallel to the surface of the casting but failing to lead into the centre of the casting.

Section Through Surface Porosity on Internal Tube Wall.
Sample Polished to 1 micron, Unetched.
Viewed Using Nomarski Differential Interference Equipment.

Figure 3.13 Section Through Surface Porosity on Internal Face of Tube Leading to Interconnected Pores Within the Casting.

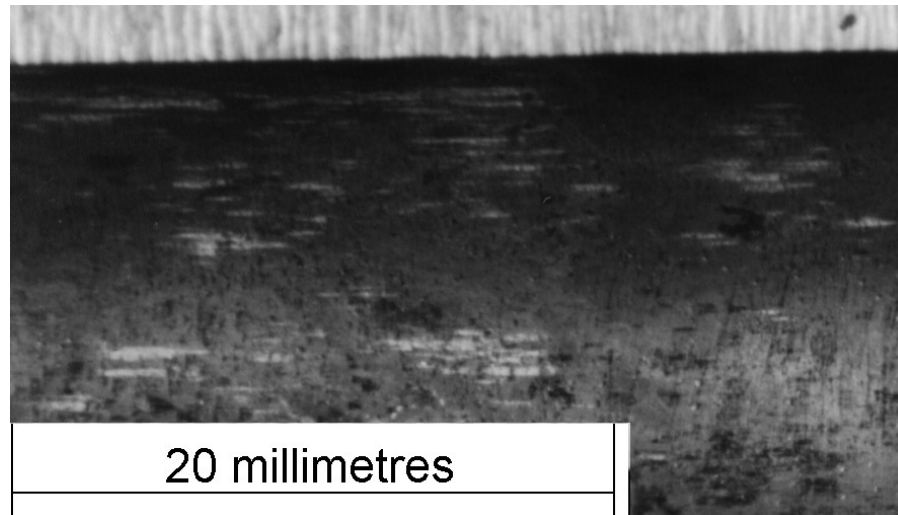
As the sliding core retracts after solidification some sticking occurs leaving drag marks on the internal walls of the tube. Figure 3.15 shows an example of drag marks on this surface.

Figure 3.15 Drag Marks on Internal Wall of Tube.

These are most severe towards the end of the sliding core, ie. towards the base of the tube. This area is well away from the machined end of the tube where nearly all leakers occur. This coupled with the fact that drag marks are found on nearly all castings, regardless of other defects including leakers, indicates that they are not a major cause of leakers in this case.

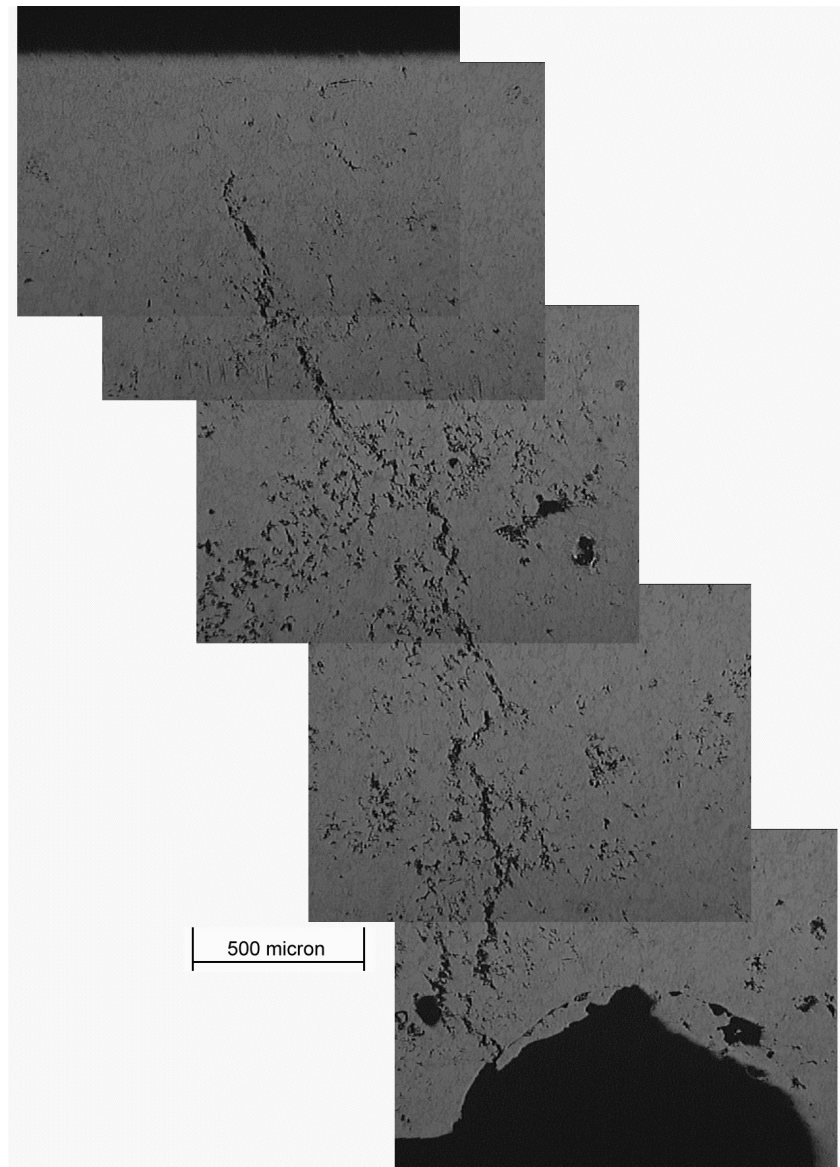
Figure 3.16 Small Crack Running Through Casting Near Base of Lug.

The cracks shown in both Figure 3.16 and Figure 3.17 are very small in width. This is consistent with the calculations in Section . In Figure 3.16 a crack has occurred in a region weakened by shrinkage porosity. Figure 3.17 shows small cracks between the outer surface of the tube and large gas pores present below the surface. It is likely that the cracks are present mainly due to the occurrence of these other defects. It is reasonable to conclude that cracking due to stresses applied after solidification may help cause leakers in some cases, but is unlikely to be the root cause of a leak. In most cases where leakage was observed around the lugs, although cracking was observed around the lugs, other defects such as cold shuts or excessive porosity were also noted on the casting.

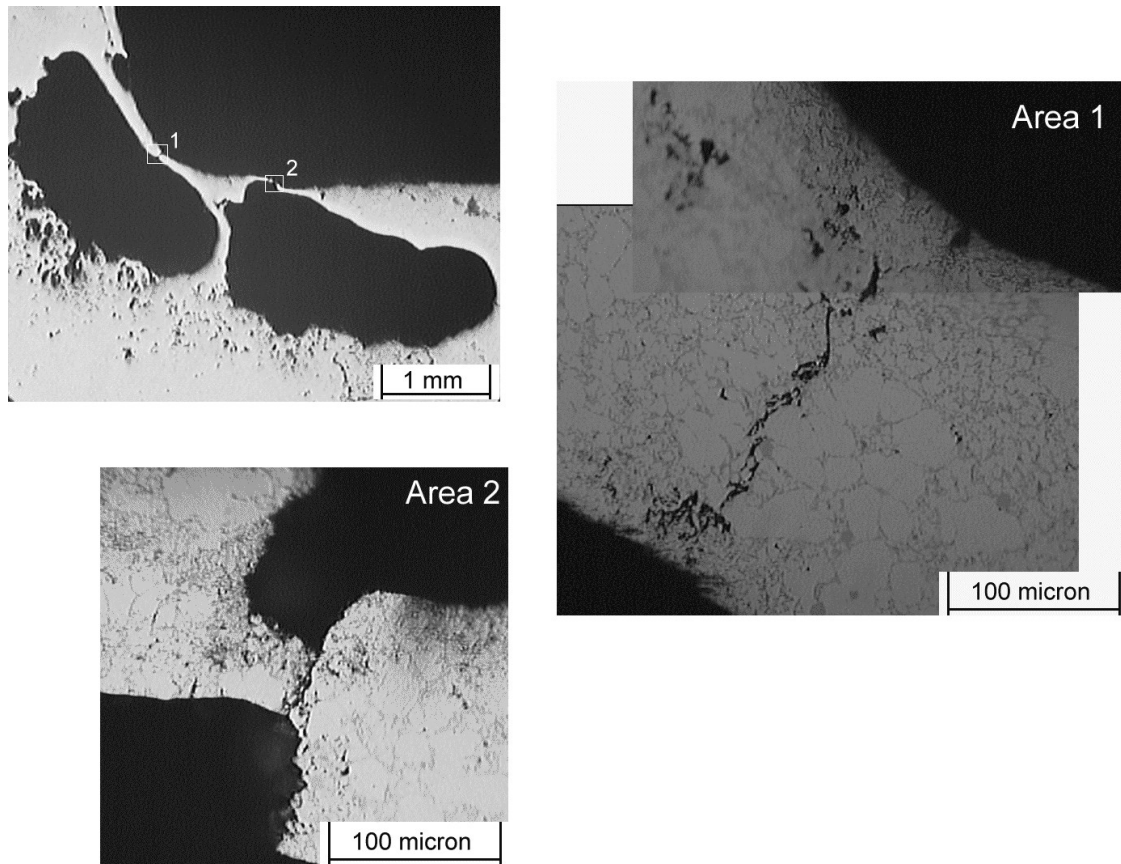
Figure 3.17 Cracks Associated With Large Gas Pores Near Base of Lug.
