INCIDENT ANOMALY REPORT

REPORT DATE: 19th October 2021.
TYPE OF ANOMALY: Material Incident.
COMPANY/VESSEL : Tranship / TS Luxento.
VESSEL ACTIVITY : Hose Handling - Offloading.
INCIDENT DATE/TIME : 15th October 2021/ 16:10LT.
INCIDENT LOCATION : FPSO Espirito Santo.

This document is the investigation report of the incident on what the communication, internet and navigation antennas of LH TS Luxento was damaged after making contact with the hawser recovery cable, near the stern of FPSO ES.

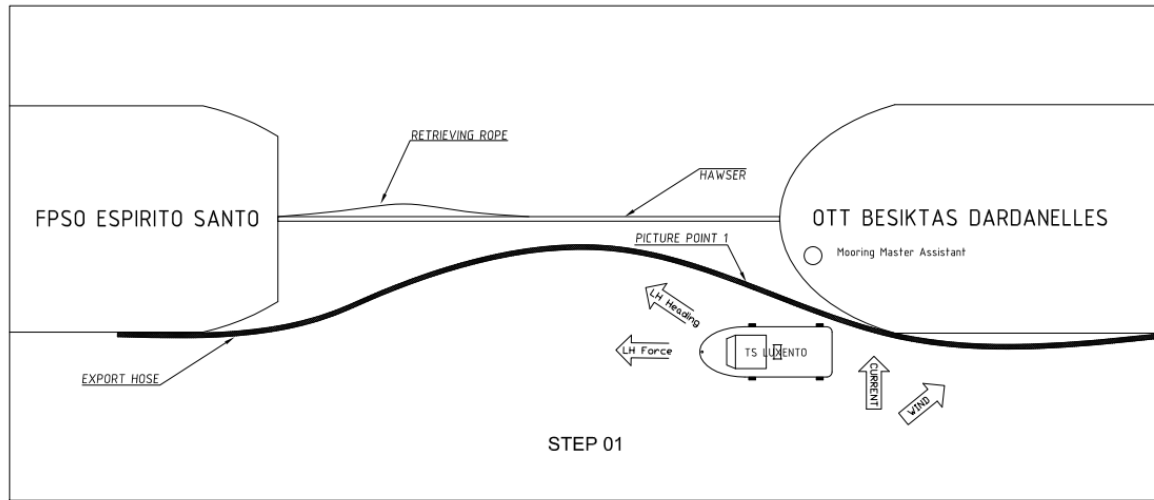
Step 01 – LH TS Luxento approaching to main line hose following instructions of Wladimir Alencar – Assistant Mooring Master to take photos along the hose using the bow command. The seaman took pictures using a mobile phone from the bridge.

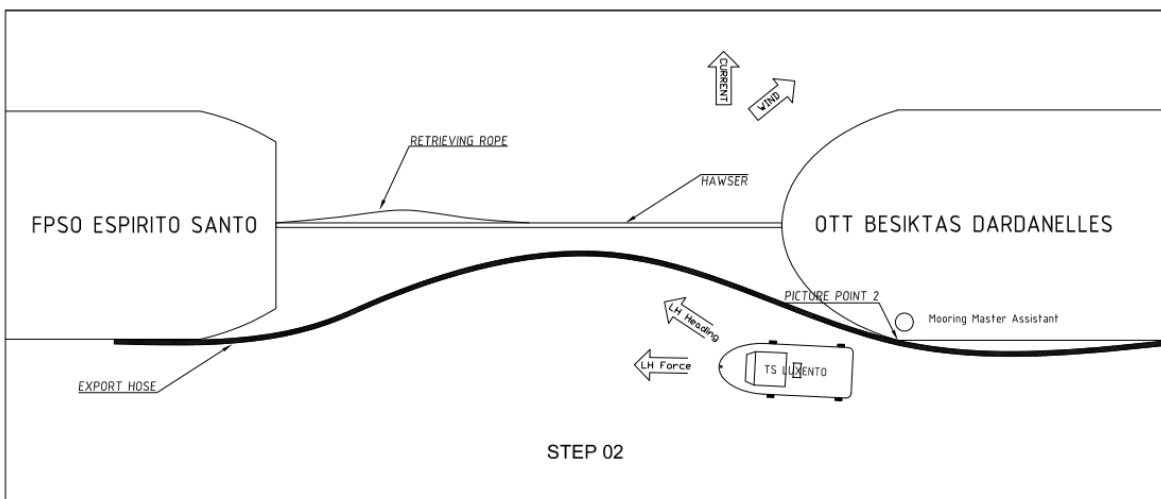
Step 02 – Following the instructions of Wladimir Alencar – Assistant Mooring Master to take photos in other point along the hose that was further after the tug. There is a Able seaman watching the distance. While he tug chief officer moved from the bow command to the stern command, due to the sea current the hose was pushed to starboard and TS Luxento commencing to move to starboard side

in the direction of the hawser. The distance from the bow to stern command is approximately 3.6 meters (Bridge arrangement below).

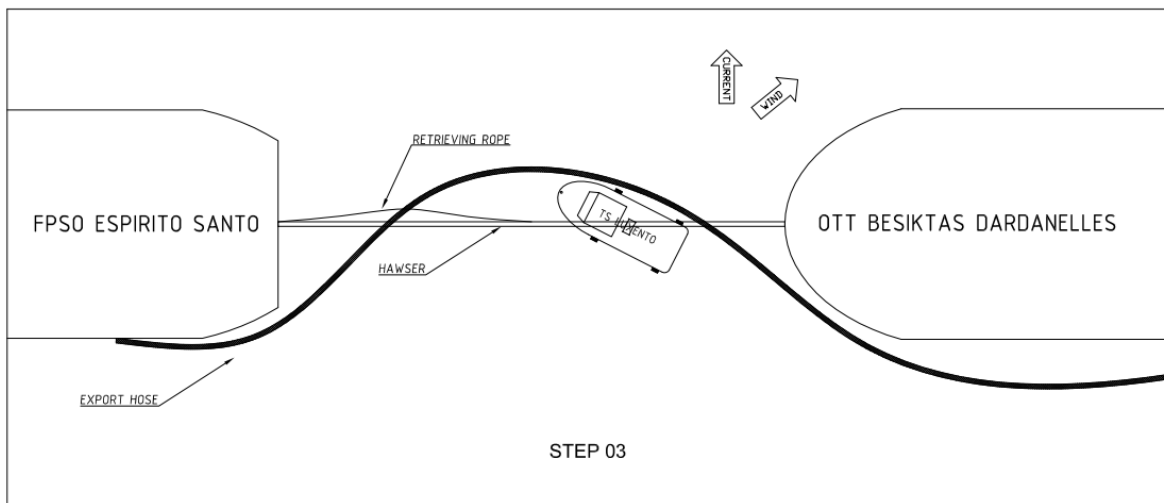
Step 03 – The tug chief officer lost the manoeuvre once the distance between the hose and the tug was less than 10 meters. The tug and the hose moved together at close and passed underneath mooring hawser without any touch. The fact was possible due to the height of the OTT. After cross the hawser, she moved slowly to the FPSO.

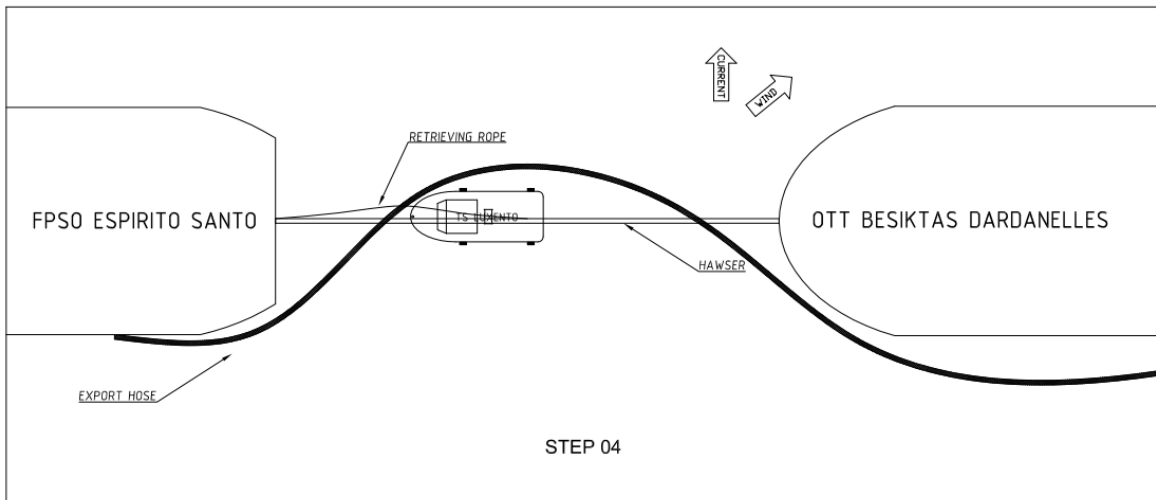
Step 04 – TS Luxento entangled communication and navigation antennas with hawser retrieving rope which is lower than the mooring hose.

- Communication, internet, navigation, anemometer antennas contact with the hawser recovery cable, near the stern of FPSO ES.

- TS Luxento operates too close to the hawser recovery cable.

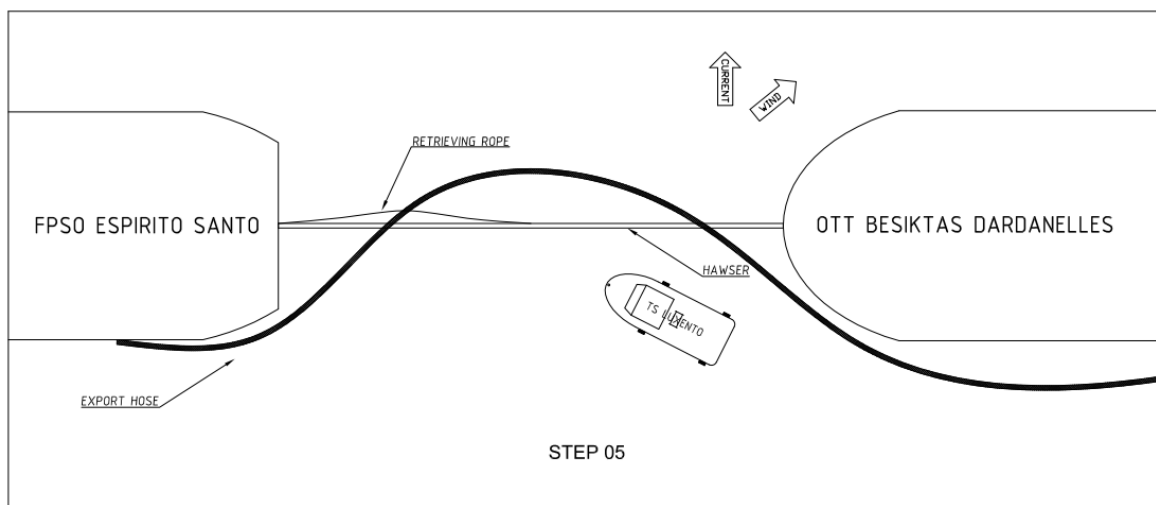
Step 05 - LH TS Luxento was moved stern following advice of Wladimir Alencar Mooring Master, when he said to pass to the port side coming back close the OTT as the mooring hawser is higher than close to the FPSO. Retrieve rope is slacked down to the water consequence that the hawser reel is free until the operation was completed
