SDX-1153 Interference Report

07/22/2014

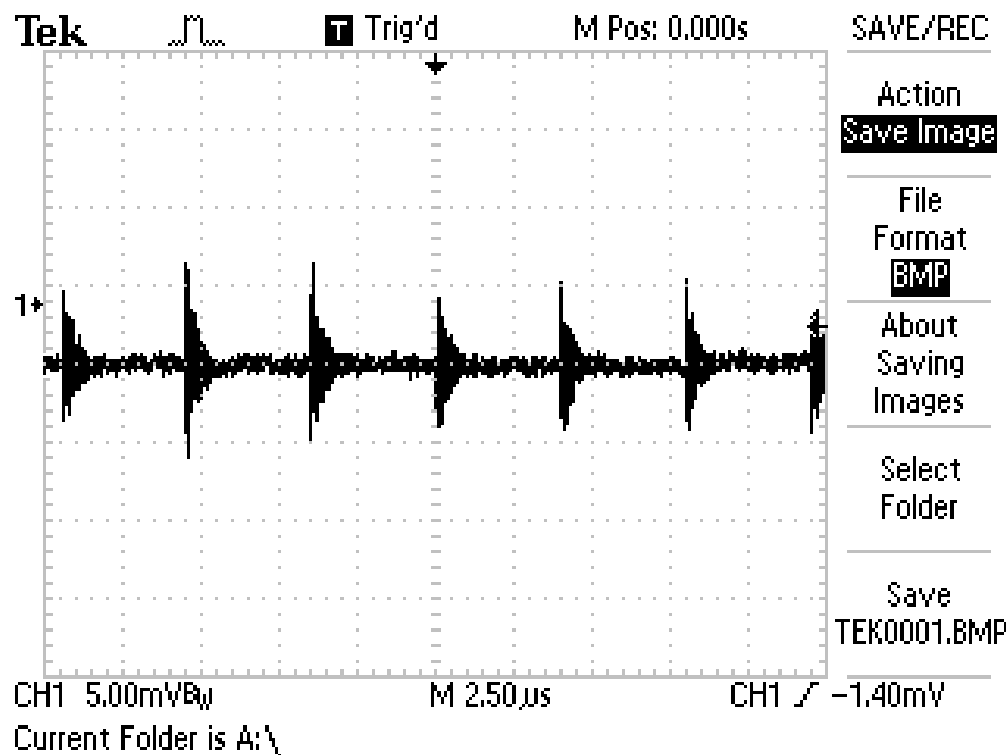
The SDX-1153 TIA instrument was returned due to an interference signal present on the output. This interference was verified at Gentec-EO USA. The interference signal is shown in figure 1.

Figure 1, Interference Signal

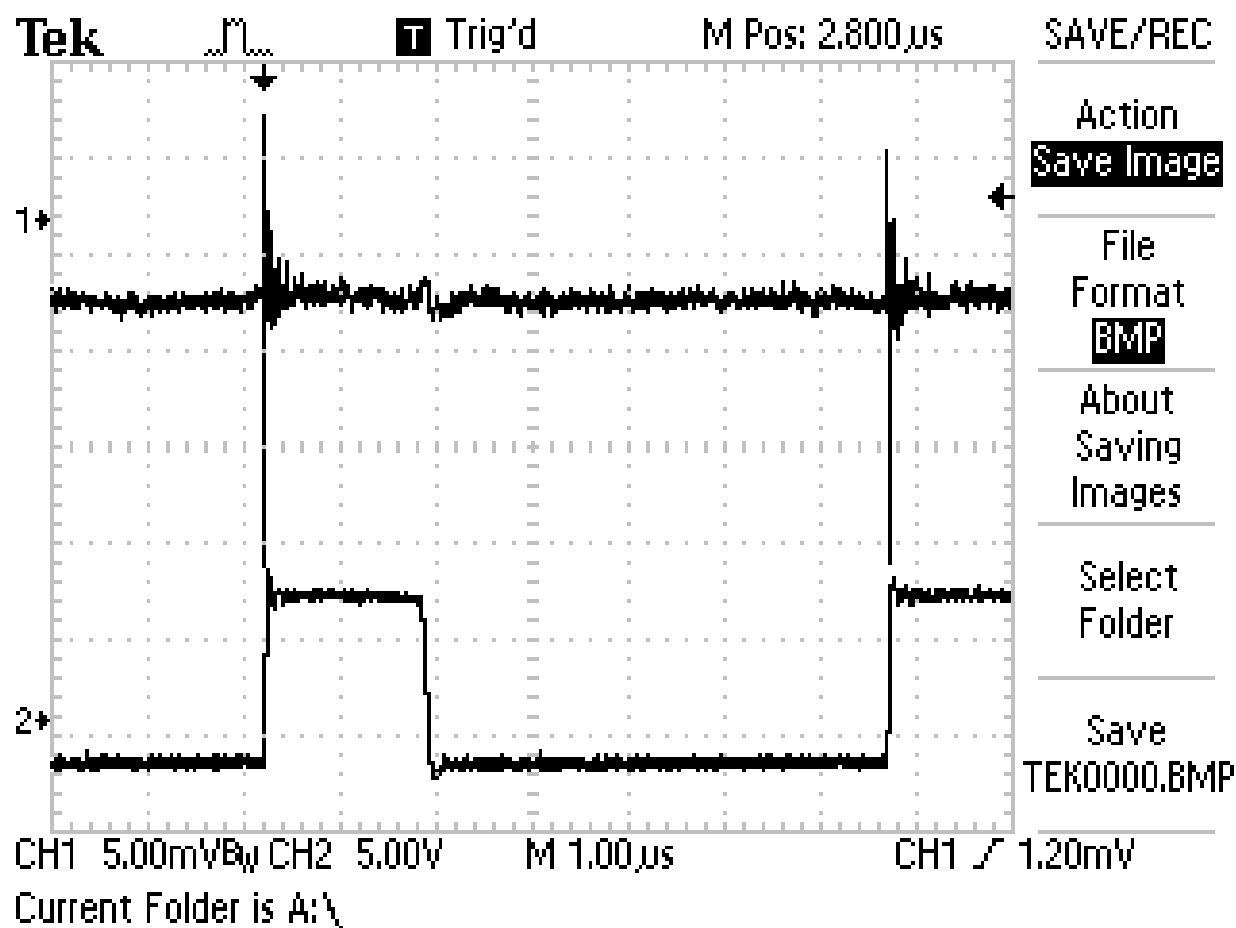
This is clearly an interference signal and not broadband noise; therefore it must have a source, a receiver, and a coupling mechanism. The amplitude of the interference signal was found to be independent of the TIA gain, so the interference is not a current induced at the TIA input, but the TIA is the receiver. Probing with an oscilloscope quickly found the source is the USB DC Voltage isolation circuit. Figure 2 shows the switch node of the isolator along with the interference. The two signals are synchronized.

Figure 2, USB DC isolation switch and signal interference

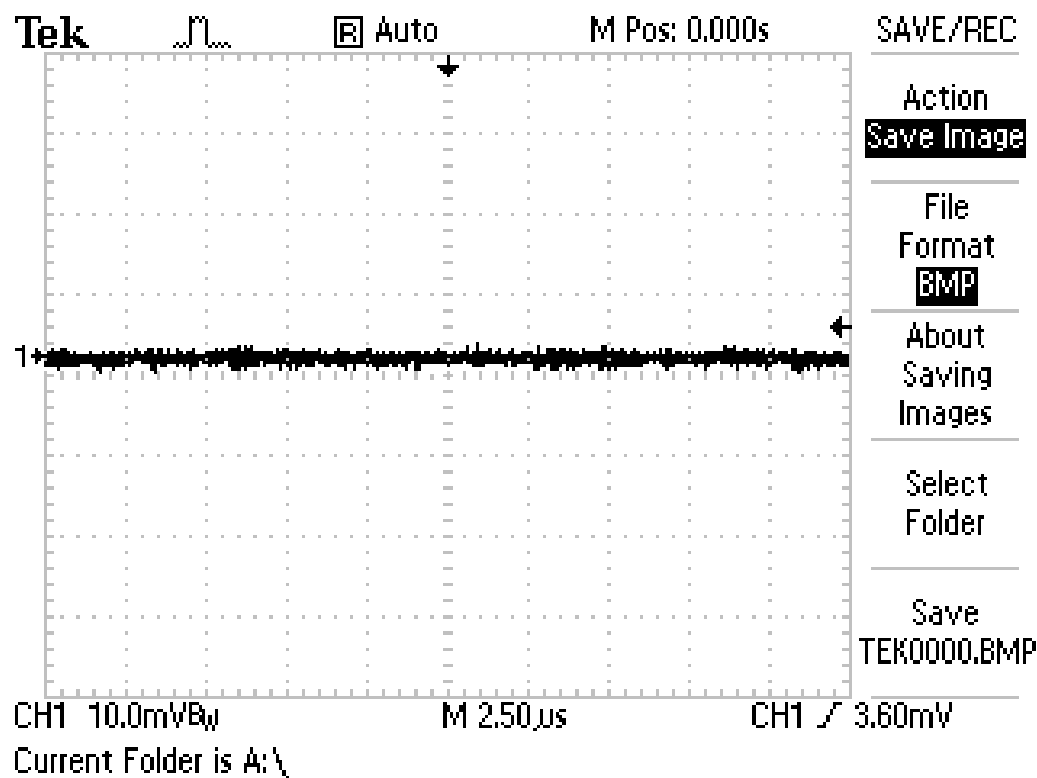
The next step was to disable the USB isolation circuit and power the SDX-1153 with an external DC supply. Figure 3 shows the result.

Figure 3, SDX-1153 on external 5V DC supply

The isolation circuit is clearly the source. Modifications to the circuit were tried to remove the transmission path and isolate the TIA, including the addition of filters, ferrites, magnetic and electrical shielding, and different values of compensation networks. While some improvements were obtained, the interference could not be eliminated.

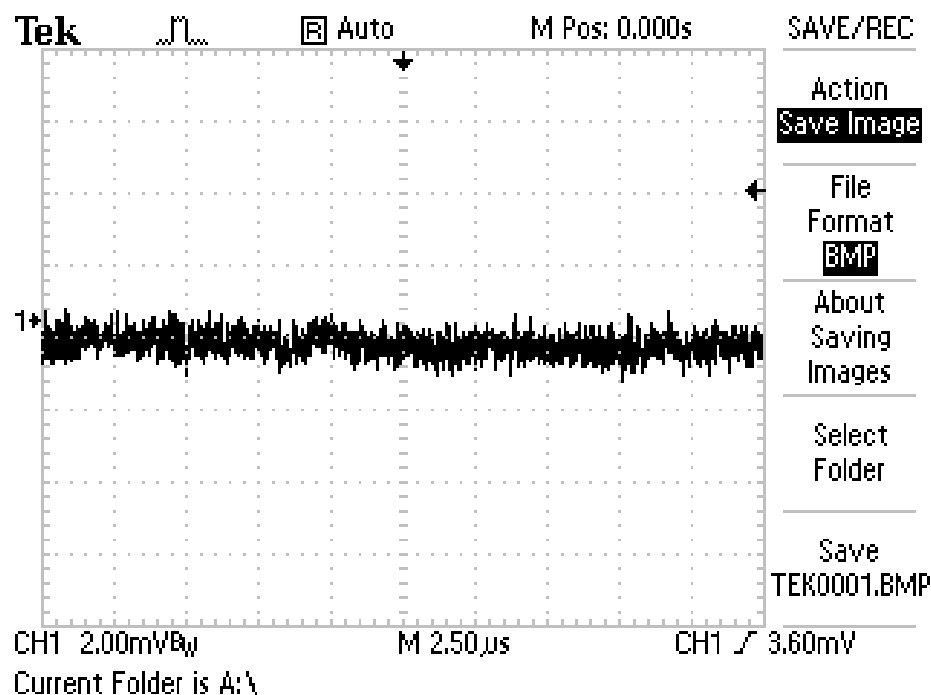
Next the DC isolation circuit was disabled and the SDX-1153 power supply circuit was connected to the +5V USB supply with no DC isolation to eliminate the source of the interference. The result is shown in figure 4 Figure 4 is shown on a 2mV per div scale. The signal interference due to the isolation circuit has been eliminated.

Figure 4, SDX-1153 on USB supply, no isolation circuit

The interference at the output of the SDX-1153 has been reduced from 15mVpp to $400\mu\text{Vpp}$ with the modifications described. This represents a reduction from 0.15% of full scale to 0.004%. Further improvements may be possible, but will require more extensive modifications that carry a risk of damage to the PCB.
