Request to leave broken piles
in place, P20101354

Deepwater Horizon - 3/12/2011

3/13/2011 Request to leave-in-place Seven (7) Steel piles, 30" and 36" diameter in the Rigolets; five (5) broke below the mud line, two (2) were cut at the mud line

Coastal Use Permit Number P20101354

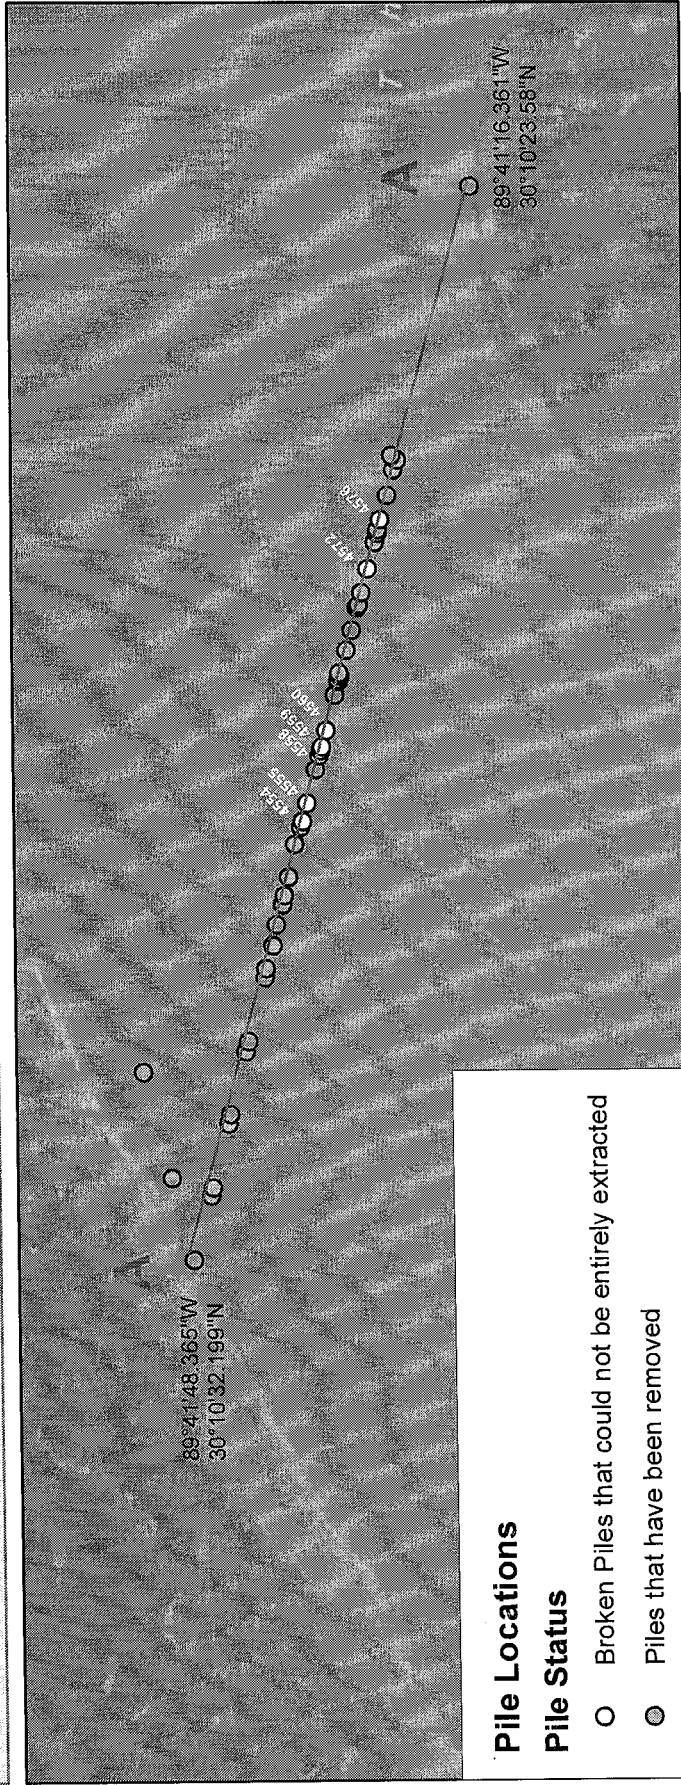
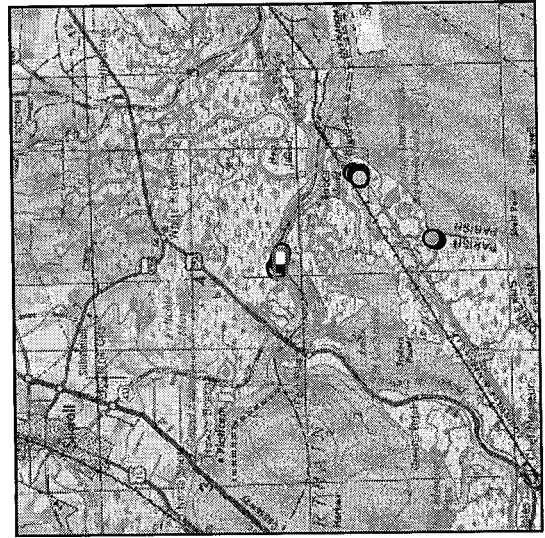
The Rigolets Detail

Location of submerged piles stubs to remain in place

These 7 steel piles, originally ranging in length from 117 to 140 feet, broke during the extraction process on February 13 – 14. Five (5) broke 4 to 13 feet below the mud line. Two (2) others that broke above the mud line were cut at the mud line on February 17.

Reasons that these 7 steel piles stubs could not be removed and could not be driven deeper include the following:

- Currents during flood stage in this area of the Rigolets approach 3 knots which created serious safety exposures to the supporting dive team
- The lack of sufficient pipe wall thickness, poor welding and observed corrosion on all the piles that were removed from the Rigolets led us to believe that the broken, submerged steel would not survive additional mechanical (vibration) energy without disintegrating further; if they disintegrated during this process, it would pose additional and unacceptable safety hazards to our dive team

Because the mud line is relatively deep in this area (40 to 64 feet below the water surface at low water), because no portion of the remaining pile stubs penetrate the mud line, and given that this does not appear to be a dredge maintained waterway, we believe the buried piles pose no future threat to navigation or fisheries in the area.

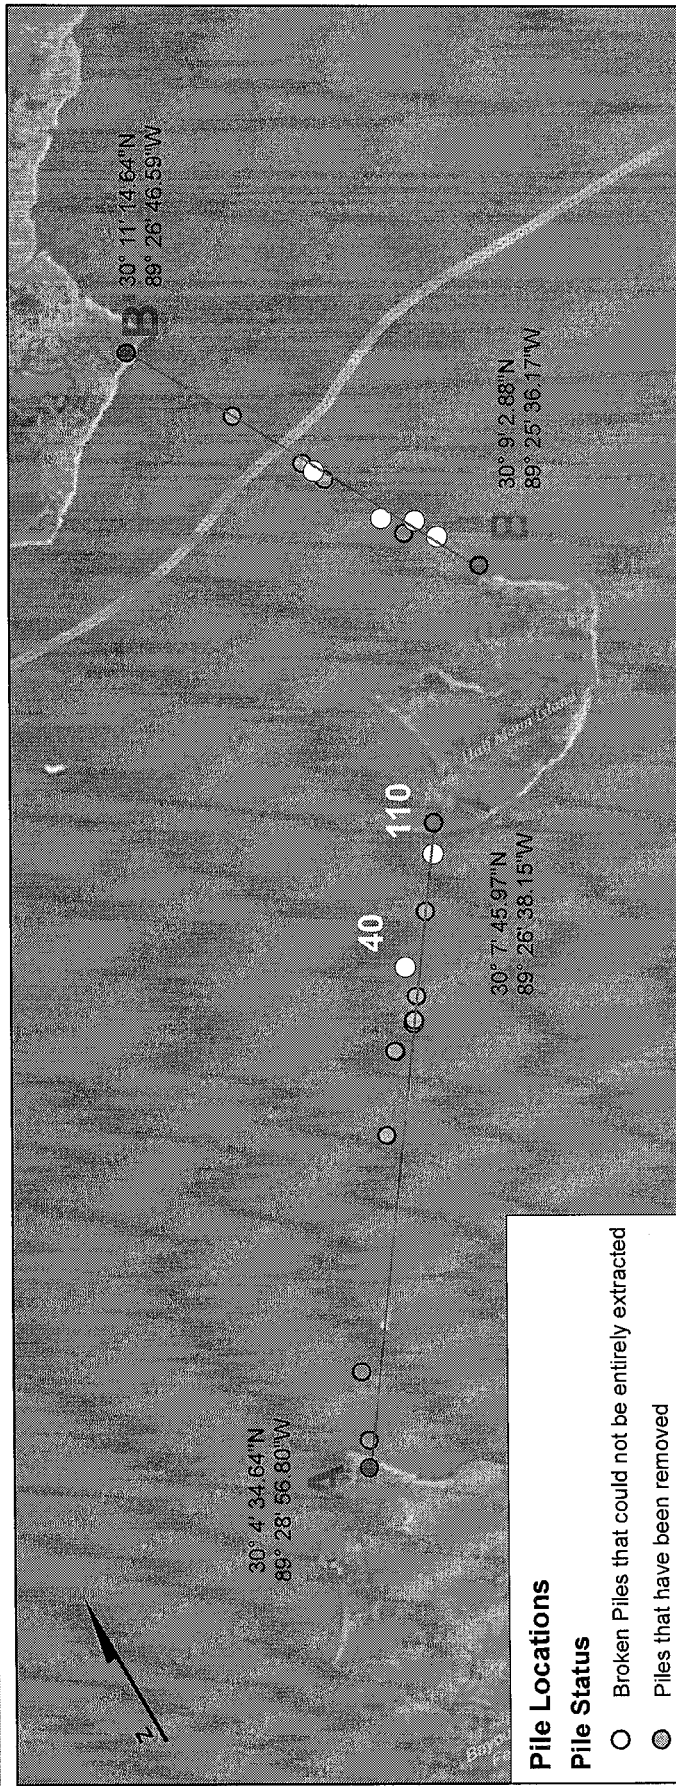
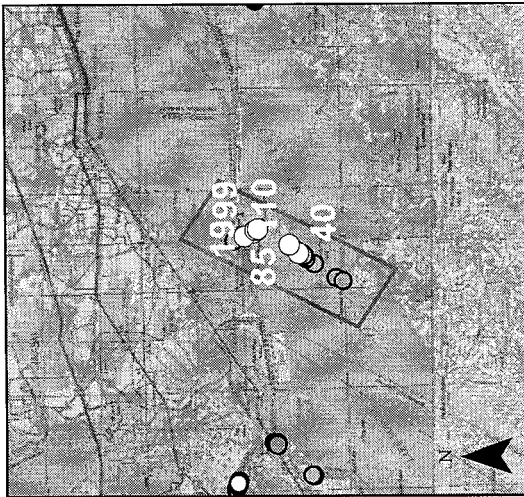
Half Moon Island Detail

Location of submerged piles stubs to remain in place

These 6 CCA piles, originally 30 – 40 feet in length, broke during the extraction process and because of the location of the remaining stubs, all were then driven 10 feet or more below the mud line in March 2011.
