3.4 IMAGE AND TRANSPORT ANALYSES

Image Analysis: Establishing Size, Velocity, Origin, and Impact Area

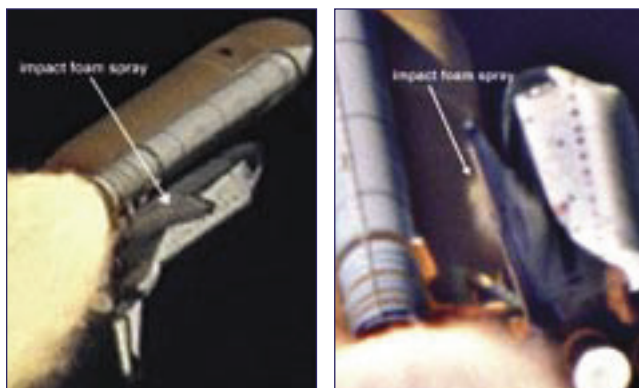
Figure 3.4-1 (color enhanced and "de-blurred" by Lockheed Martin Gaithersburg) and Figure 3.4-2 (processed by the National Imagery and Mapping Agency) are samples of the type of visual data used to establish the time of the impact (81.9 seconds), the altitude at which it occurred (65,860 feet), and the object's relative velocity at impact (about 545 mph relative to the Orbiter).

A 35-mm film camera, E212, which recorded the foam strike from 17 miles away, and video camera E208, which recorded it from 26 miles away, provided the best of the available evidence. Analysis of this visual evidence (see Figures 3.4-1 and 3.4-2) along with computer-aided design analysis, refined the potential impact area to less than 20 square feet in RCC panels 6 through 9 (see Figure 3.4-3), including a portion of the corresponding carrier panels and adjacent tiles. The investigation image analysis team found no conclusive visual evidence of post-impact debris flowing over the top of the wing.

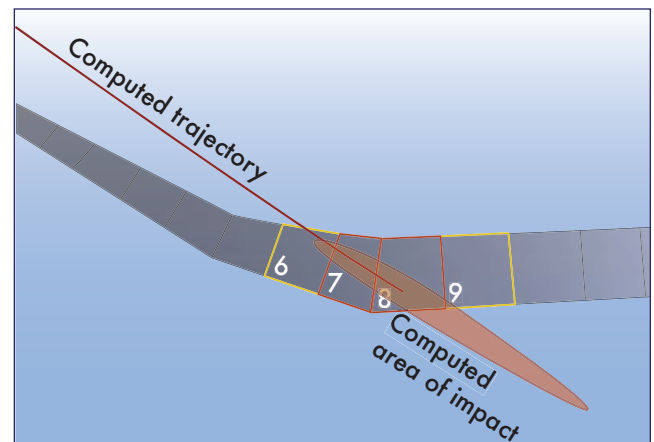
Figure 3.4-3: The best estimate of the site of impact by the center of the foam.

- The center of the foam struck the leading edge structural subsystem of the left wing between panels 6 to 9. The potential impact location included the corresponding carrier panels, T-seals, and adjacent tiles. (Based on further image analysis performed by the National Imagery and Mapping Agency, the transport analysis that follows, and forensic evidence, the Board concluded that a smaller estimated impact area in the immediate vicinity of panel 8 was credible.)

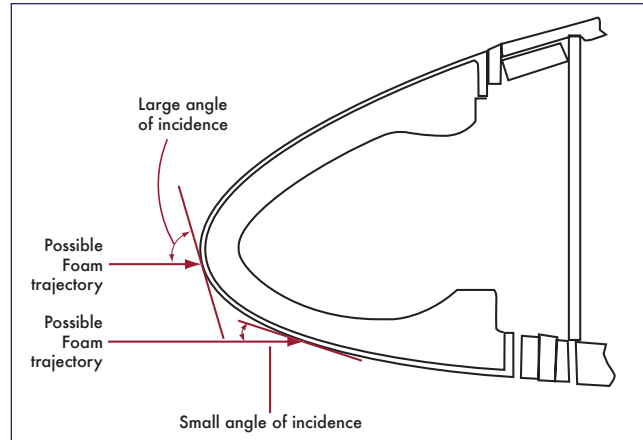
Image analysis determined that the foam was moving almost parallel to the Orbiter's fuselage at impact, with about a five-degree angle upward toward the bottom of the wing and slight motion in the outboard direction. If the foam had hit the tiles adjacent to the leading edge, the angle of incidence would have been about five degrees (the angle of incidence is the angle between the relative velocity of the projectile and the plane of the impacted surface). Because the wing leading edge curves, the angle of incidence increases as the point of impact approaches the apex of an RCC panel. Image and transport analyses estimated that for impact on RCC panel 8, the angle of incidence was between 10 and 20 degrees (see Figure 3.4-4).⁹ Because the total force delivered by the impact depends on the angle of incidence, a foam strike near the apex of an RCC panel could have delivered about twice the force as an impact close to the base of the panel.

Figure 3.4-4. This drawing shows the curve of the wing leading edge and illustrates the difference the angle of incidence has on the effect of the foam strike.

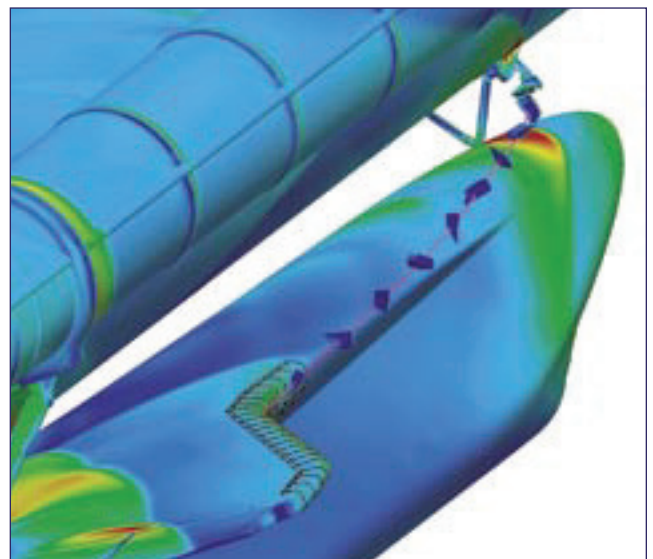
Figure 3.4-6. These are the results of a trajectory analysis that used a computational fluid dynamics approach in a program called CART-3D, a comprehensive (six-degree-of-freedom) computer simulation based on the laws of physics. This analysis used the aerodynamic and mass properties of bipod ramp foam, coupled with the complex flow field during ascent, to determine the likely position and velocity histories of the foam.

The undetermined and yet certainly irregular shape of the foam introduced substantial uncertainty about its estimated aerodynamic characteristics. Appendix D.8 contains an independent analysis conducted by the Board to confirm that the estimated range of ballistic coefficients of the foam in Figure 3.4-6 was credible, given the foam dimension results from the image analyses and the expected range of the foam density. Based on the results in Figure 3.4-7, the physical dimensions of the bipod ramp, and the sizes and shapes of the available barrels for the compressed-gas gun used in the impact test program described later in this chapter, the Board and the NASA Accident Investigation Team decided that a foam projectile 19 inches by 11.5 inches by 5.5 inches, weighing 1.67 pounds, and with a weight density of 2.4 pounds per cubic foot, would best represent the piece of foam that separated from the External Tank bipod ramp and was hit by the Orbiter’s left wing. See Section 3.8 for a full discussion of the foam impact testing.

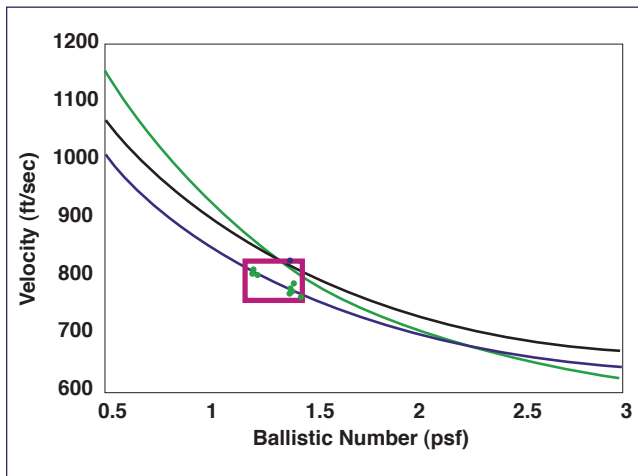
Figure 3.4-7. The results of numerous possible trajectories based on various assumed sizes, shapes, and densities of the foam. Either the foam had a slightly higher ballistic coefficient and the Orbiter struck the foam at a lower speed relative to the Orbiter, or the foam was more compact and the wing struck the foam at a higher speed. The “best fit” box represents the overlay of the data from the image analysis with the transport analysis computations. This data enabled a final selection of projectile characteristics for impact testing.
