Moro Cojo water levels

Preliminary analysis and model results

Tom Connolly (MLML)

July 12, 2018

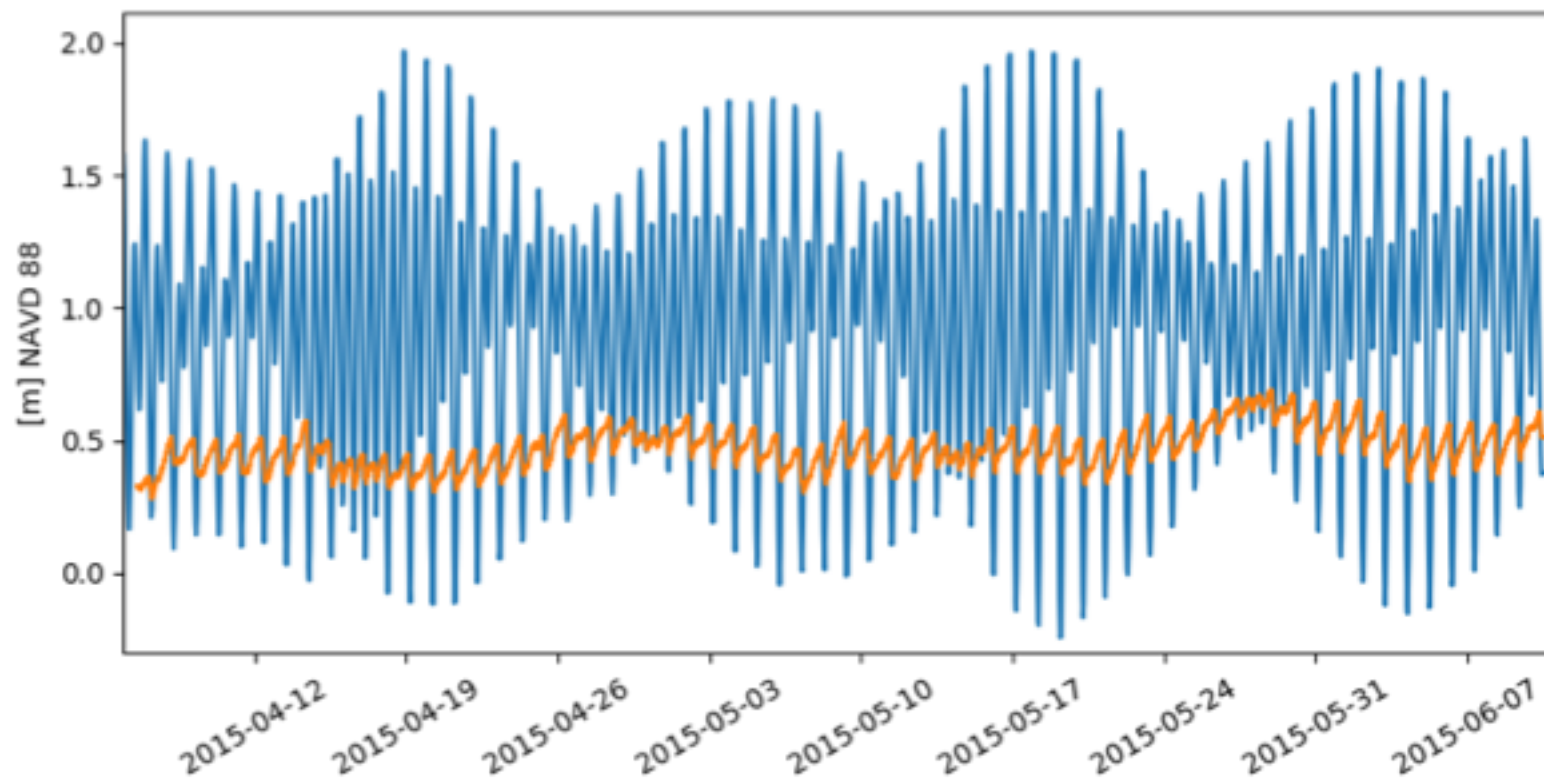
Monterey and Moro Cojo water levels

After tide gate failure

Before repair

Period used to develop model for
"Scenario A" - failed tide gates

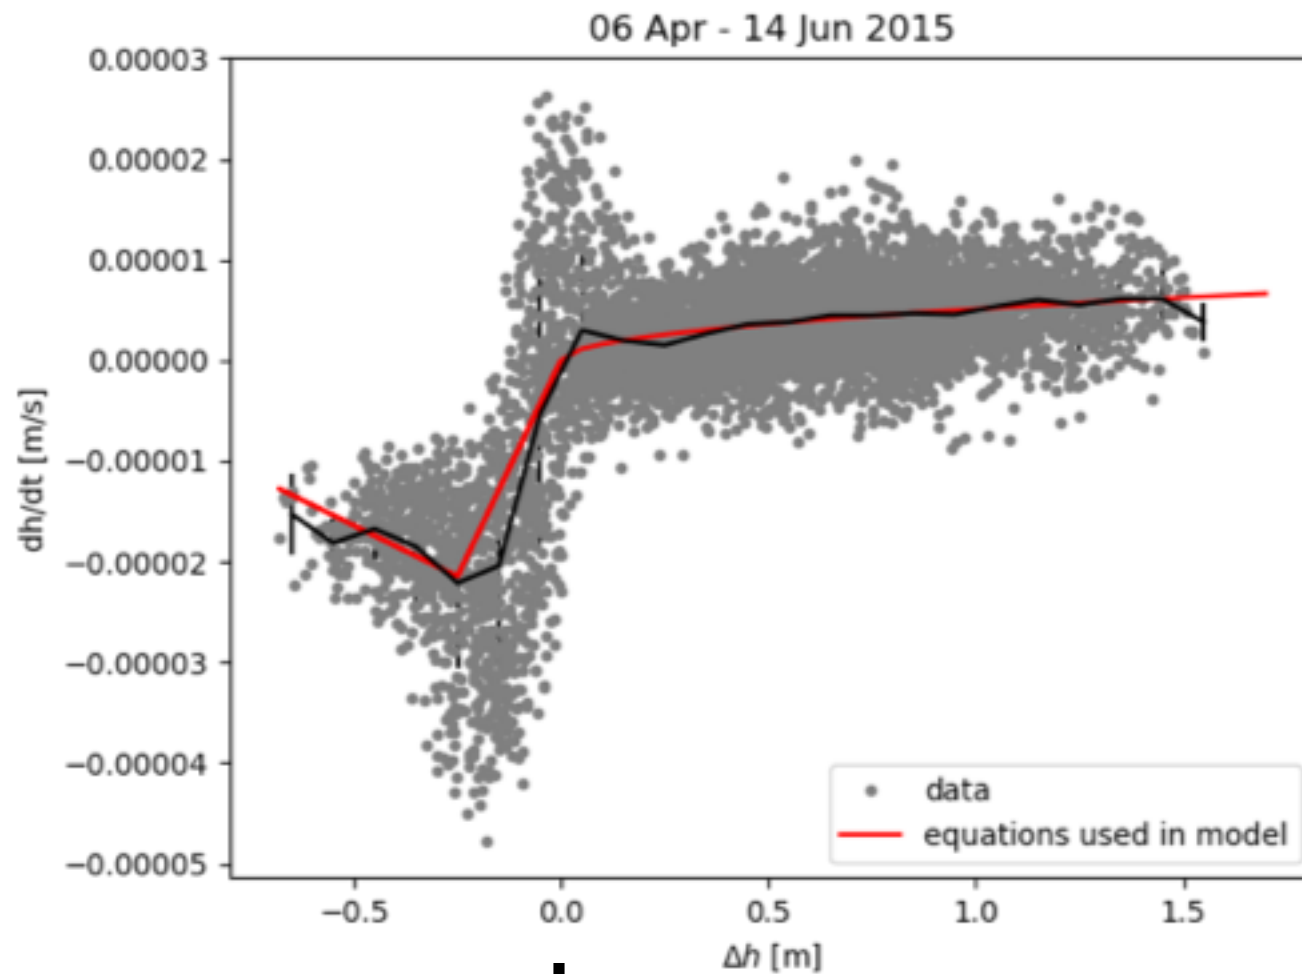
Ocean water level lower
than Moro Cojo

Ocean water level higher
than Moro Cojo

After tide gate failure

Before repair

Period used to develop model for
“Scenario A” - failed tide gates

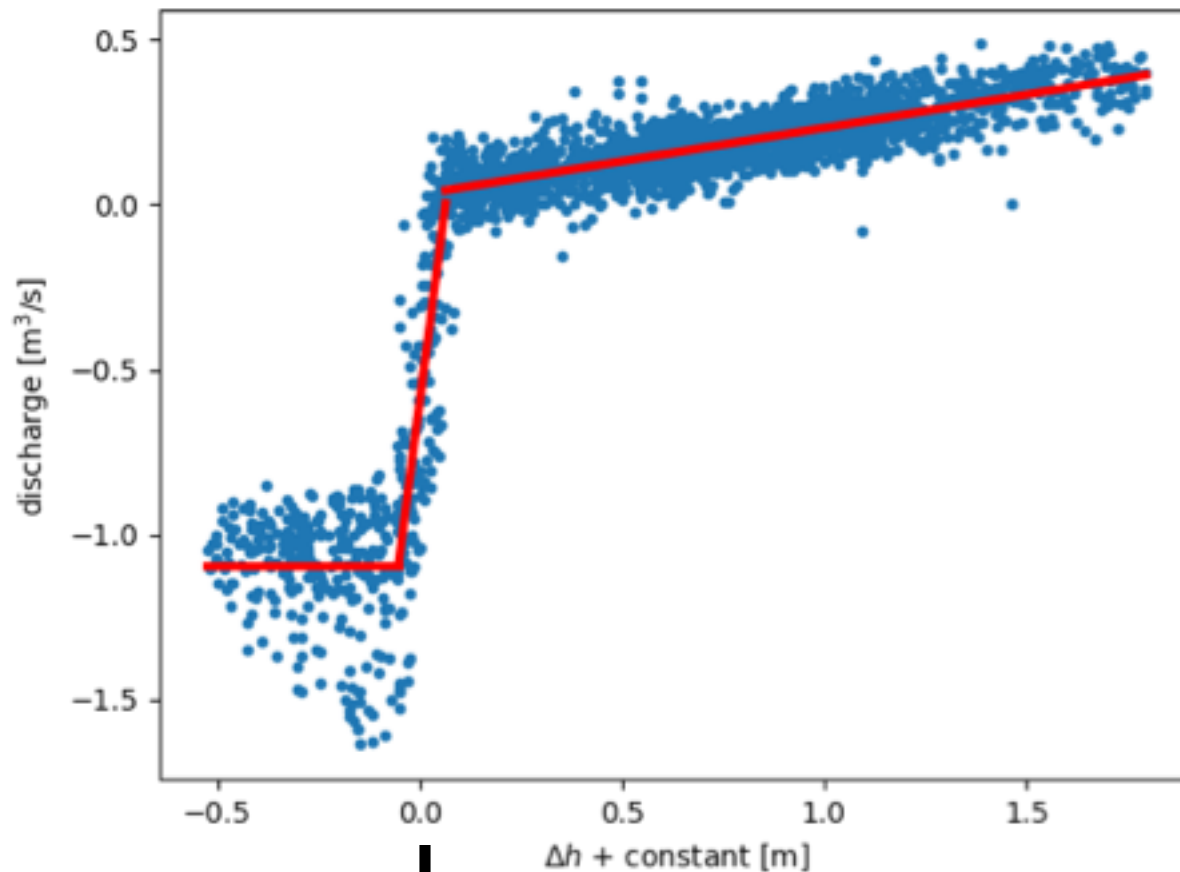
Ocean water level lower
than Moro Cojo

Ocean water level higher
than Moro Cojo

After tide gate repair

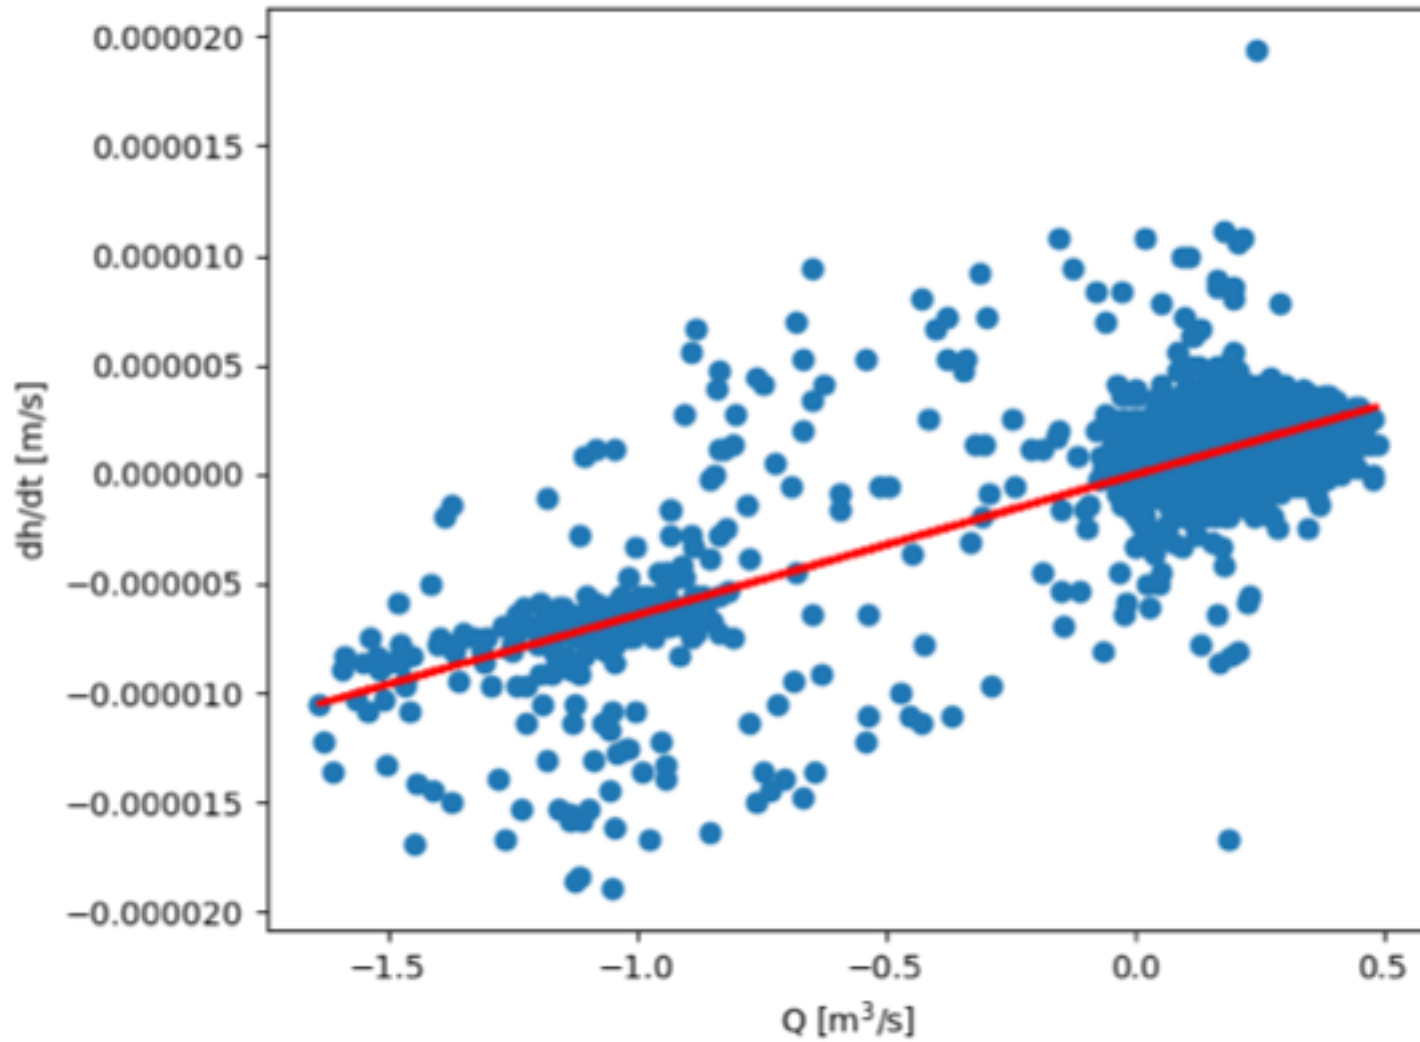
Relationship between discharge (Q) and dh/dt from ADCP (summer 2016)

Slope of line indicates area of approximately 157,000 m²
