# UAS Pipeline Monitoring Burnt Lake Gas COOP Findings Report - TAP 10

May 6, 2019

**Silver Spring Energy Consulting Ltd.**

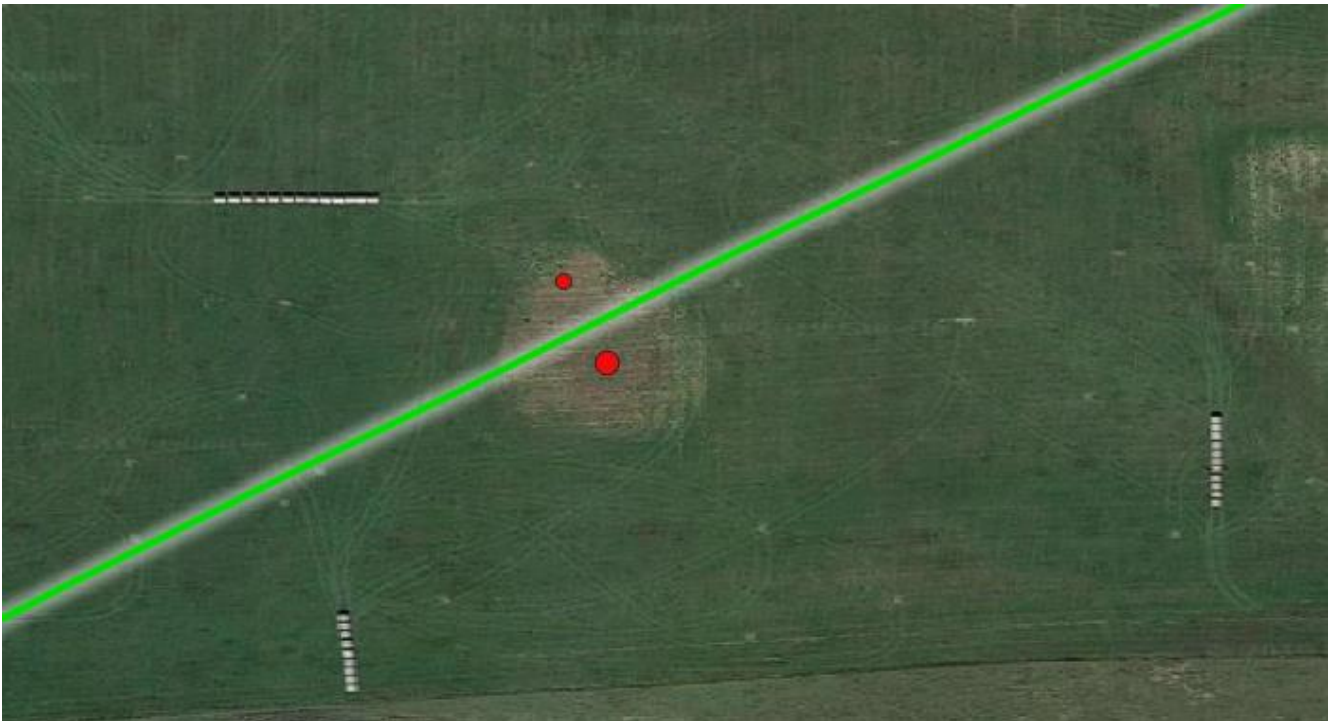
#	Concern Level	Coordinates (WGS84 Lat/Long)	Description
1	Immediate (611 - 761ppmm)	52.172402, -114.0349482	Moderate to high gas readings with visibly poor vegetation health in surrounding area. No other environmental factors present to otherwise explain readings.
2	Moderate	52.130842, -114.059996	Moderate to high gas readings with no visible environmental factors to otherwise explain readings.
3	Minor	52.190162, -113.981248	Moderate gas readings with no visible environmental factors to otherwise explain readings.

This report finds moderate evidence of possible leakage at the location(s) indicated above. Location #1 (below) merits immediate attention due to factors surrounding the region; primarily the low vegetation health surrounding the high readings. This area should be closely inspected if gas balance readings indicate a leak on Tap 10.

*Figure 3: Location #1 (52.172402, -114.0349482) - Note poor vegetation health (brown patch) surrounding the readings (red).*

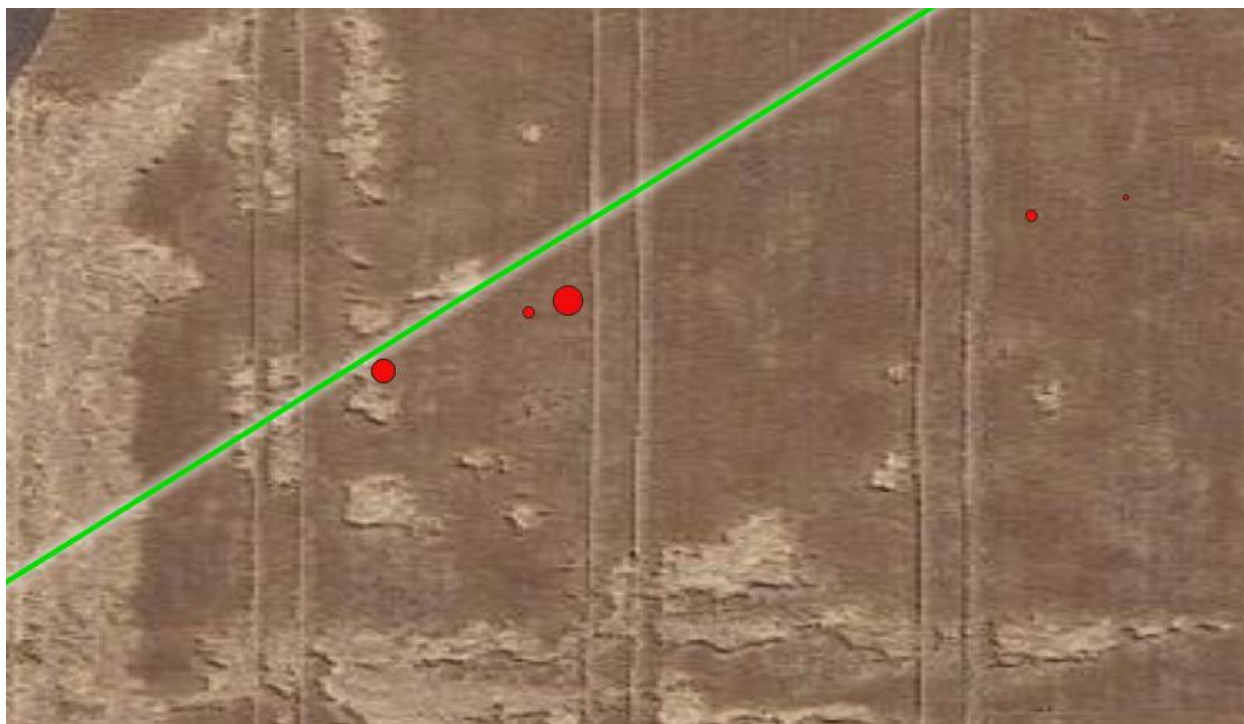
Location #2 shows a cluster of moderate gas readings in an area with no visible cause, and merits moderate concern. There are no physical/environmental signs of leakage (dying vegetation, etc.), however the cluster of points in the area may indicate a leak. This area should be considered if gas balance readings indicate a significant leak in the line.

*Figure 4: Location #2 (52.130842, -114.059996) - Note the cluster of readings in this area. No visible crop damage or other signs of leakage.*

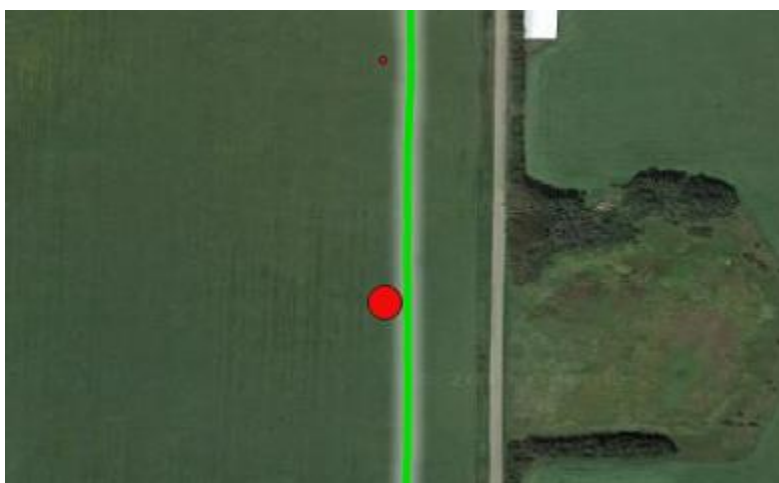
Location #3 is similar to Location #2; however the gas readings are lower. Still, there are no visible features in the area to account for these readings, and therefore this area has been classified as one of minor concern.

*Figure 4: Location #3 (52.190162, -113.981248) - Note the lack of methane causing features in this region*
