Tower of St Mary Somerset
Lambeth Hill
EC4V 4AG

Report on Structural Condition of Existing Timber Joists

Date	Revision	Comments
16 June 2014	/	First issue

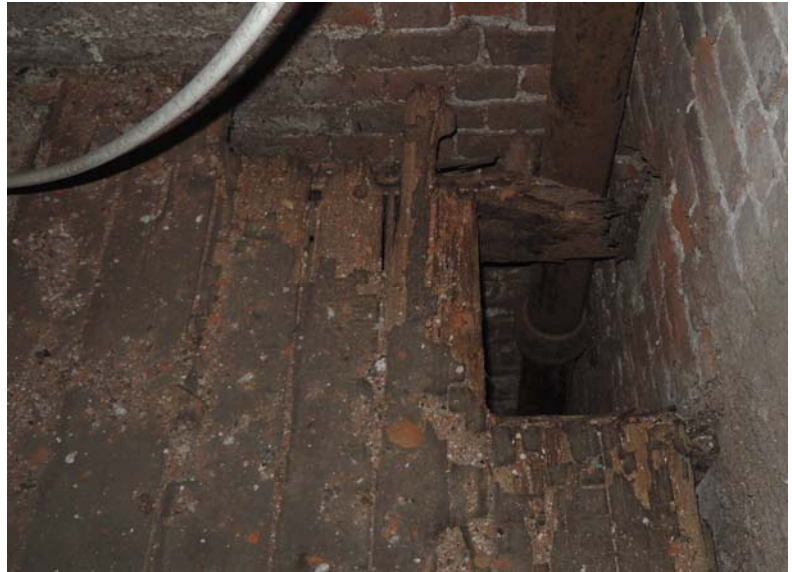
Figure 1- level 5 joists north west corner

We understand that the relatively new joists at level 5 are to be replaced with a new floor structure and the condition of these joists is therefore less important in the long term. We assume, however, that the floor may be used temporarily during the works and it is therefore important to note that the joist ends in the north west corner (adjacent to the down pipe) have rotted away entirely due to water ingress. This end of the floor should therefore be propped if it is to be used temporarily.

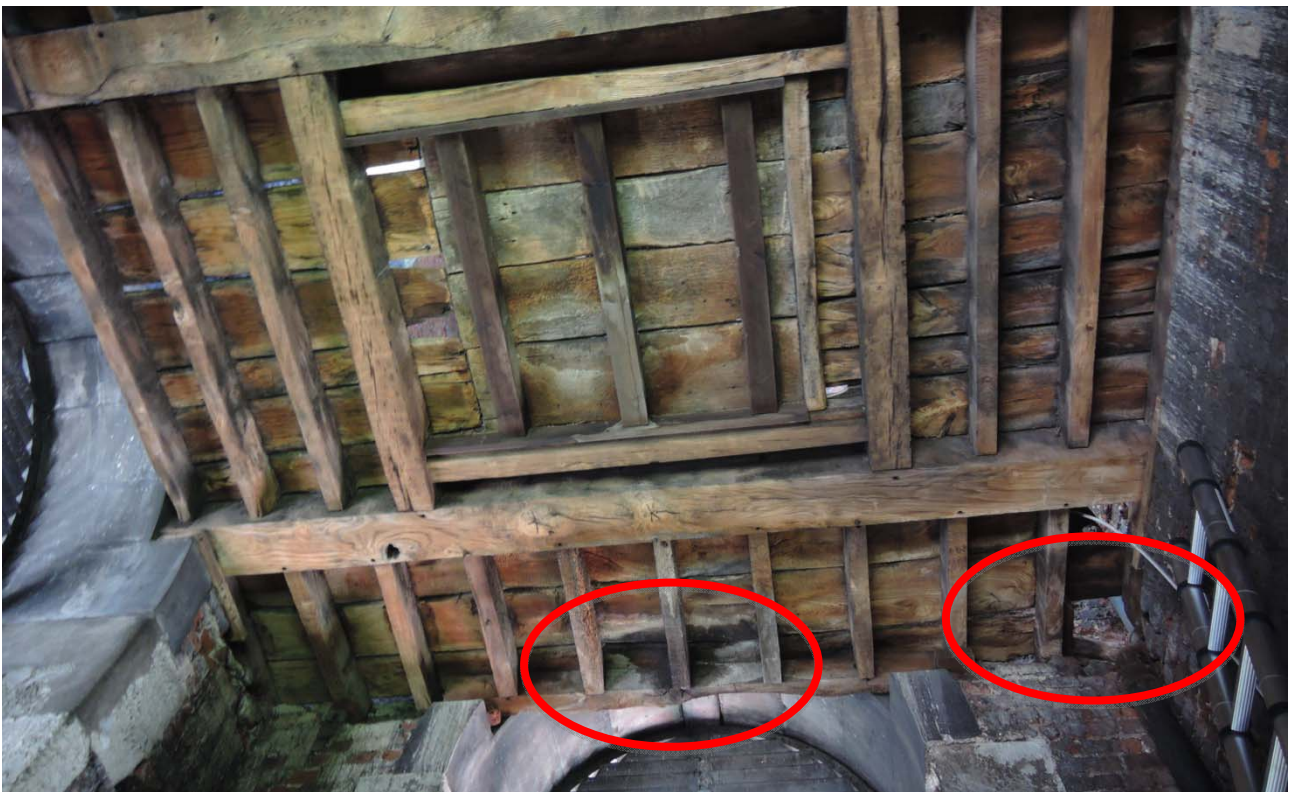
The first area of concern is, again, the north west corner. Here the immediately adjacent floor joist and boarding have clearly deteriorated due to water ingress. However, the primary beam into the north wall appears to be dry and solid. The beam end sits in a pocket in the wall with good air circulation around it and this detail has probably contributed to its current condition. As a general note, where timber beam ends sit into walls they benefit from easy passage of air to remove any moisture. If there are pockets around the beam that need to be filled as part of the finishing work they should not be concreted into position, but instead matching bricks should be selected and the beam simply wedged, allowing the air to circulate.

The other place where water appears to have done damage is to the trimming beam across the west arched louvred window. The trimmer beam generally is 110mmwd x 120mm dp. A quick calculation (assuming domestic live load, no ceiling below and low quality oak) shows that a section of 100mm wd x 60mm dp would be sufficient. This obviously must be checked by the engineer for the project, but give some reassurance that the current loss of section should not be a major concern and that the section may have sufficient capacity for the future use.

Figure 3 - underside level 7, red circles indicate two areas of distress

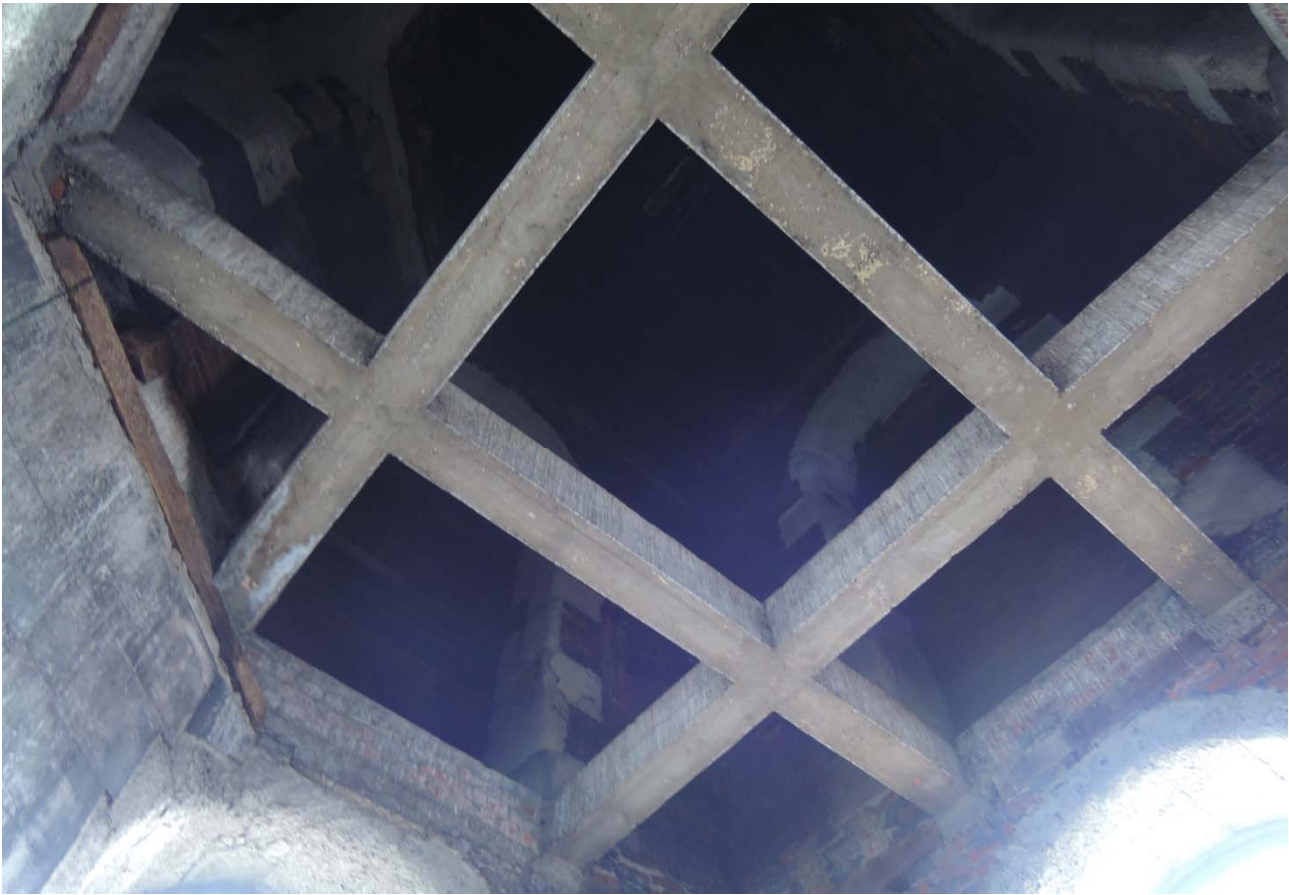
At this level there is currently a grillage of concrete beams put in by the Corporation of London in the 1950s, presumably to add some rigidity to the tower. We understand that this is to be replaced by a new floor structure, which will replace the structural action of the beams.

Figure 4 - underside level 9 showing concrete grillage of beams

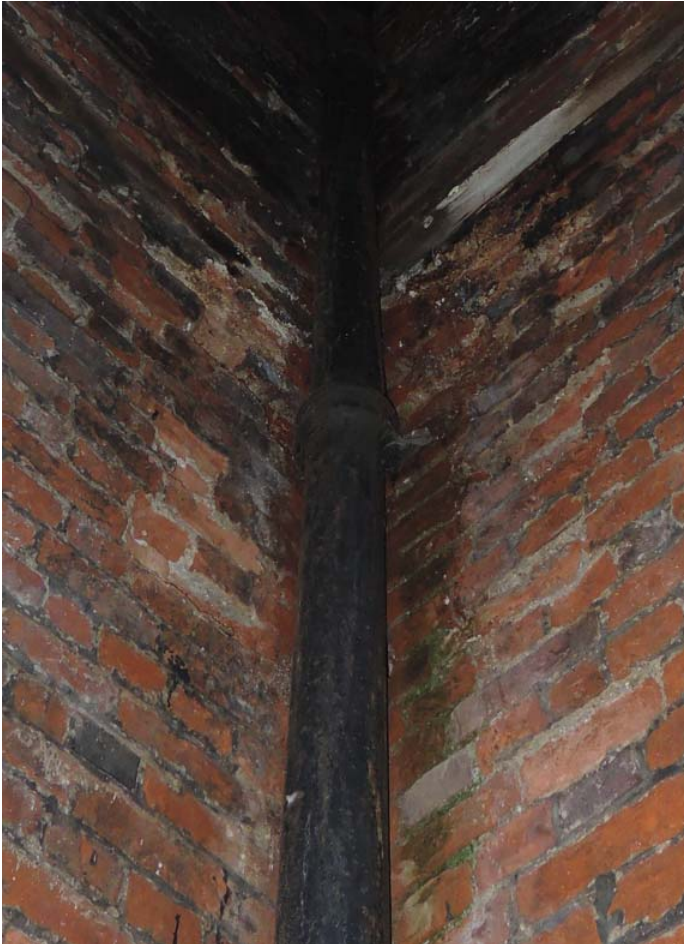
Internally the brickwork generally appears to be in reasonable condition. The face of the brickwork has been damaged adjacent to the rainwater down pipe in the north west corner and this should be assessed further. Given the thickness of the walls it seems unlikely that this, apparently surface, damage will be important structurally, but this should be assessed by the engineers for the project. Obviously the brickwork in that area may still be relatively wet and will need time to dry before any moisture sensitive finishes are applied. As a general note traditional finishes (such as lime plaster) which allow the passage of moisture are likely to be more successful than modern hard finishes (such as gypsum plaster).

Figure 5 - water damage to brickwork

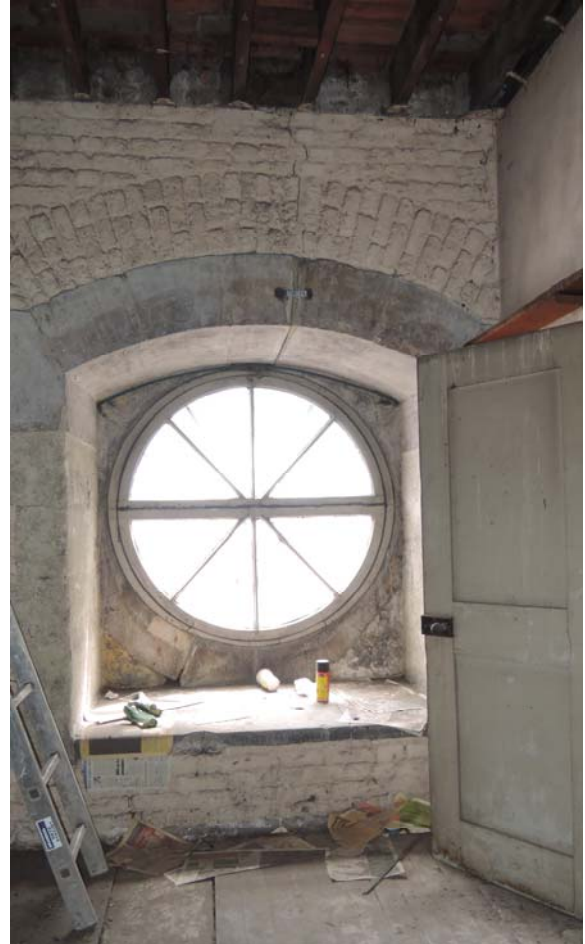
Figure 6 - crack over window arch

There is some cracking over each arched window/door opening, but this does not appear to be structurally significant. Additional floors will tend to help to tie the building together so this situation is likely to be improved by the proposed works.

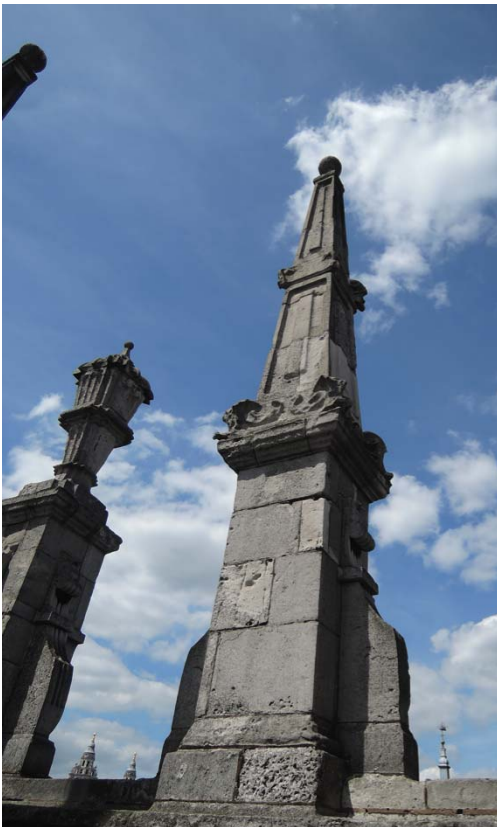
Figure 7 - typical centre pinnacle

The pinnacles were removed for repair in the 1950s and when returned were put back using iron cramps between the stones. The cramps are now corroding and there is clear movement in the pinnacles where the rusting is lifting the stonework. This is a clear concern, as obviously any falling stonework from this height would do considerable damage. We suggest that a metal detector should be used to identify all the iron cramps in the stonework so that the extent of the problem can be assessed. In particular there may be iron pins down the centre of the pinnacles and the urns. This may be sufficiently “buried” that it is hard to detect. It may also be sufficiently buried that the stone has provided protection and the metal is in good condition, but this should be checked.

We suggest that the pinnacles be assessed by a stone mason with conservation experience and that they should work alongside the design team to provide advice on extent of repairs and appropriate repair techniques. English Heritage will obviously be interested in these works and an appropriately experienced mason should be able to describe the approach and the extent of the works to their satisfaction. We or your project engineers can provide additional advice on this if required.

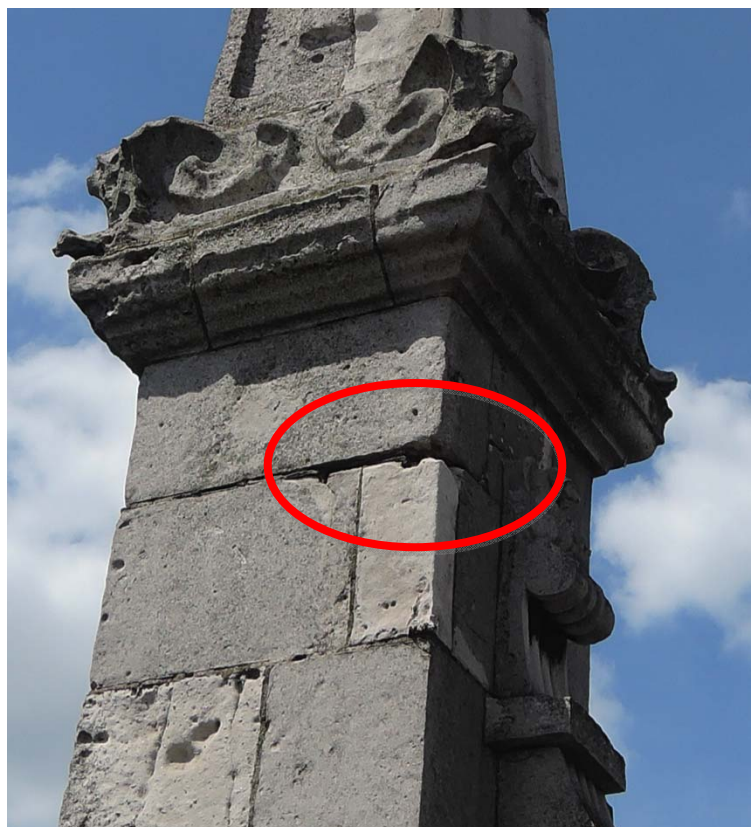
Figure 8 - centre pinnacle highlighting deteriorating iron cramp
