Case Study 15

Streambank Stabilization in the Guadalupe River Basin, Santa Clara County, California

Issued August 2007

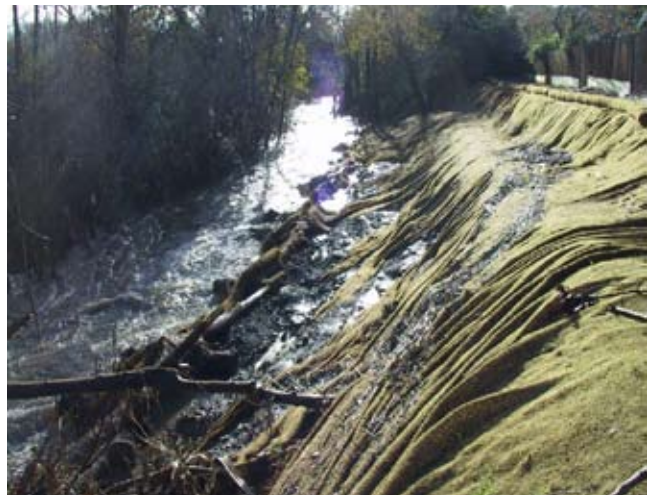
During December 2002, the first winter following project completion, a significant storm event occurred with a 5-year return frequency. The coir netting was severely damaged, and the underlying fill on the toe and midslope of the streambank was undercut and washed away (fig. CS15-3). The logs at the toe of the slope remained in place, yet extensive scour occurred around the structures (fig. CS15-4).

Hydraulic analysis indicated that the river reached velocities of 6 feet per second, developed shear forces of approximately 1 pound per square foot, and was at least 17 feet deep during the storm. The question was whether the failure was due to shear forces too great for the geotextile material or due to improper installation.

Figure CS15-3 Damaged streambank following a 5-year frequency event in December 2002

The authors determined that the blankets had been installed incorrectly because the application had been applied based on the principles of slope stabilization, not channel stabilization. Channel installation requires that blankets be oriented parallel to the flow and include anchor slots (fig. CS15-7). Prior to coir

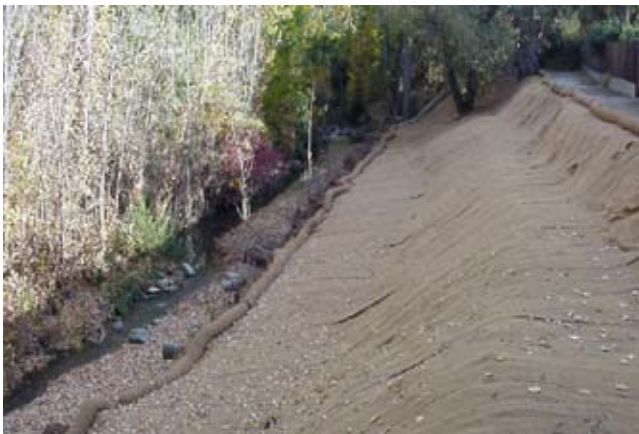
Installation proceeded as planned in fall of 2002 (fig. CS15-2). Log structures were keyed into the toe of the slope to provide anchoring and stability. Blankets made from coir netting (900 g/m^2) were laid out vertically along the slope (or perpendicular to the flow, which was consistent with manufacturer recommendations for slope protection), with coir rolls installed on the top and toe edges of the blanket layer. The blanket was then stapled along the length of each section.

Figure CS15-2 Finished original project in fall of 2002

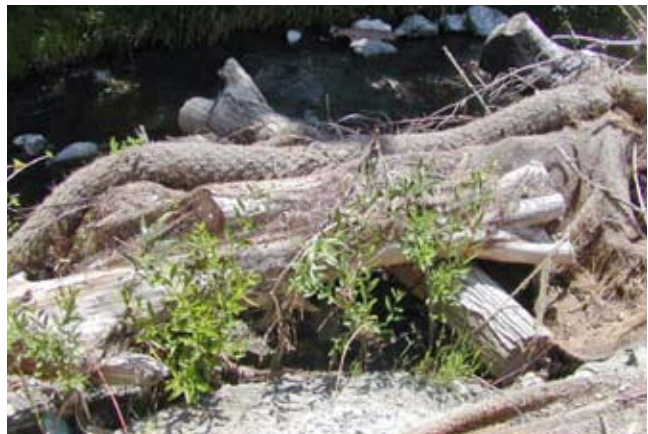
Figure CS15-4 Evidence of scour and exposure of the log structures

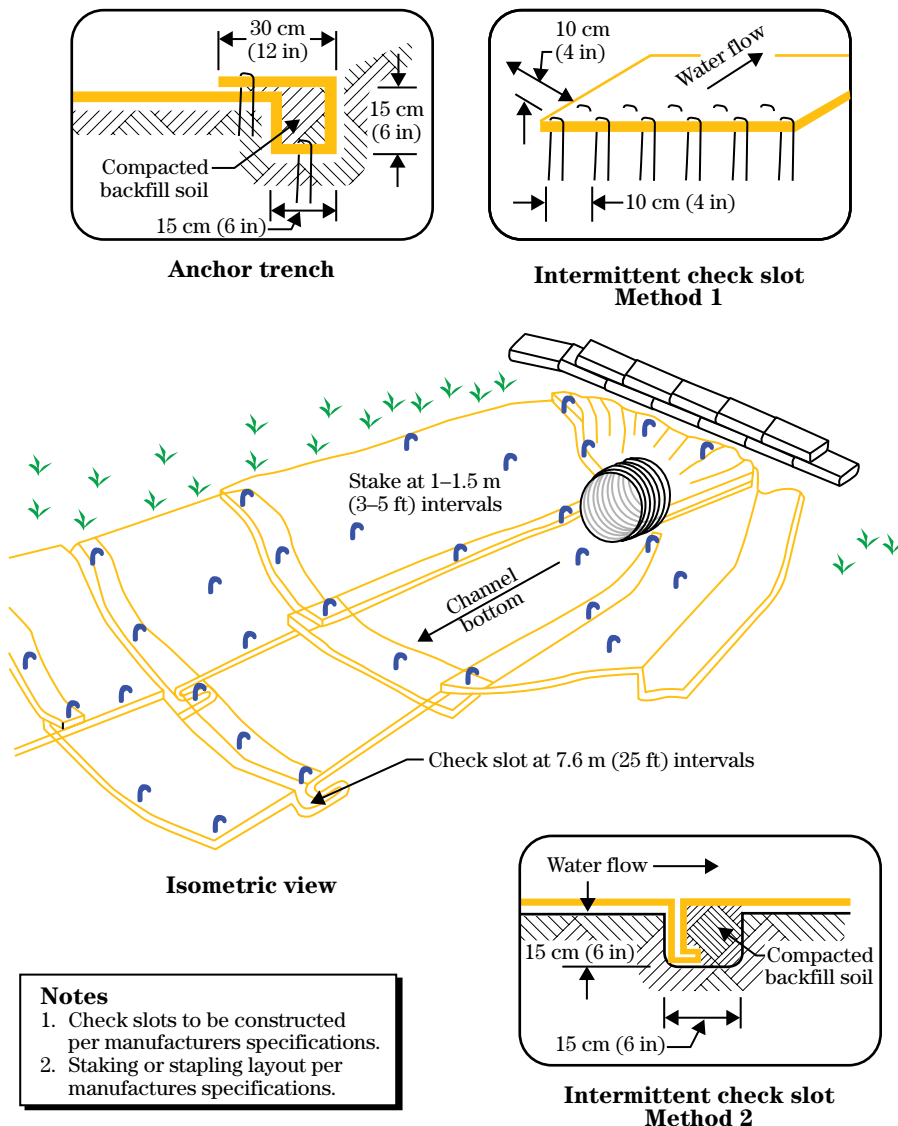
Figure CS15-7 Erosion control blankets channel installation

blanket application, the slope was regraded, top soil was placed on terraces and compacted to 85 percent of optimum density, and mulch and seed were applied hydraulically to the slope. Longitudinal slots (horizontal) and check slots (vertical) were dug into the fill material on the middle and upper portions of the bank to serve as footings for anchoring the blankets and coir logs.

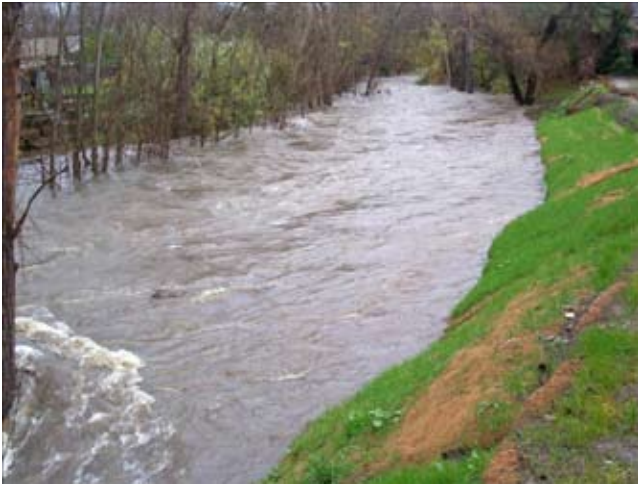
events demonstrated the inundation experienced by the slope during high flows (fig. CS15-10). Following a storm in January 2004, the flow line reached high elevations on the slope and indicated that the restoration work had been successful (fig. CS15-11).

Figure CS15-10 Inundation of the restored slope

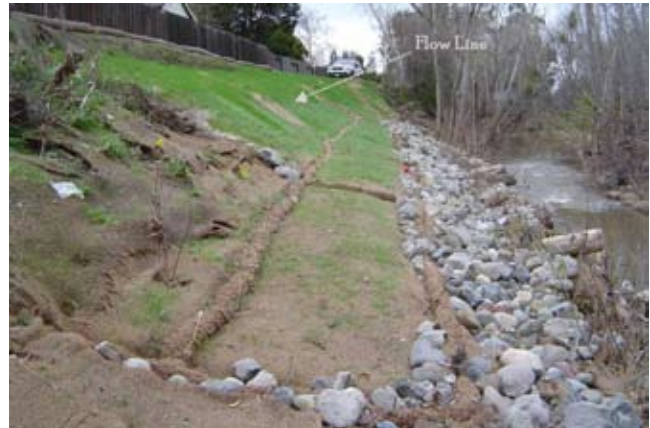
Figure CS15-11 Flow line after a storm in January 2004

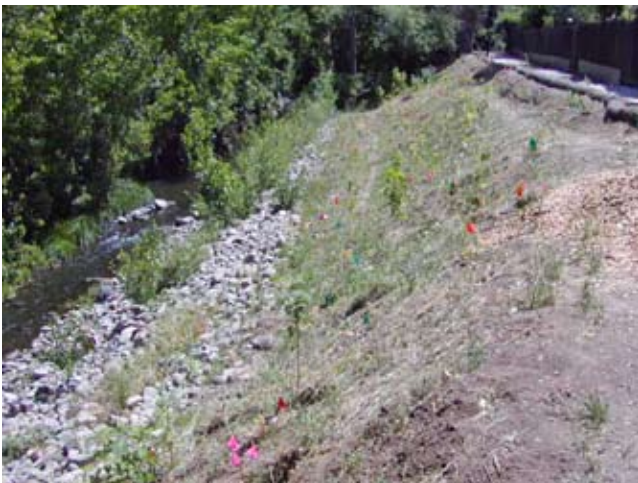
The restoration work performed in 2003 was extremely successful in stabilizing the slope. In April 2004, the bank was becoming vegetated (fig. CS15-12), and the willows were successfully established at the toe (fig. CS15-13). For future projects, plantings should be performed with minimal disturbance to the geotextile blanket (holes cut for the vegetation were quite large and could provide a potential point of undermining). The project emphasized the importance of installing geotextile blankets parallel to the flow of water within channels where inundation will occur. Combining techniques such as cobble revetment, live staking, pole planting, live siltation, hydroseeding, and coir blankets provided the stability, habitat, and aesthetic value needed for the site.

Figure CS15-12 Revegetated slope 1 year later

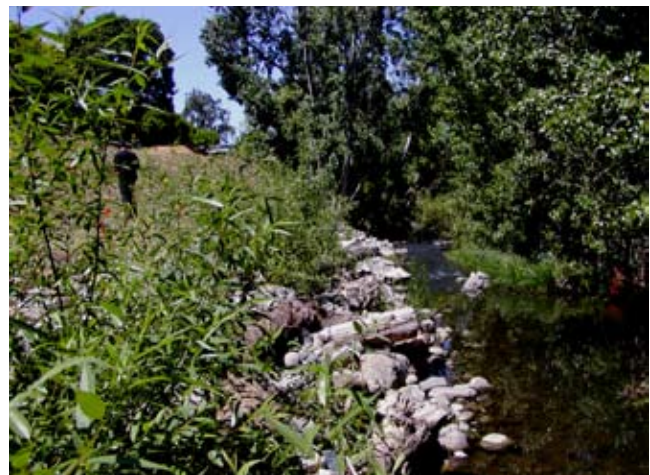
Figure CS15-13 Willow establishment at the toe
