May 26, 2022

RE: Lot 66 Wetland Mitigation

The Terra Firm, Inc.

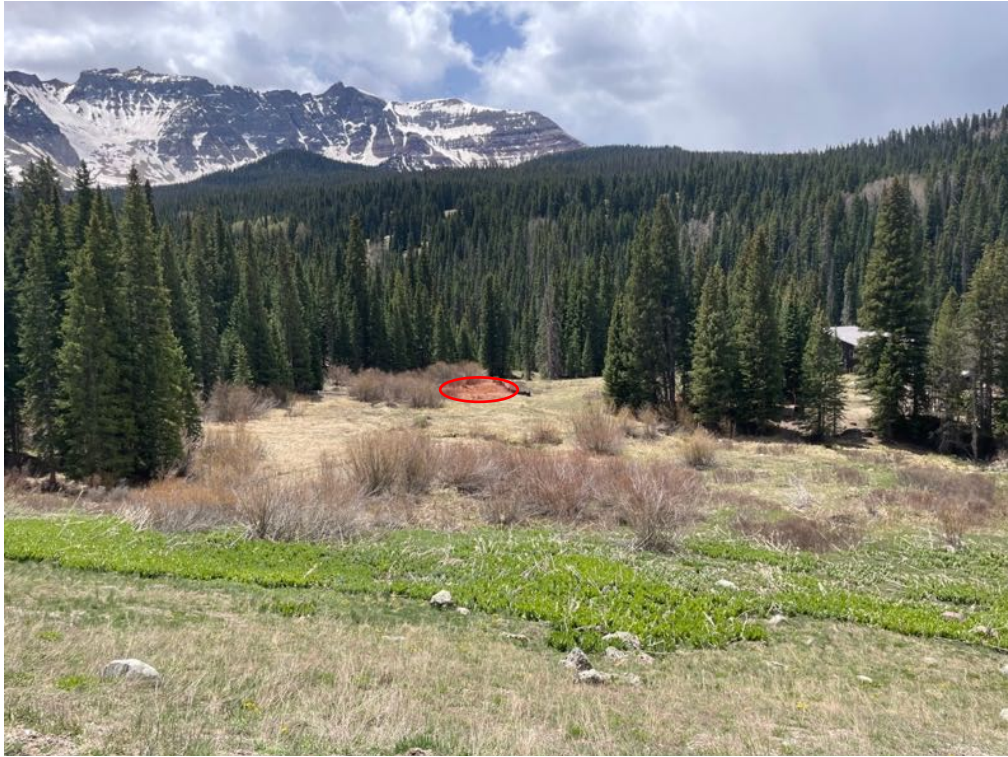
Image 1: Photo from Trout Lake Rd. looking south towards Lot 66. Mitigation area circled in red.

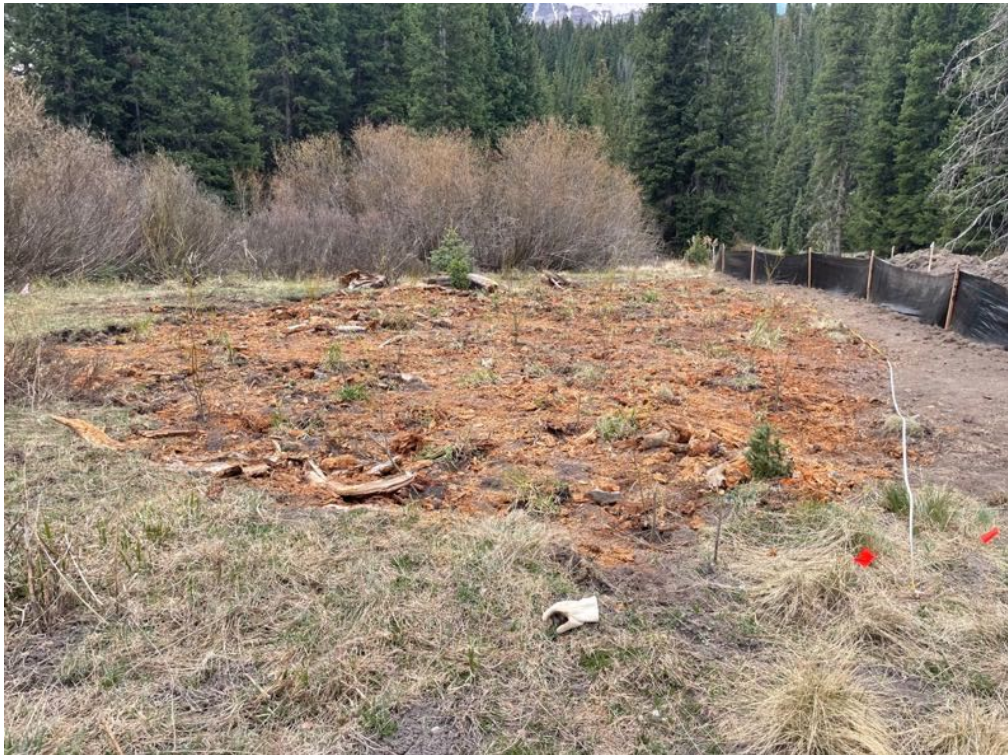
Image 2: Looking south from the northern point of the mitigation site. Transplanted sedge, willows and spruce saplings visible in image. The orange-colored mulched area is where the grade was lowered and transplanting occurred. The grassy margin in the bottom of the image is one of the buffer areas described in the report. Pre-existing wetland area located in left of image and identified by mature willow growth. Driveway alignment right side of image beyond the silt fencing.

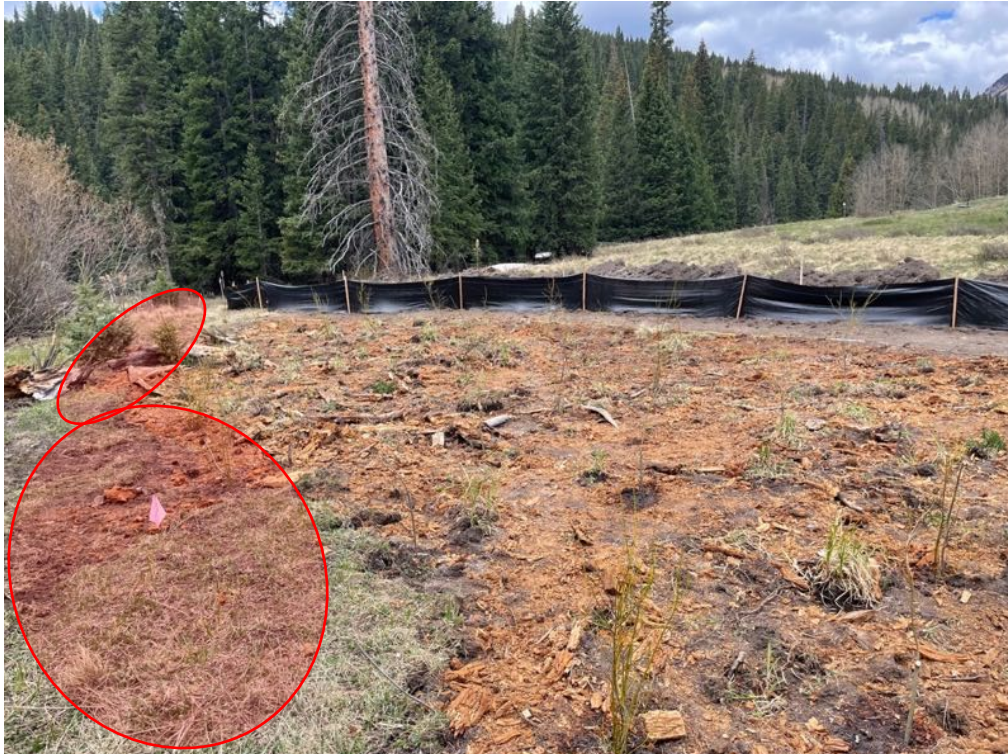
Image 3: Image looking southwest from the eastern most point of the mitigation area. Driveway alignment located behind silt fencing. Buffer area between existing wetlands and disturbed mitigation area visible on left of image and highlighted in red.

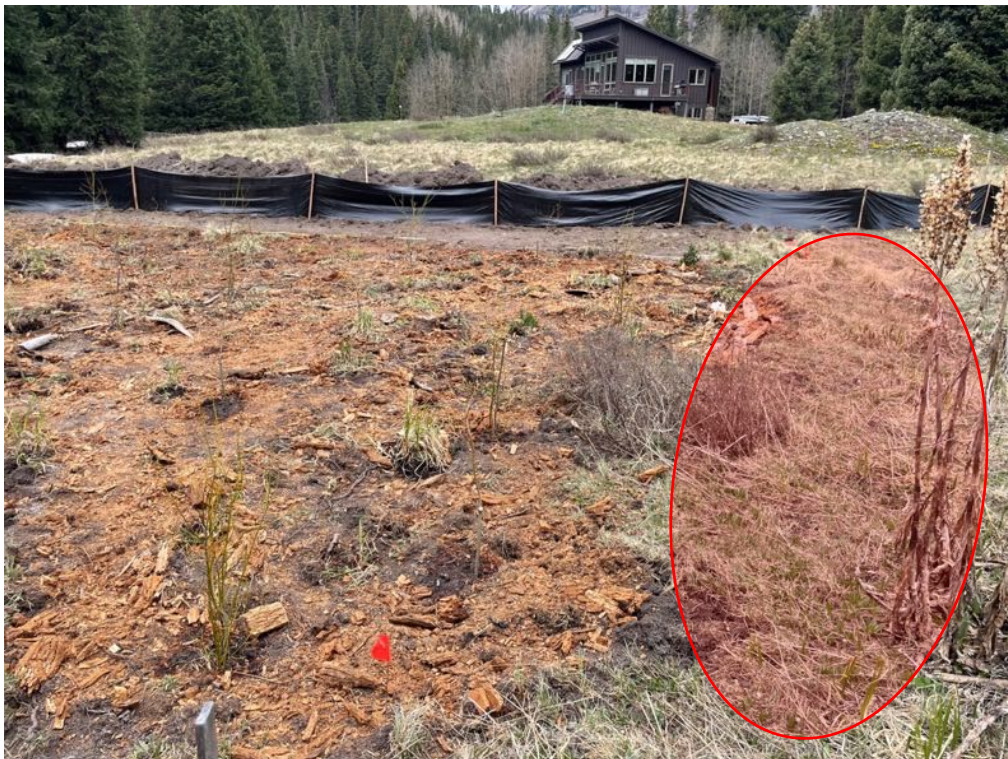
Image 4: Image taken from same location as Image 3 but looking to the west. Dave Foley's house visible in background. Northern margin of restoration area visible in image. Buffer area highlighted in red. Driveway alignment behind silt fencing.

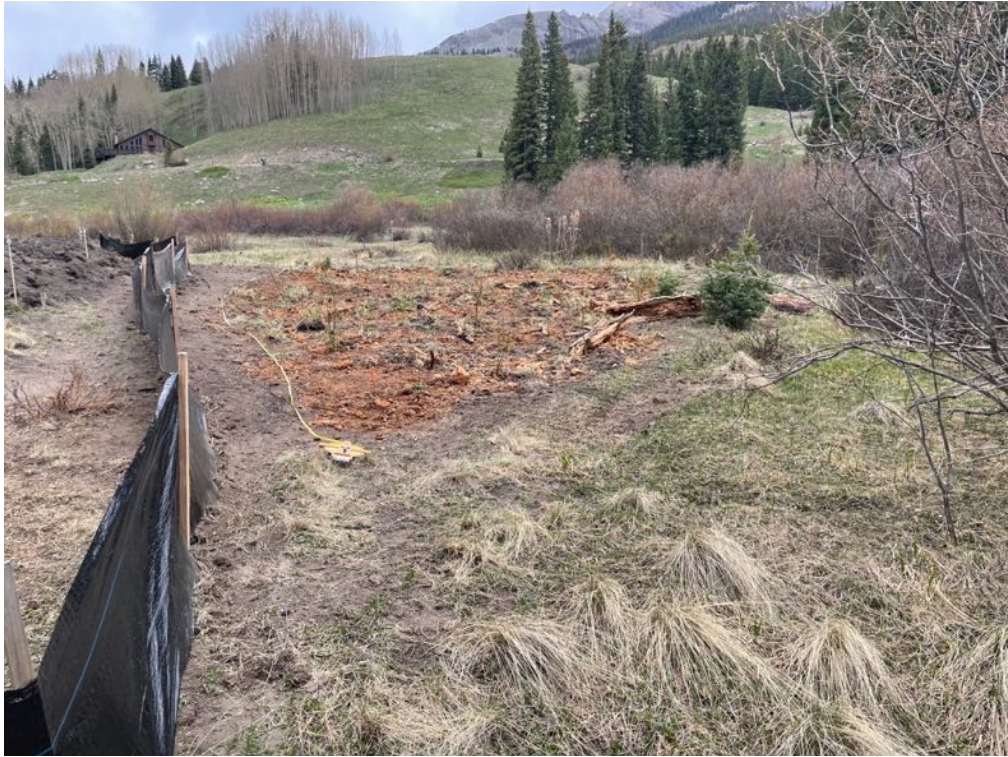
Image 5: View to the north of mitigation area taken from the southern extent of the silt fencing. Pre-existing wetland area dominates right side and background of the image.

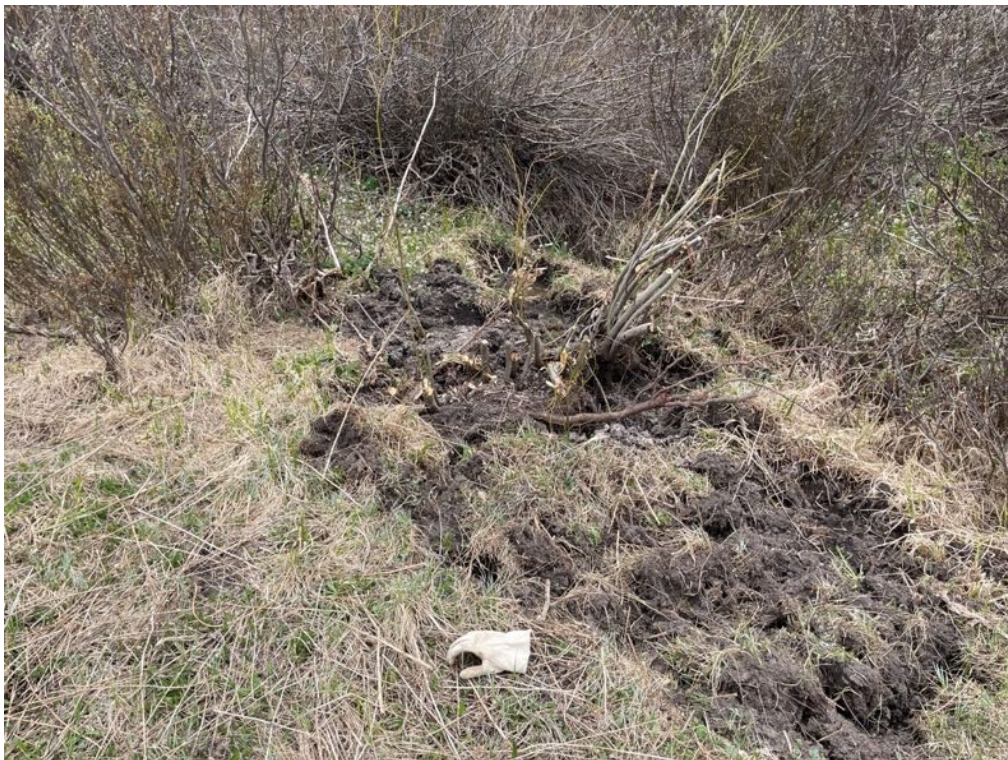
Image 6: First of three willow transplants from willow that was removed from the driveway alignment. Located in northeast of mitigation area.

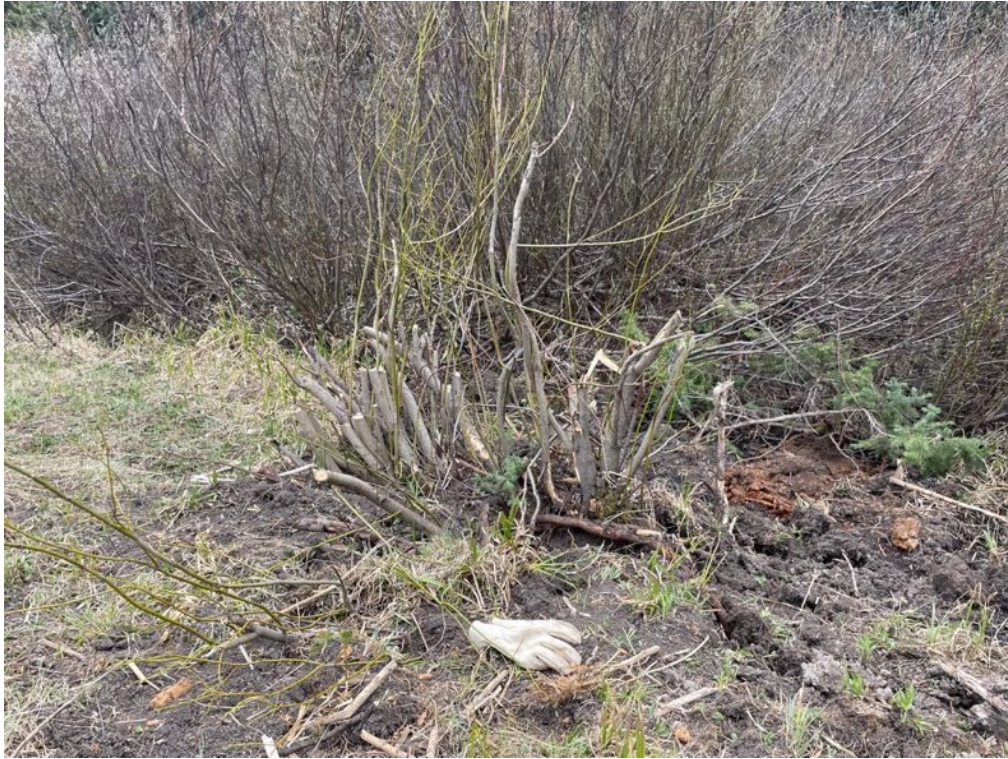
Image 7: Second of three willow transplants from willow that was removed from the driveway alignment. Located in the eastern margin of mitigation area.

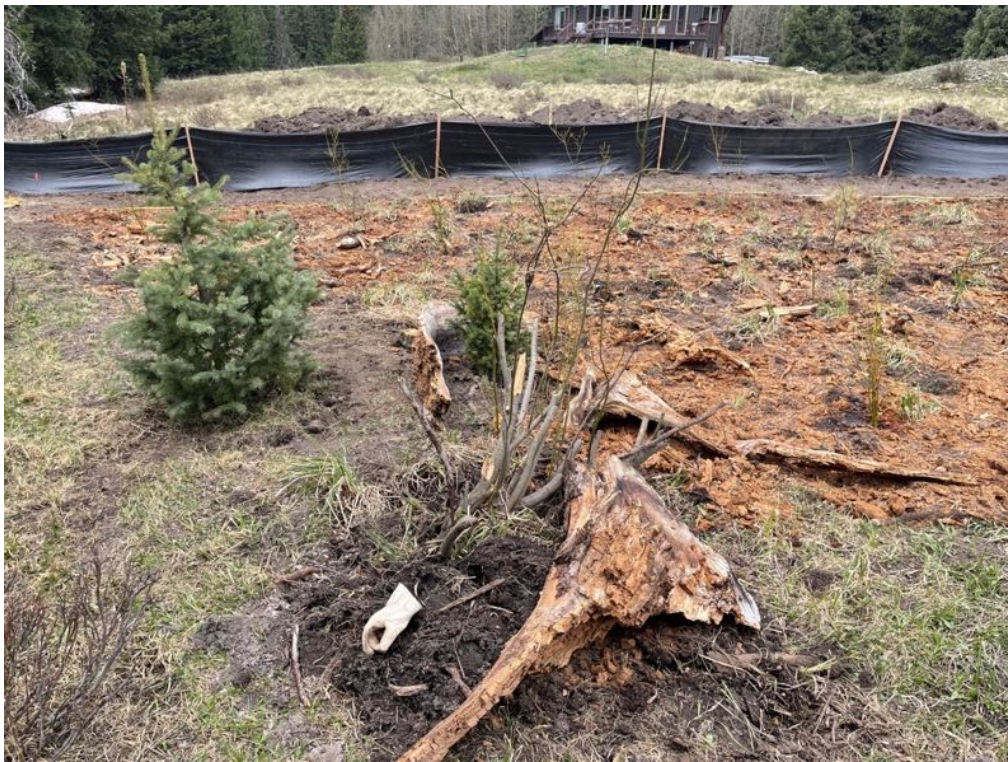
Image 8: Third of three willow transplants from willow that was removed from the driveway alignment. Located in eastern margin of mitigation area. Two of three pine tree sapling transplants visible in middle of image.

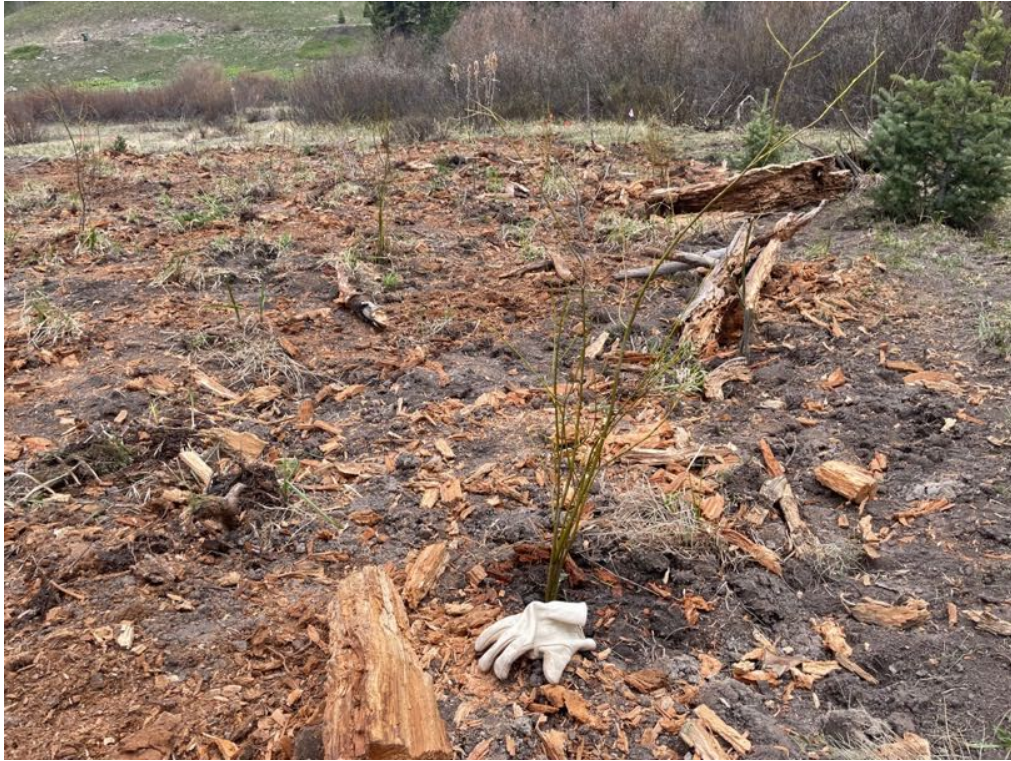
Image 9: Typical clumped willow cuttings (immediately behind glove) used for planting of mitigation area.

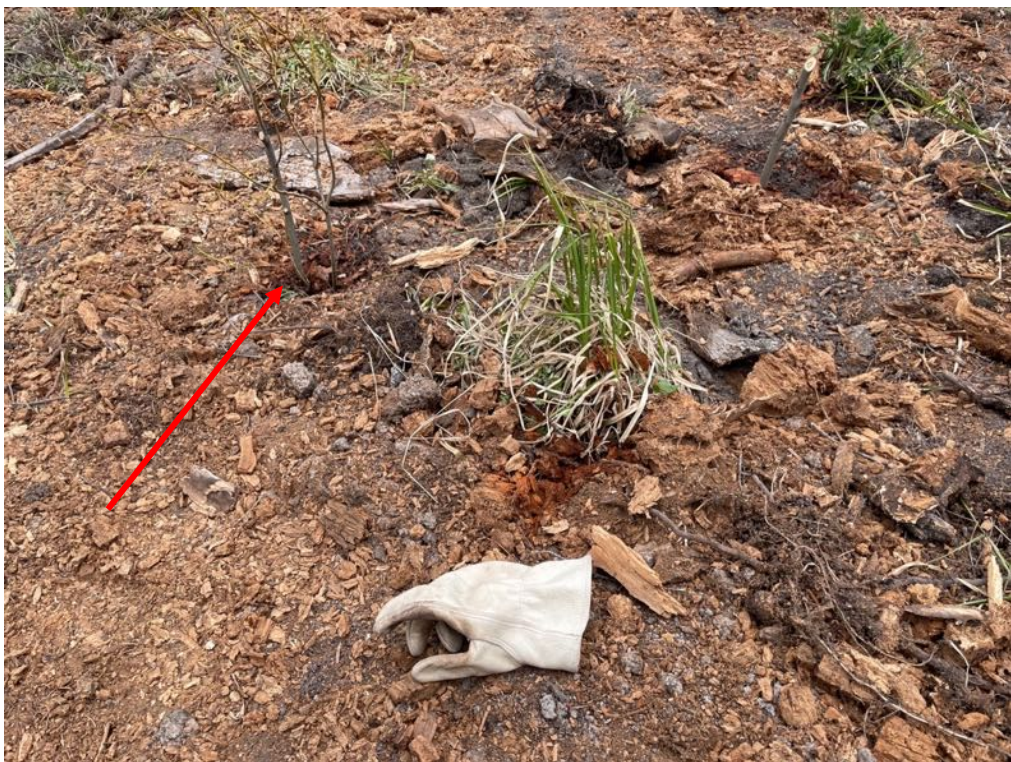
Image 10: Typical willow cutting highlighted by red arrow. Typical small sedge plug located just above glove.

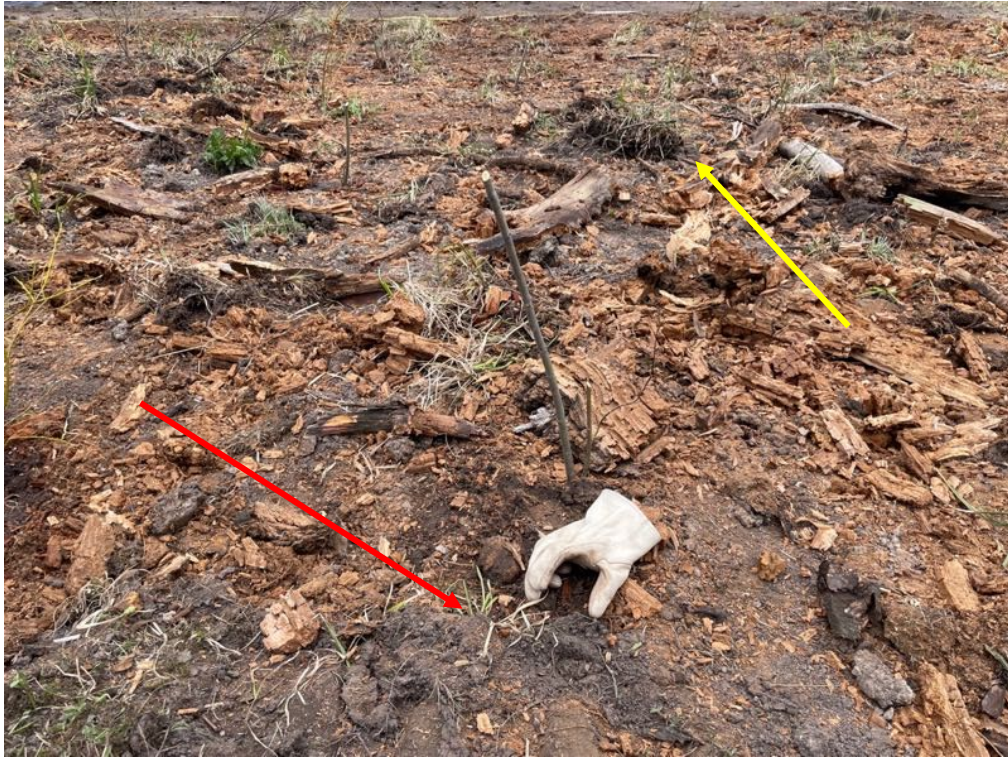
Image 11: Typical willow cutting behind glove. Typical singular sedge plug highlighted by red arrow. Typical large sedge mat highlighted by yellow arrow.

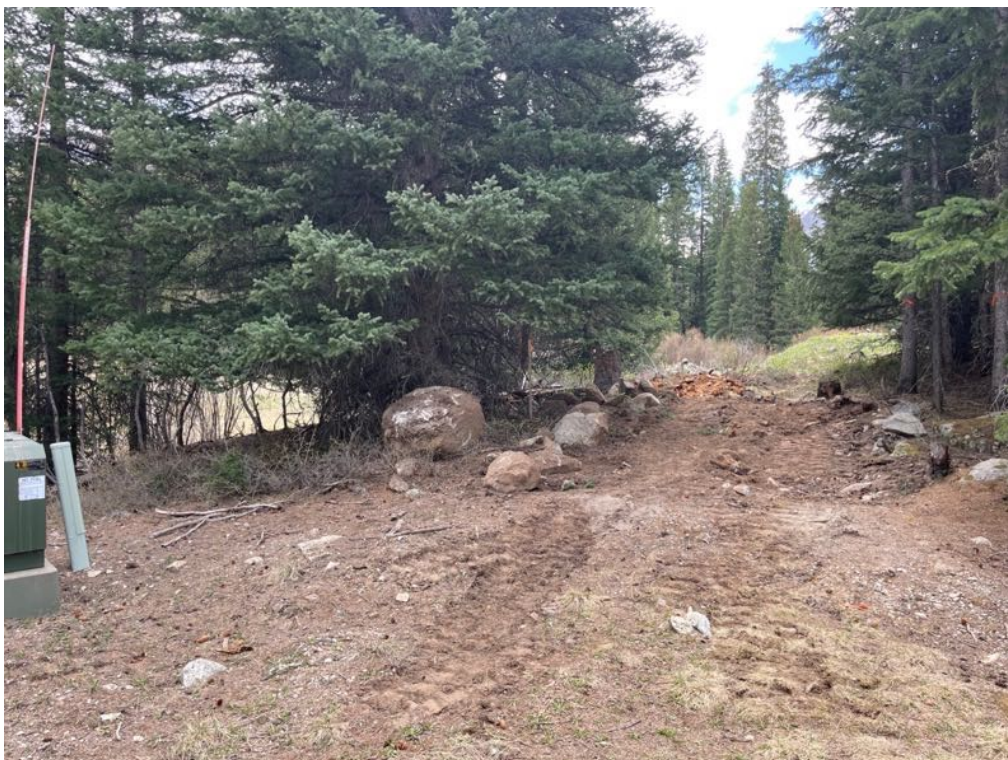
Image 12: View to southeast from driveway entrance. Relocated boulders visible on either side of driveway access.

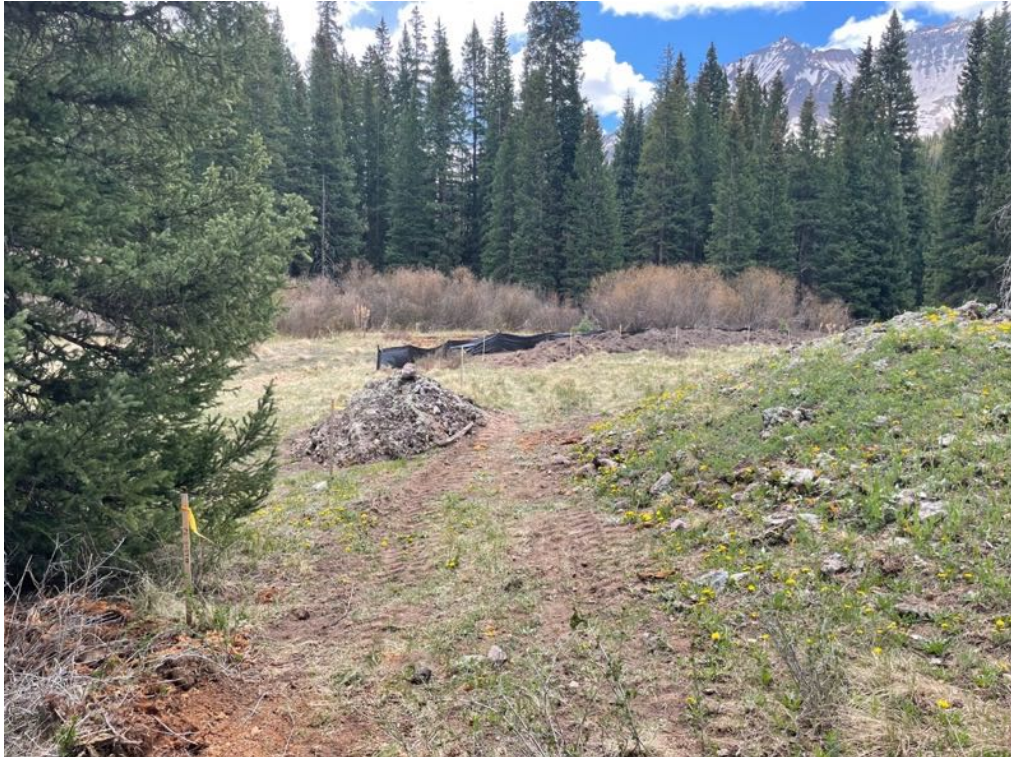
Image 13: View from driveway centerline towards mitigation area to the southeast. Wind row of dirt stacked on driveway centerline. Silt fencing visible between driveway and mitigation area.

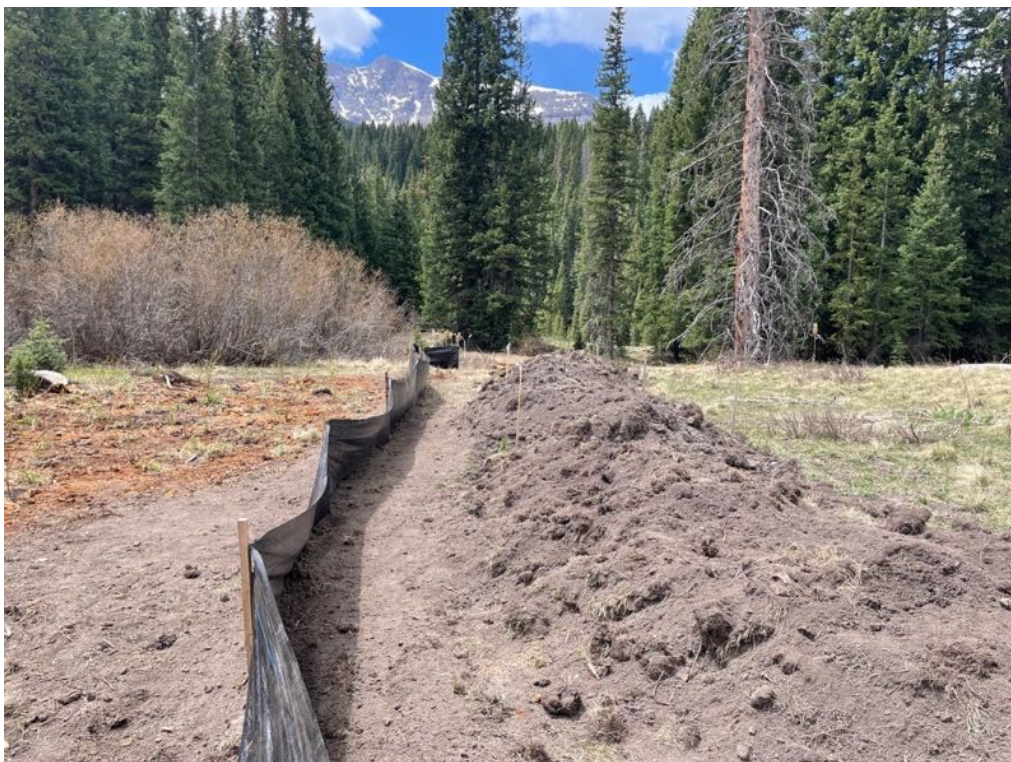
Image 14: View to the south along the silt fence line. Mitigation area in left of image, dirt staged on centerline of driveway alignment.

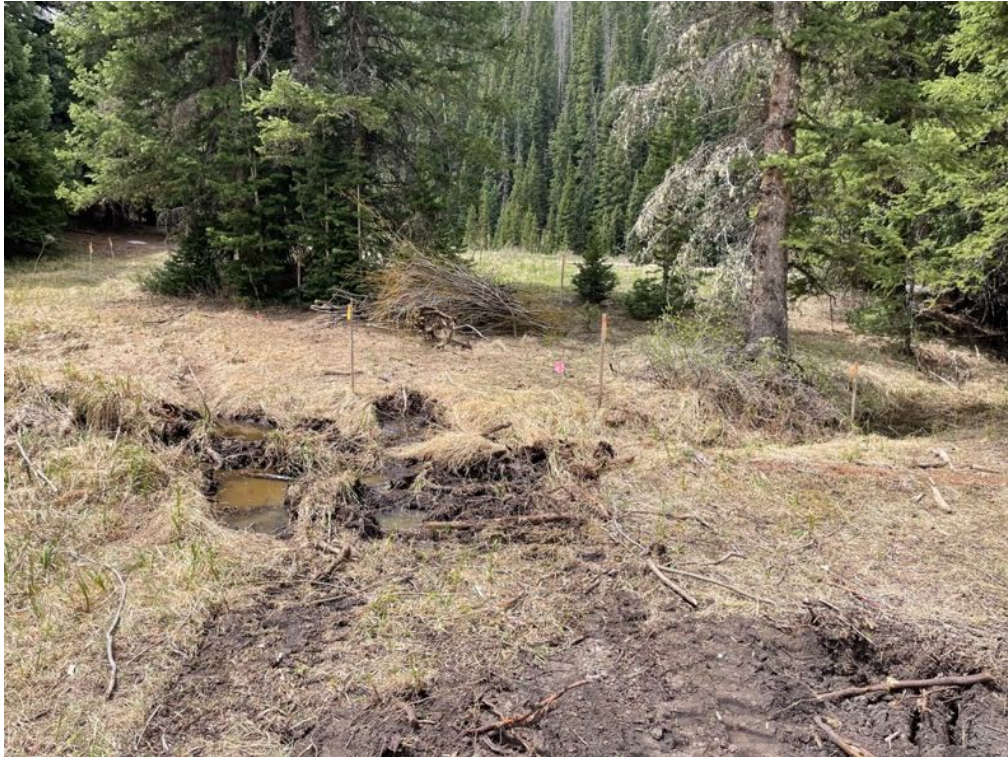
Image 15: View to the south of the channel crossing where driveway transitions to turnaround. Building envelope visible in background of image. Sedge for transplanting was harvested from this location. The transplanted willow was in the bottom right corner of the image. Roots of removed and transplanted willow visible.
