CSU Antenna Test Range – Physical Functional Evaluation

Department of Electrical and Computer Engineering, Colorado State University

September 8, 2022

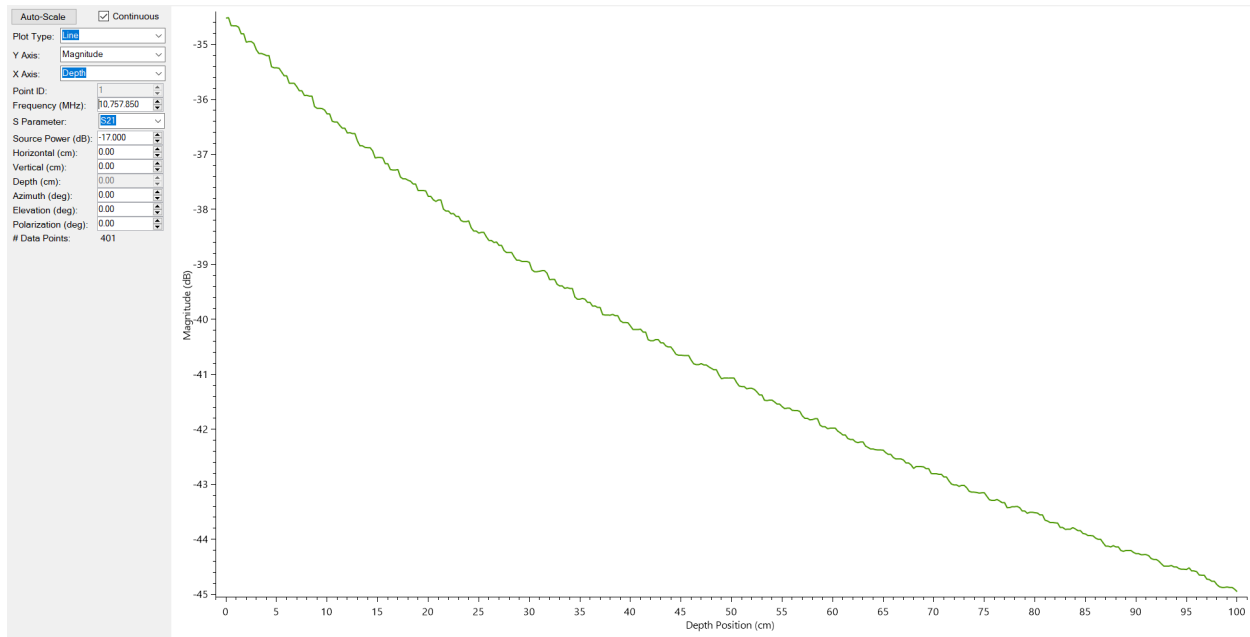
Figure 1: Radiation pattern from depth scan from ~15cm to 115cm from aperture to aperture.

Based on the results seen in Figure 1, the depth scan does show a decay of what appears to be $\frac{1}{d^2}$ where d is the distance from aperture to aperture. The plot shows the magnitude of the power and power decreases proportionally to $\frac{1}{r^2}$ which is why this plot shows a good reading. There will be no further action needed with the depth axis of freedom.

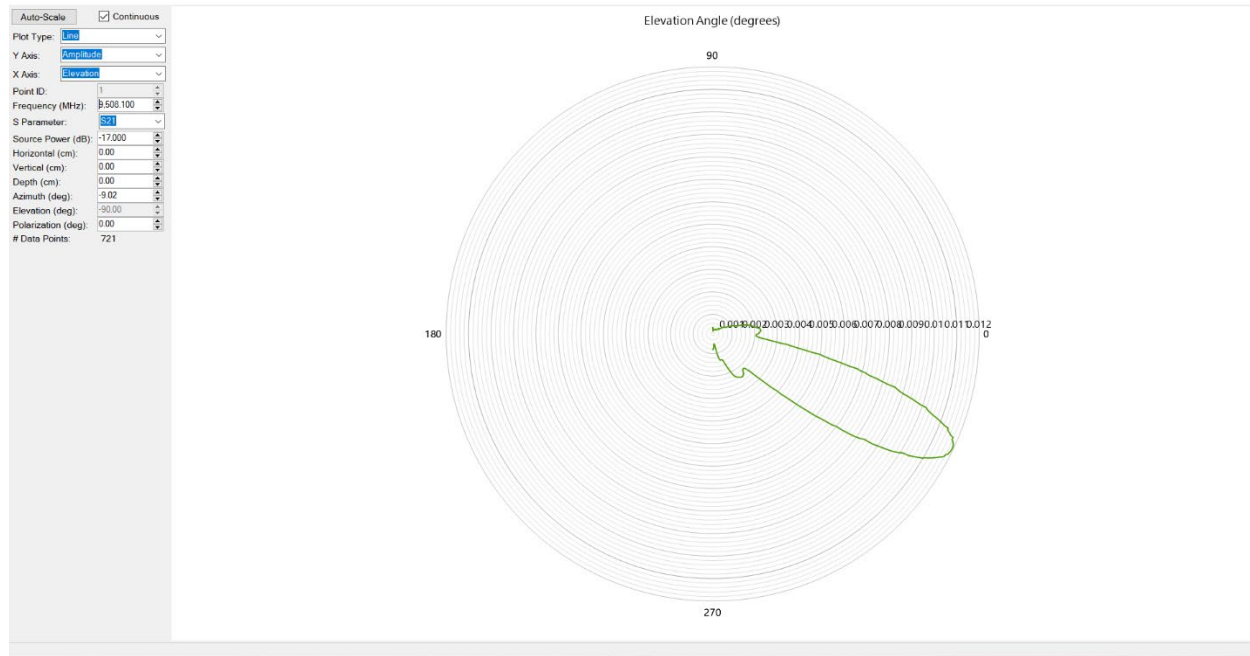
Figure 2: Radiation pattern from elevation scan from $-180^\circ \leq \theta \leq 0^\circ$.

Based on the results of the elevation scan, the actual pattern does look correct and smooth. This is the look that was looked for, so the overall shape of the radiation pattern is correct. However, the actual angle which it shows the max, is not correct. But this could be due to a zeroing error, so further action of investigating the software side could potentially fix this. Or, forgetting to set all coordinates to zero before setting the elevation to -180° could also play an affect on the actual positioning of the plot.

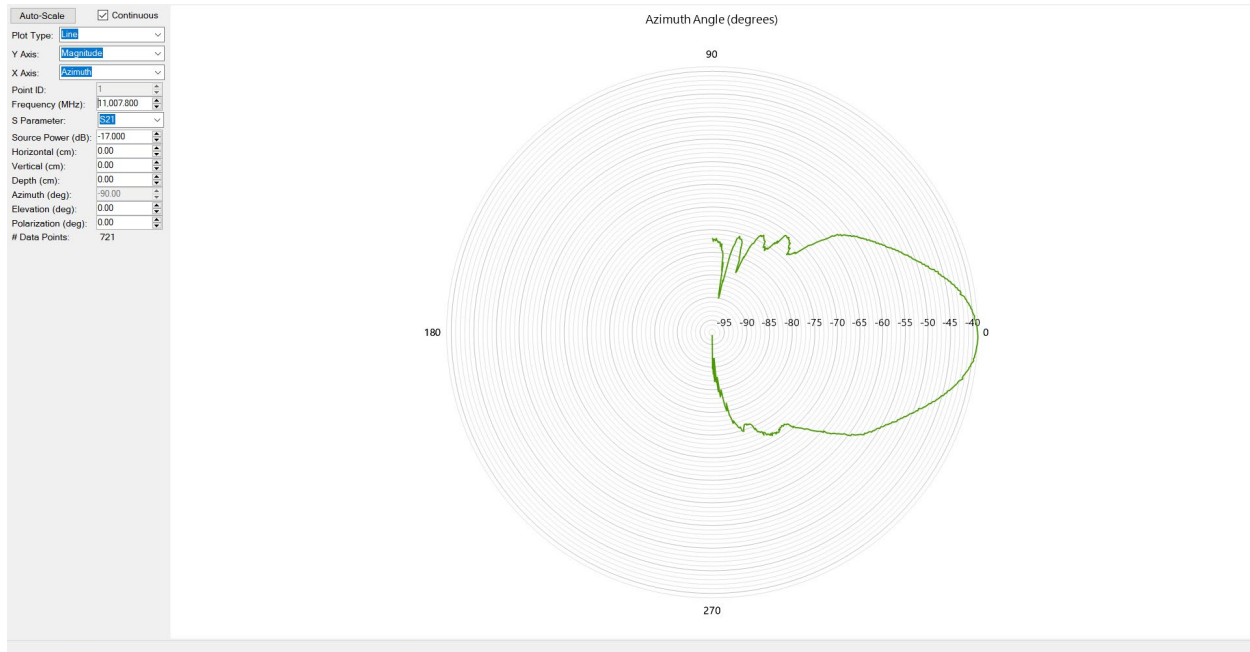
Figure 3: Radiation pattern from azimuth scan from $-90^\circ \leq \phi \leq 90^\circ$.

Based on the results of the azimuth scan, this does have a relatively correct shape. However, when Carlos was looking at the test range, he made a critical discovery of noticing that the aperture of the antenna is *not* directly above the axis rotation. So, the actual scan is of the antenna making an arc around ϕ with a radius of roughly 9 – 10cm, which this is why the main lobe so wide. This is a very large problem because that will mean any reading that involves a ϕ component will not give an accurate reading. This problem is one that needs to be resolved as soon as possible and is already in the works. The solution is to design and manufacture a new mount to hold the antenna which will provide an offset to center the aperture at the axis of rotation.

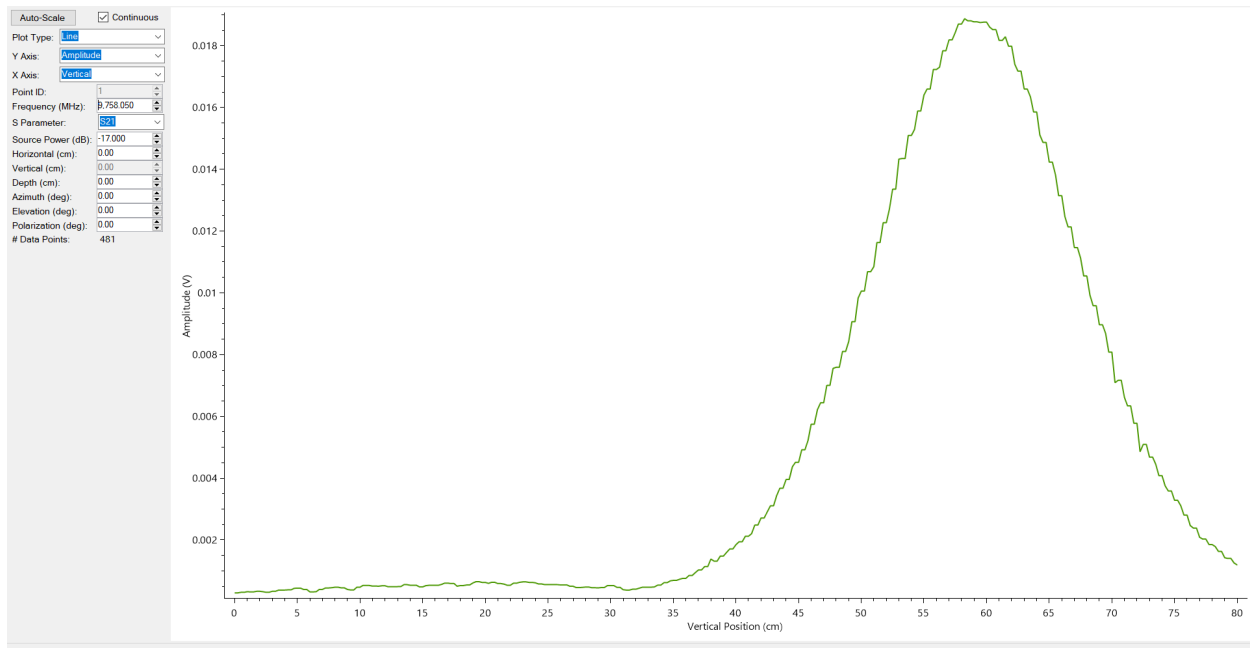
Figure 4: Radiation pattern from vertical scan from 0 to 80 cm with center at 40 cm.

Based on the results from the vertical scan, the pattern does look correct with having a peak. However, the peak is not at the 40 cm mark which is where the peak should be since both antennas will be in direct line of each other. This is again an issue that can possibly be due to calibration in the software and will need to be investigated further.

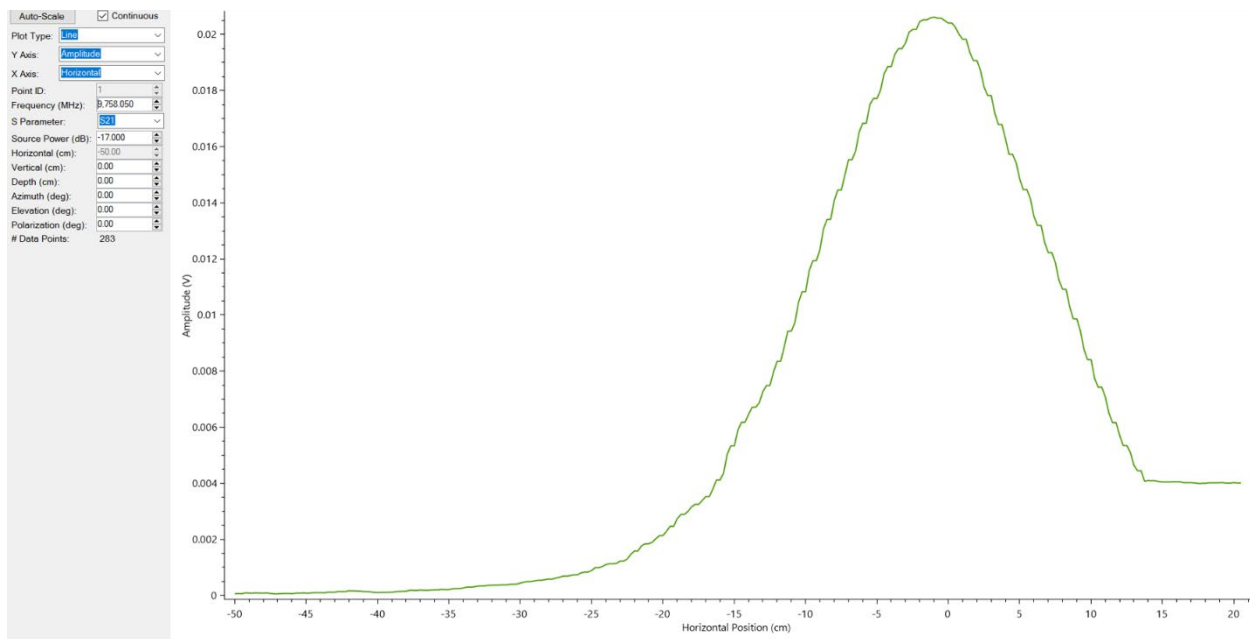
Figure 5: Radiation pattern from vertical scan from -50 to 50 cm with center at 0 cm.

Based on the results of the scan of the horizontal direction, the scan looks very good with the peak of the scan centering at ~ 0 cm. At first glance, the plot does flatline around the 13cm marks, but after investigating this issue, it was found that a wire had gotten on the rail and was prohibiting the mechanism from moving. This issue has been resolved and the wires have been tied up and out of the way so they will not interfere with the movement.
