Clash Detection Report

We decided to do a clash test between the structural and the HVAC Model. This gave an initial value of 48 clashes. We have decided to solve the first three clashes, as indicated below:

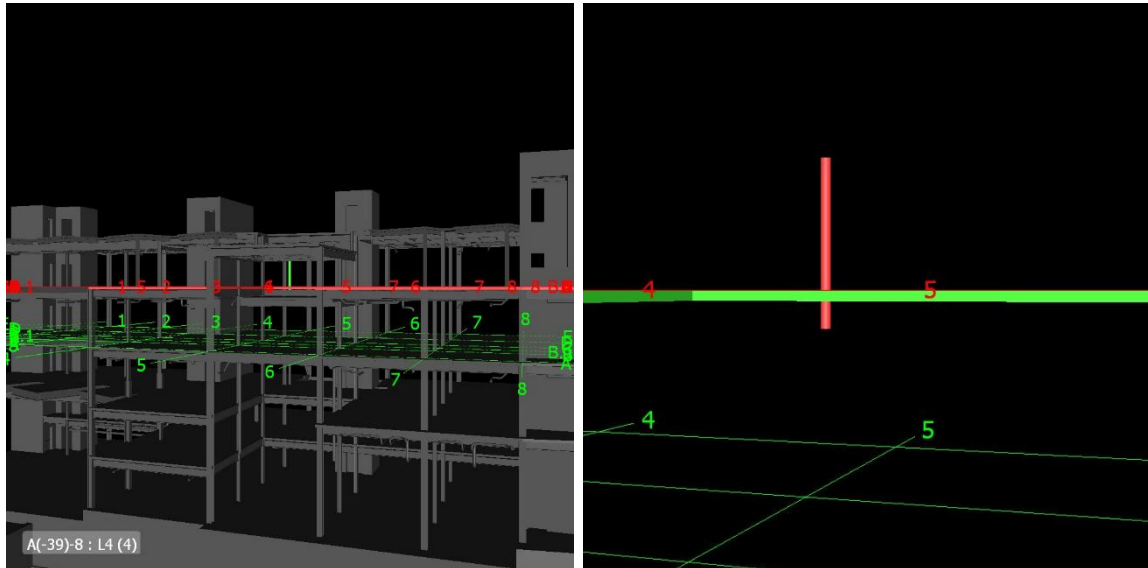
Clash 1

On grid D-5 at level L4, a round duct tee runs confidently through the ceiling zone, only to run straight into a concrete floor slab above. Both elements sit on layer L5, which means the duct and the NW concrete-on-metal-deck floor are competing for exactly the same vertical space. In practice, this reads as a mechanical service trying to pass through a structural floor without a proper opening or coordination.

We solved all the clashes in Revit, after this we tested again in Navisworks and some of the clashes were solved. In the initial models we had 48 clashes after this we start by solving each time one clash and after each test we checked if there was one less clash in the models. We solved three of the clashes by adjusting the structural model in Revit, as shown below:

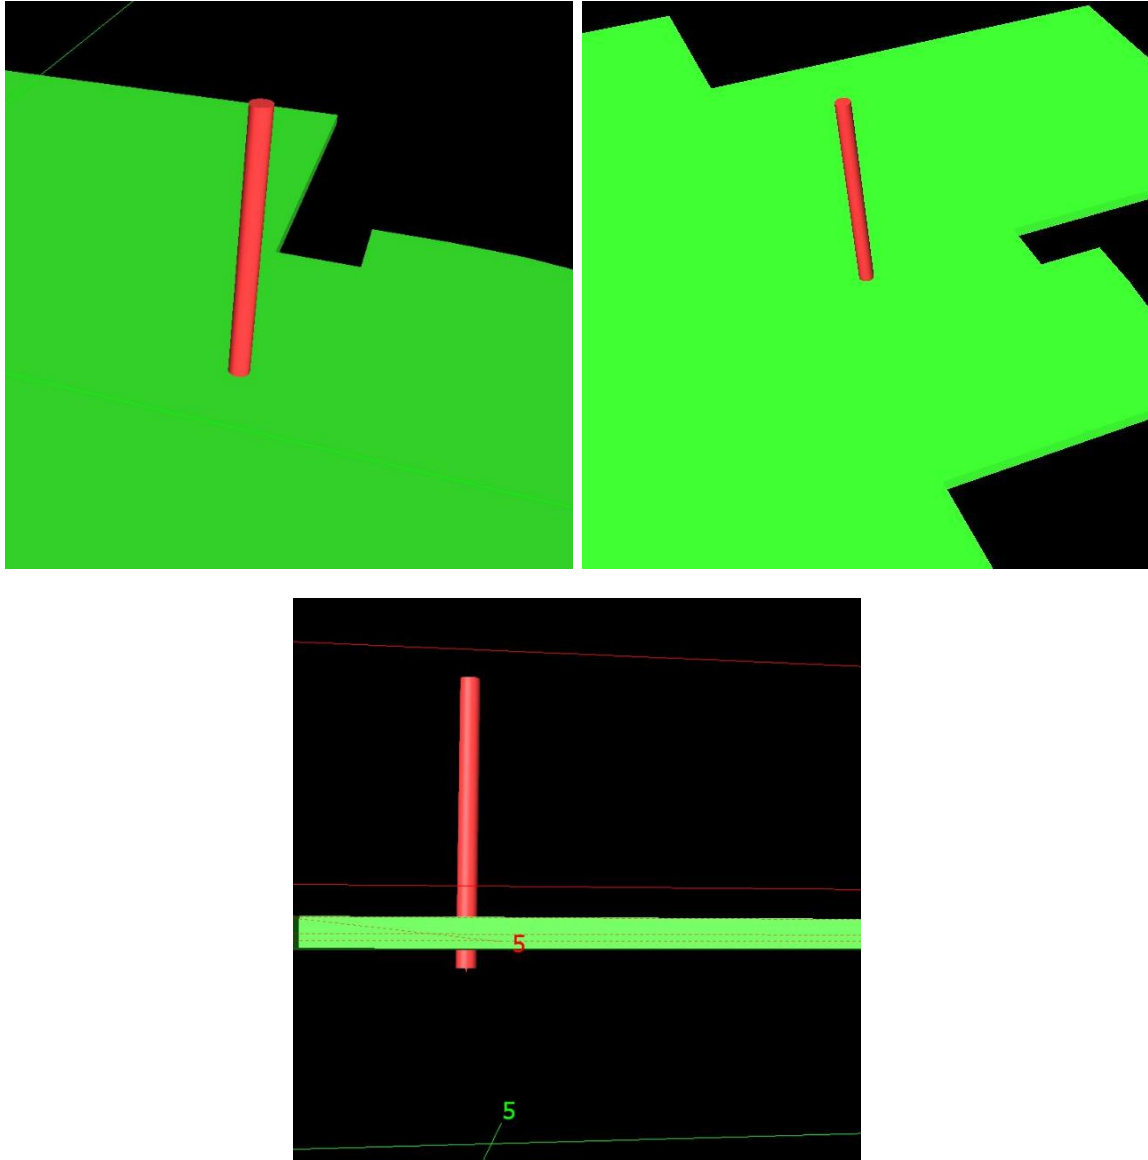
Clash 2

A little lower in the building, still at grid D-5 but on level L2, another round duct tee tries to thread its way through the structure. This time the duct sits on layer L2 while a concrete floor from level L3 drops into its path, so the Level 2 ductwork is pushing up into the underside of the Level 3 slab. The clash shows a vertical coordination issue between the mechanical distribution at L2 and the structural floor system above.

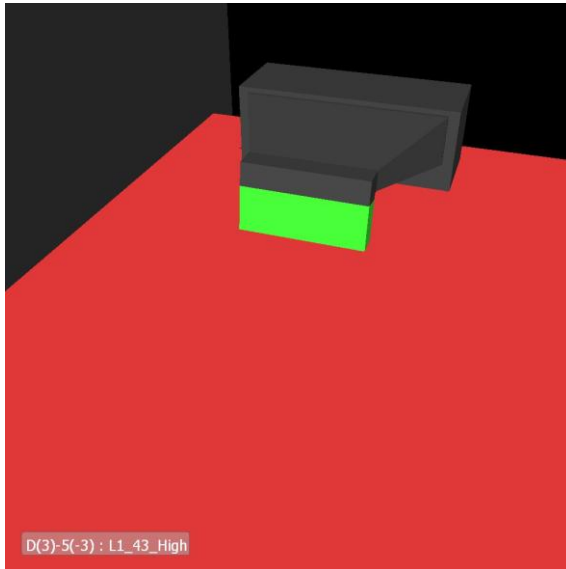
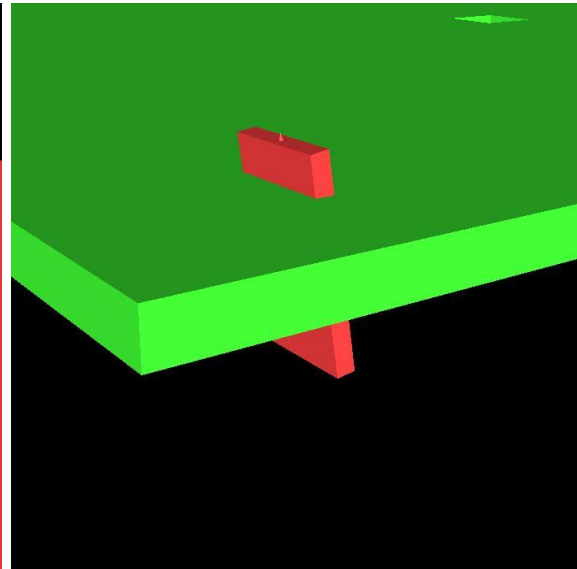
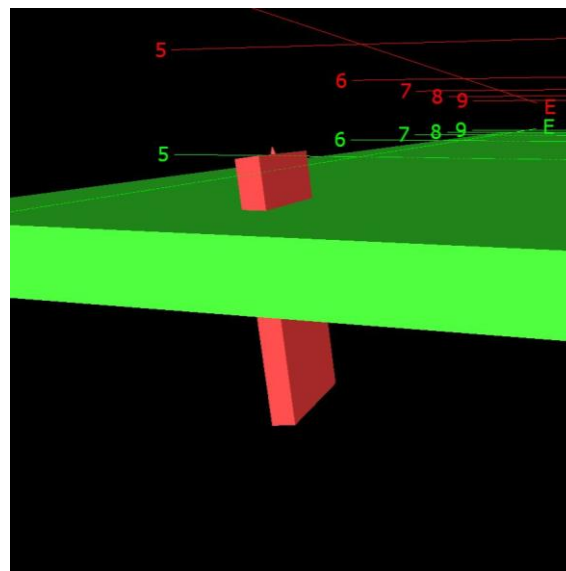
Clash 3

Over at grid E-4 on level L1 in Block 35, the conflict shifts into the parking area where a rectangular duct with mitered elbows attempts to navigate through a tight zone. The duct, assigned to the Parking layer, collides with a relatively thin “Concrete 10” floor on layer L1_37_Med, indicating that the parking ventilation route slices into the structural floor plane. This clash highlights a coordination problem between the parking ventilation strategy and the slab geometry at that block and level.
