**TMS320F28335, TMS320F28334,  
TMS320F28332, TMS320F28235,  
TMS320F28234, TMS320F28232 DSC**

## **Silicon Errata**

Literature Number: SPRZ272G  
September 2007–Revised January 2012

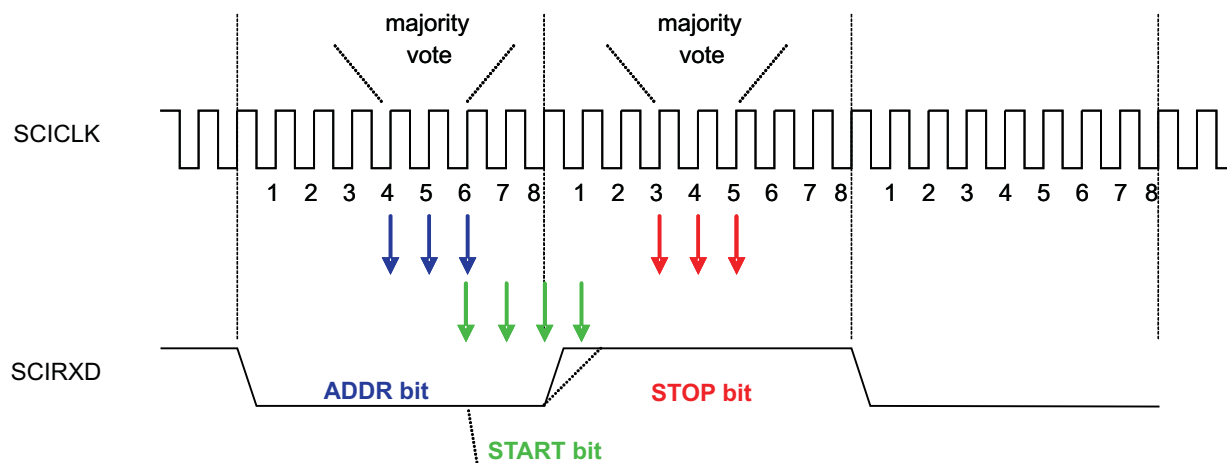
**Figure 3. Difference Between Expected and Erroneous Operation of START Bit**

**Advisory**      **SCI: Incorrect Operation of SCI in Address Bit Mode**
**Revision(s) Affected**      0, A

**Details**      SCI does not look for STOP bit after the ADDR bit. Instead, SCI starts looking for the start bit beginning on sub-sample 6 of the ADDR bit. Slow rise-time from ADDR to STOP bit can cause the false START bit to occur since the 4th sub-sample for the start bit may be sensed low.

**Workaround(s)**      Program the baud rate of the SCI to be slightly slower than the actual. This will cause the 4th sub-sample of the false START bit to be delayed in time, and therefore occur more towards the middle of the STOP bit (away from the signal transition region). The amount of baud slowing needed depends on the rise-time of the signal in the system. Alternatively, IDLE mode of the SCI module may be used, if applicable.

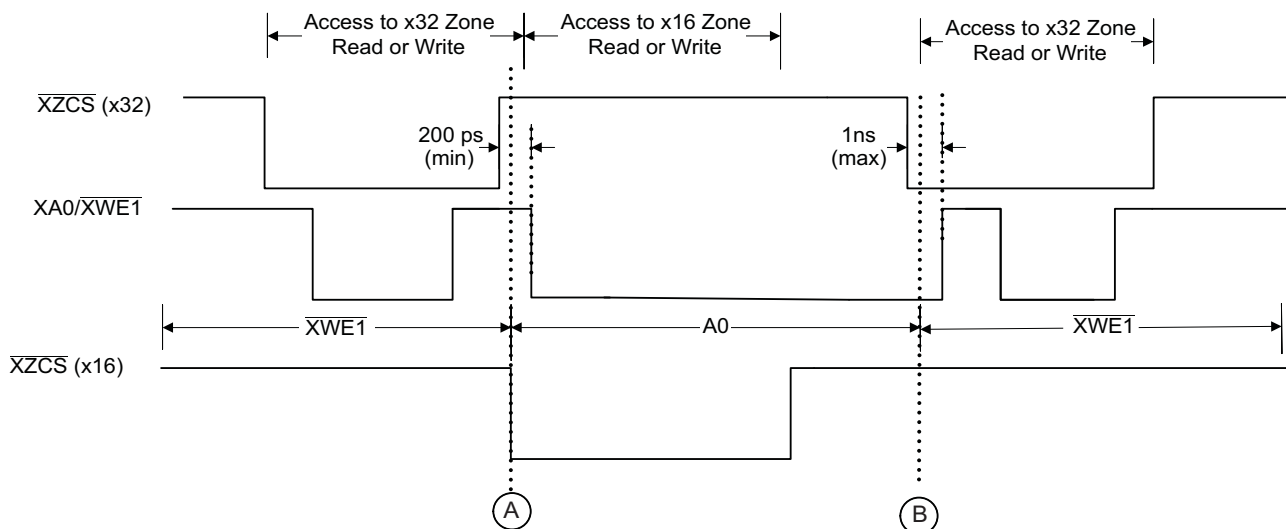
**Figure 4. Behavior of Zone Chip Select Signals and XA0/XWE1**

## **XINTF Rogue Write for Back-to-Back Accesses to x16/x32 Zones**

Figure 4 shows the behavior of zone chip select signals and XA0/XWE1 for back-to-back accesses between zones configured for different data bus widths.

For the x32-bit zone (XTIMINGx[XSIZE] = 1) the A0/XWE1 signal is the write enable XWE1. For the x16-bit zone (XTIMINGx[XSIZE] = 3) the A0/XWE1 signal is address line A0.

- A Design simulation data indicates the delta between XZCS (x32) high and XA0/XWE1 low can be as small as 200 ps.
- B Design simulation data indicates XA0/XWE1 can stay low for as long as 1 ns after XZCS (x32) goes low.

When A0/XWE1 changes functionality, the x32 zone chip select signal (XZCS x32) changes state. Depending on the board design and peripherals attached to the XINTF, it is possible that an external memory or peripheral on the x32 zone may respond to A0/XWE1 switching as a write access. If this happens, a rogue write to the x32 zone can occur.

1. If all zones are configured for x16 operation, then no action is required.
2. If all zones are configured for x32 operation, then XA0/XWE1 will switch from XA0 to XWE1 on the first access. After the first access, the XA0/XWE1 pin will remain as XWE1. To keep external devices from responding to the XA0/XWE1 change, follow these steps when configuring the XINTF module:

- (a) Enable the clock to the XINTF module.
  - (b) Configure the data-width and timing of the XINTF zones.
  - (c) Configure the zone chip select pins as GPIO inputs for the next step. This is the default behavior after reset.

- (d) Perform a dummy read from a x32 XINTF zone. This read will force XA0/XWE1 to behave as XWE1. Since the zone chip selects are configured as GPIO inputs, the external devices will not respond to XA0/XWE1 switching to XWE1. After the first read, XA0/XWE1 will continue to behave as XWE1.

- (e) Configure the GPIO MUX registers for XINTF operation.
3. Use external logic to delay the falling edge of the x32 zone chip select signal and the falling edge of the XWE1 signal as shown in Figure 5. With the delay the x32 zone

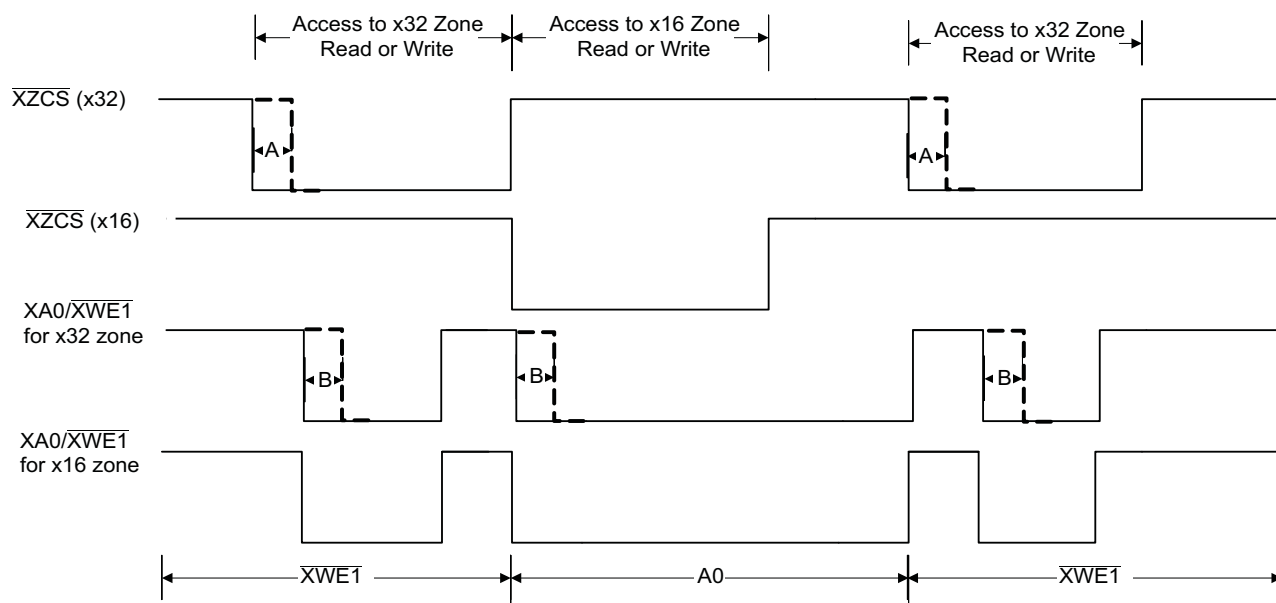
**Figure 5. Behavior After Application of Delay**

- A Delayed falling edge of zone chip select for x32 zone.
- B Delayed falling edge of  $\overline{XWE1}$ . The x16 zone will not see this delay.

chip select sees the  $\overline{XWE1}$  signal high at the critical points.

The timing configuration of the x32 zone must account for the additional delay. The zone chip select delay may require additional lead time. The  $\overline{XWE1}$  delay enable may require additional active write time. In addition, specify at least 1 trail cycle for writes to the x32 zone.
