**TMS320F28335, TMS320F28334,
TMS320F28332, TMS320F28235,
TMS320F28234, TMS320F28232 DSC**

Silicon Errata

Literature Number: SPRZ272G
September 2007–Revised January 2012

TMS320F2833x and TMS320F2823x DSC Silicon Errata

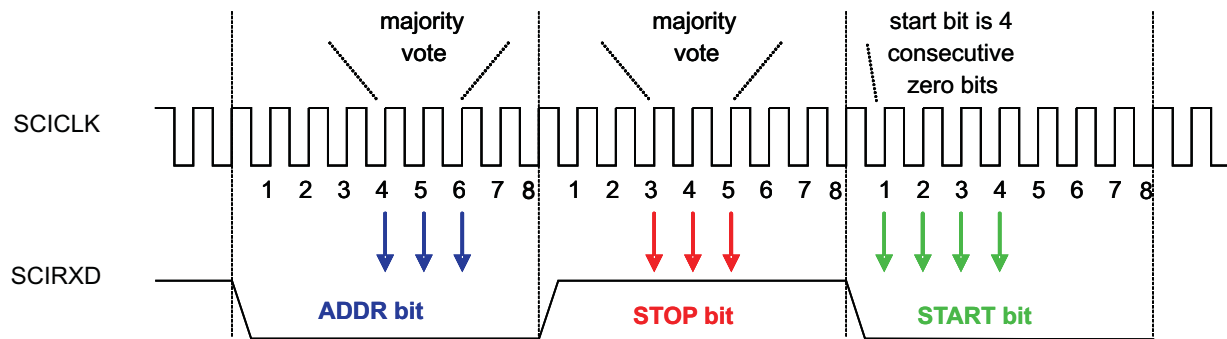
Figure 3. Difference Between Expected and Erroneous Operation of START Bit

Advisory **SCI: Incorrect Operation of SCI in Address Bit Mode**
Revision(s) Affected 0, A

Details SCI does not look for STOP bit after the ADDR bit. Instead, SCI starts looking for the start bit beginning on sub-sample 6 of the ADDR bit. Slow rise-time from ADDR to STOP bit can cause the false START bit to occur since the 4th sub-sample for the start bit may be sensed low.

Workaround(s) Program the baud rate of the SCI to be slightly slower than the actual. This will cause the 4th sub-sample of the false START bit to be delayed in time, and therefore occur more towards the middle of the STOP bit (away from the signal transition region). The amount of baud slowing needed depends on the rise-time of the signal in the system. Alternatively, IDLE mode of the SCI module may be used, if applicable.

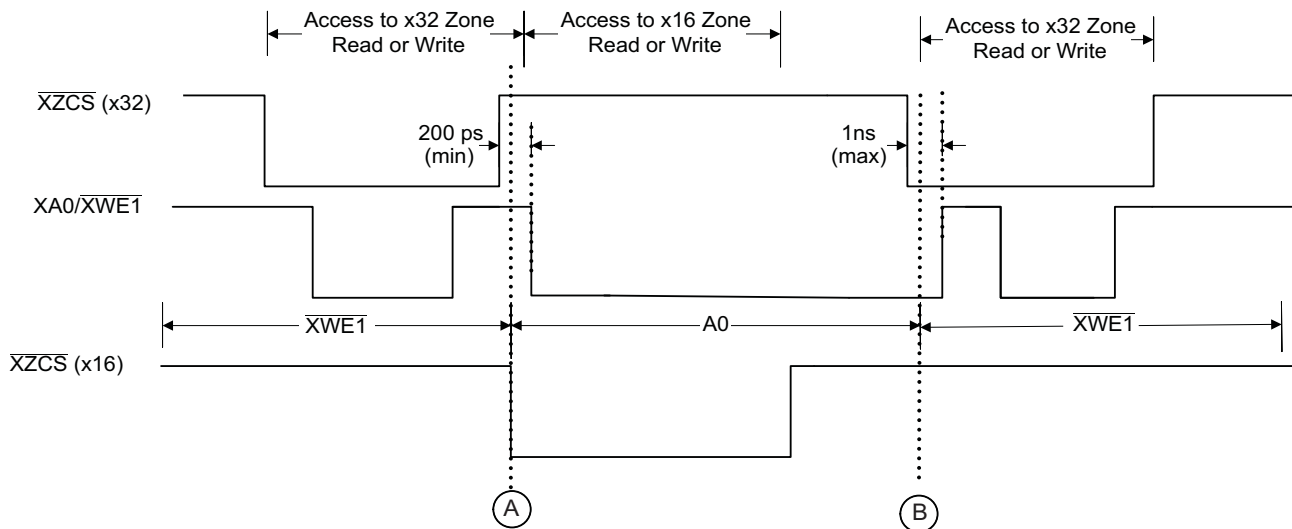
Figure 4. Behavior of Zone Chip Select Signals and XA0/XWE1

Figure 4 shows the behavior of zone chip select signals and XA0/XWE1 for back-to-back accesses between zones configured for different data bus widths.

For the x32-bit zone (XTIMINGx[XSIZE] = 1) the A0/XWE1 signal is the write enable XWE1. For the x16-bit zone (XTIMINGx[XSIZE] = 3) the A0/XWE1 signal is address line A0.

- A Design simulation data indicates the delta between XZCS (x32) high and XA0/XWE1 low can be as small as 200 ps.
- B Design simulation data indicates XA0/XWE1 can stay low for as long as 1 ns after XZCS (x32) goes low.

When A0/XWE1 changes functionality, the x32 zone chip select signal (XZCS x32) changes state. Depending on the board design and peripherals attached to the XINTF, it is possible that an external memory or peripheral on the x32 zone may respond to A0/XWE1 switching as a write access. If this happens, a rogue write to the x32 zone can occur.

1. If all zones are configured for x16 operation, then no action is required.
2. If all zones are configured for x32 operation, then XA0/XWE1 will switch from XA0 to XWE1 on the first access. After the first access, the XA0/XWE1 pin will remain as XWE1. To keep external devices from responding to the XA0/XWE1 change, follow these steps when configuring the XINTF module:

- (a) Enable the clock to the XINTF module.
 - (b) Configure the data-width and timing of the XINTF zones.
 - (c) Configure the zone chip select pins as GPIO inputs for the next step. This is the default behavior after reset.

- (d) Perform a dummy read from a x32 XINTF zone. This read will force XA0/XWE1 to behave as XWE1. Since the zone chip selects are configured as GPIO inputs, the external devices will not respond to XA0/XWE1 switching to XWE1. After the first read, XA0/XWE1 will continue to behave as XWE1.

- (e) Configure the GPIO MUX registers for XINTF operation.
3. Use external logic to delay the falling edge of the x32 zone chip select signal and the falling edge of the XWE1 signal as shown in Figure 5. With the delay the x32 zone

This has been fixed in Rev A silicon. The external delay logic is no longer required to avoid this issue in Rev A. The behavior of the XA0/ $\overline{XWE1}$ signal has been modified such that it goes high during inactive cycles. Use the XBANK feature to force inactive cycles between back-to-back zone accesses. See the *TMS320x2833x, 2823x DSC External Interface (XINTF) Reference Guide* ([SPRU949](#)) for more information.

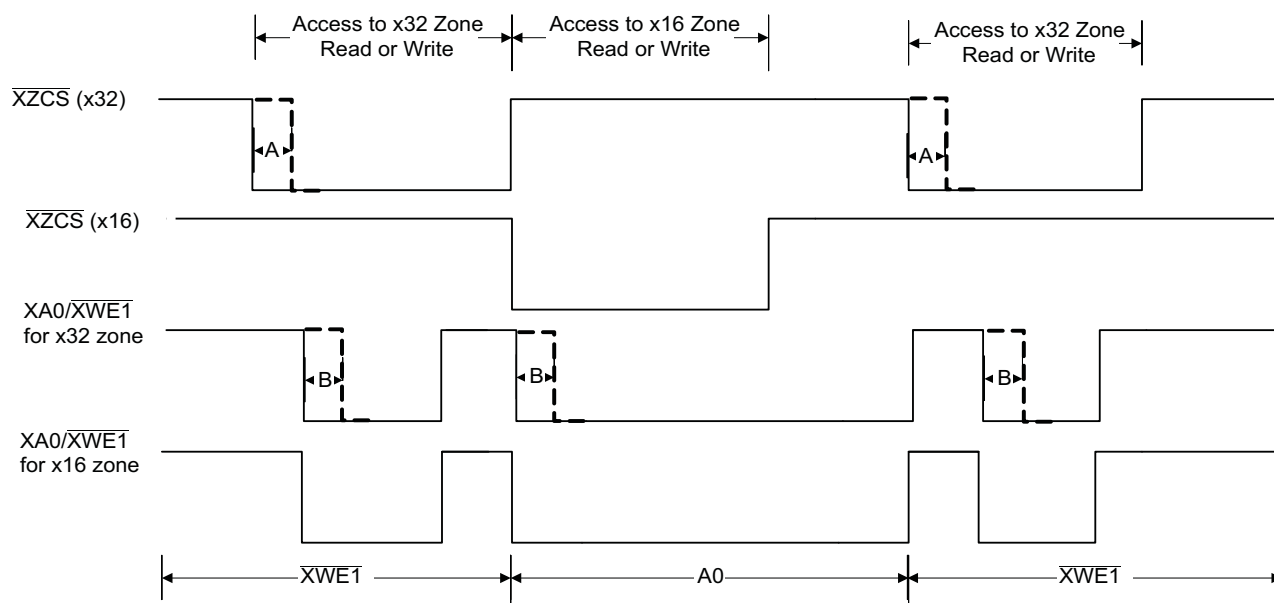
Figure 5. Behavior After Application of Delay

- A Delayed falling edge of zone chip select for x32 zone.
- B Delayed falling edge of $\overline{XWE1}$. The x16 zone will not see this delay.

chip select sees the $\overline{XWE1}$ signal high at the critical points.

The timing configuration of the x32 zone must account for the additional delay. The zone chip select delay may require additional lead time. The $\overline{XWE1}$ delay enable may require additional active write time. In addition, specify at least 1 trail cycle for writes to the x32 zone.
