# Thermal Inspection

<b>Company</b>	Thermal Specialists of Conway LLC	Tester:
	3180 Cresthaven Conway AR	Thomas Epperson Phone: 501-733-7390 E-Mail: thomas.epperson@gmail.com

<b>Customer</b>	100 Cooper Lane Austin AR 72007	Measuring Site:
		100 Cooper Lane Austin AR 72007 Measuring Date: 12/13/2010

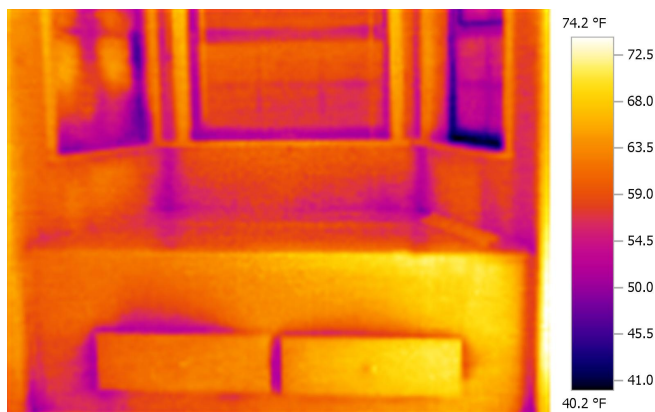
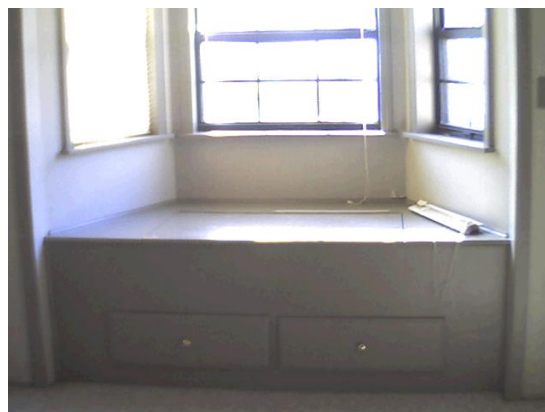
**File:**  
IV\_00222.BMT

There is some heat loss at this cabinet. The interior of the cabinet is much colder than the inside of the house. Some heat loss here could be reduced by adding insulation to the walls within the structure. This would reduce the usable storage space slightly however.

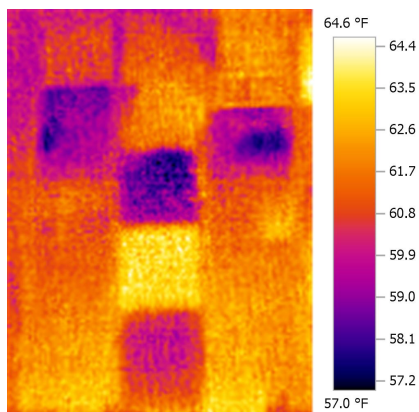
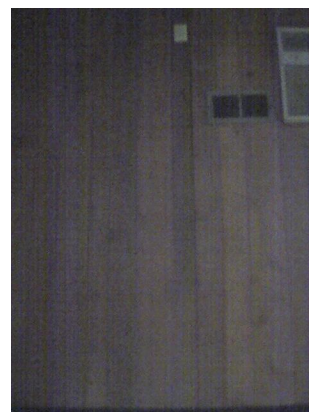
**File:**  
IV\_00235.BMT

Air ducts in the outer wall of the upper room are a source of heat loss.

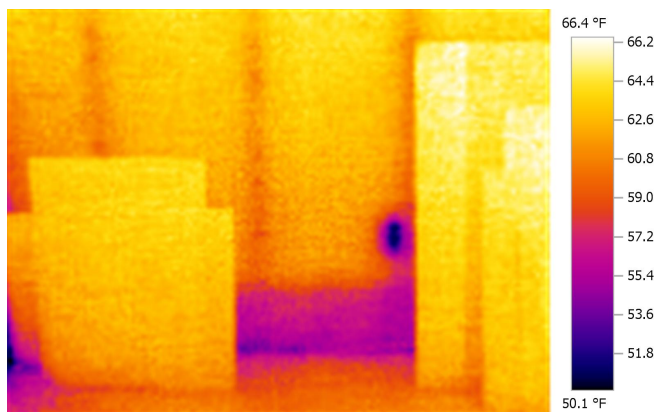
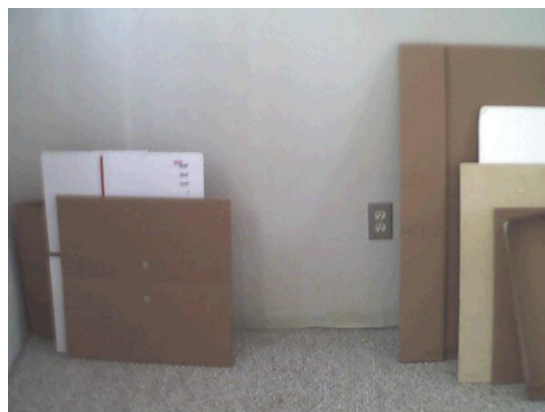
**File:**  
IV\_00220.BMT

This electrical outlet in the back bedroom has the same heat loss as the others. The base of the back wall in this room is slightly cooler than the rest of the walls. The wall studs are also visible in this photo.

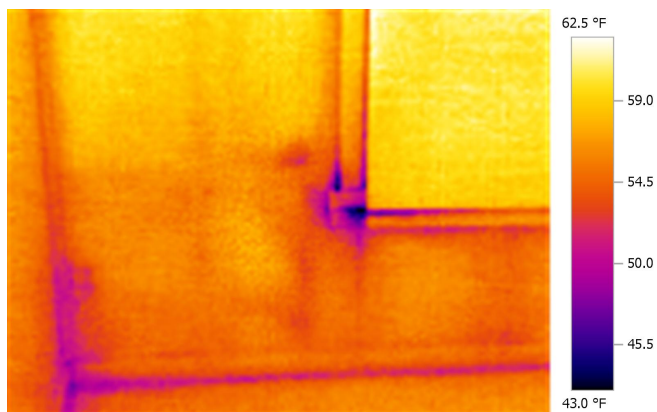
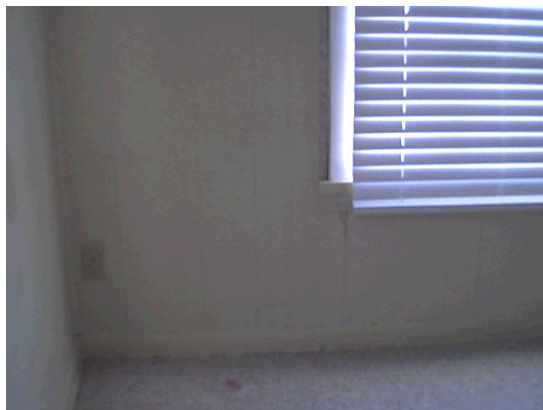
**File:**  
IV\_00200.BMT

The window in the front bedroom has some leaks near the lower left corner.

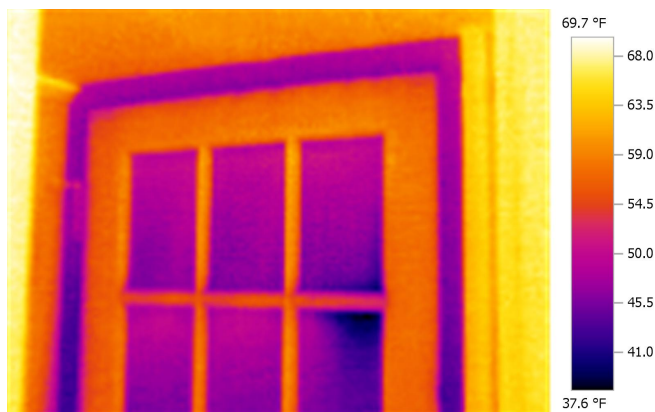
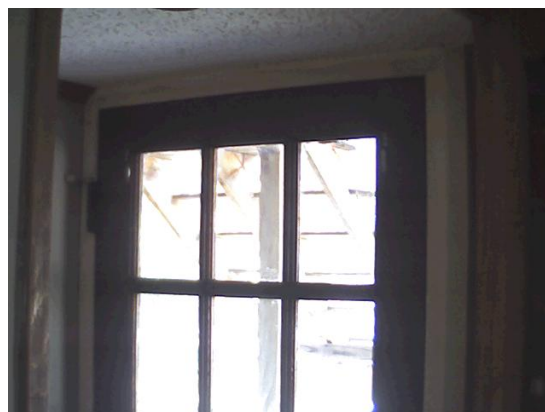
**File:**  
IV\_00209.BMT

The door frame in the kitchen is showing heat loss. There is probably some space around the door frame that could use some insulation.

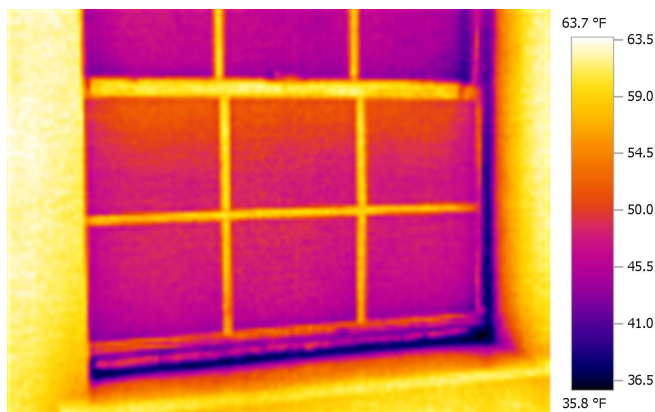
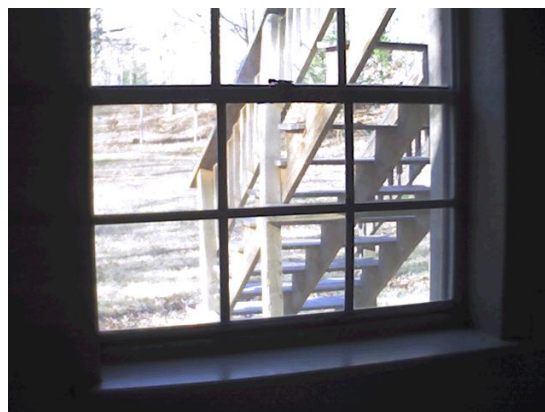
**File:**  
IV\_00229.BMT

The window in the rear bathroom shows heat loss similar to the other windows.

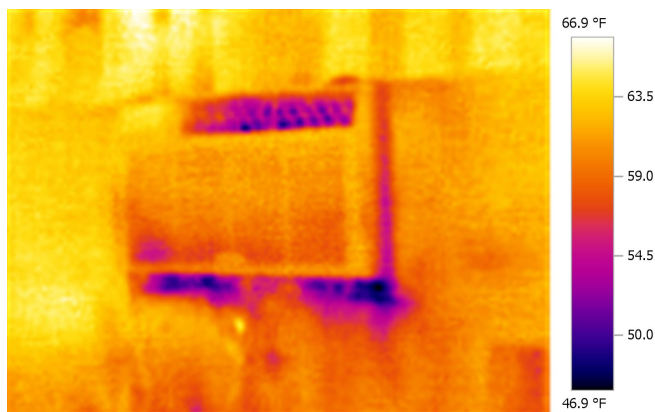
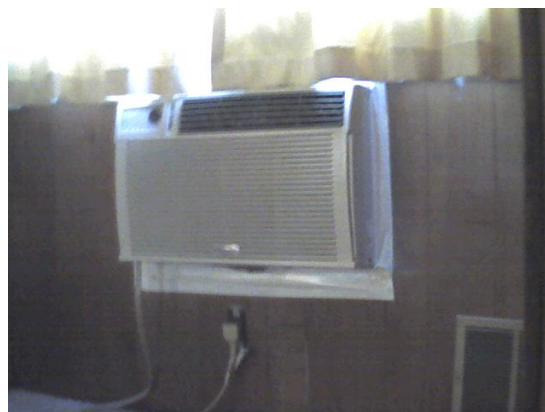
**File:**  
IV\_00231.BMT

There is some heat loss around the air conditioner in the upstairs room. The tape should have some insulation placed behind it.

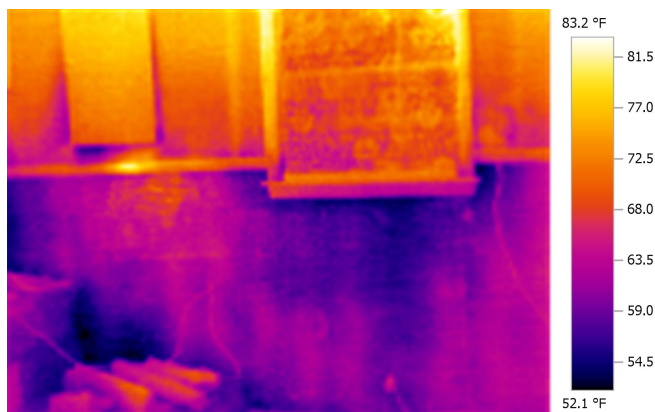
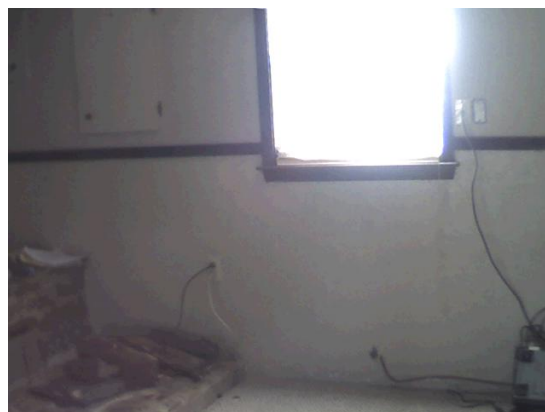
**File:**  
IV\_00207.BMT

There are a lot of air leaks around the window on the other side of the living room. These will probably be handled best with a spray in foam that would be sprayed in through a small hole in the wall.

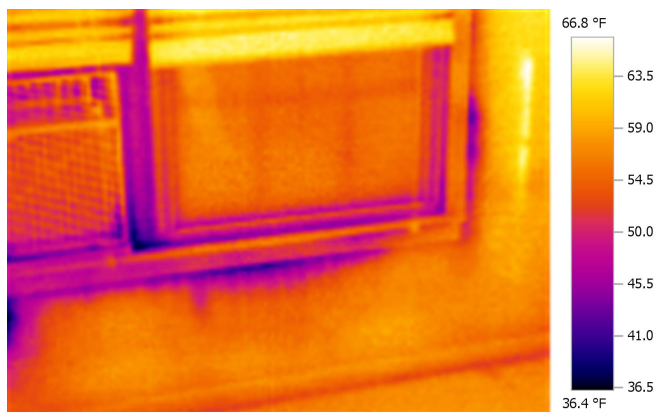
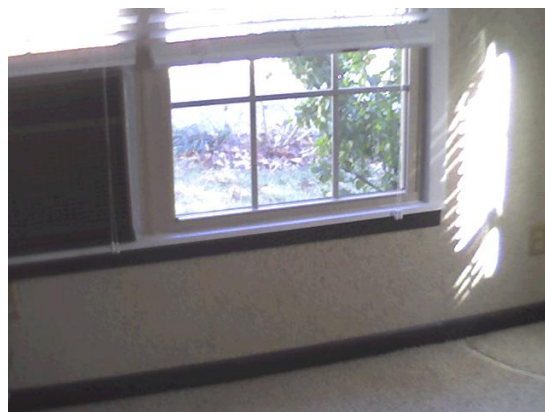
**File:**  
IV\_00199.BMT

Another shot of the window area in the front room. There are some heat losses around the window.

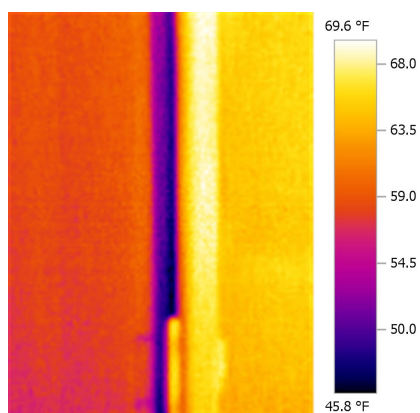
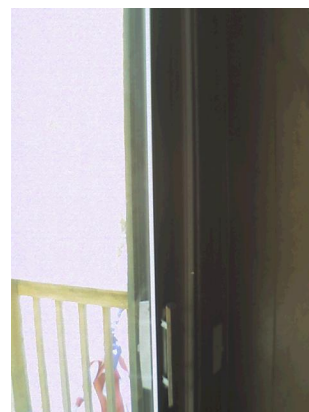
**File:**  
IV\_00241.BMT

There is some heat loss around the upstairs patio door.

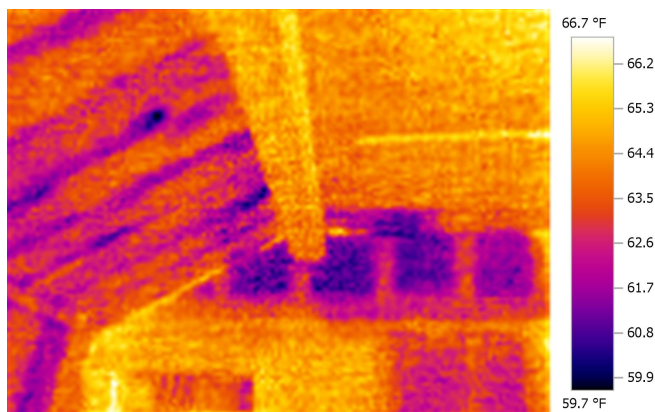
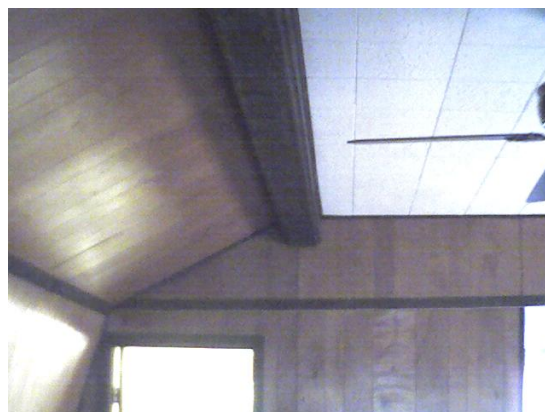
**File:**  
IV\_00233.BMT

There is a lack of insulation in the upper wall area of the upstairs room near the bathroom. The cold spots between the warmer lines show where the insulating value of the wall is below the studs in the wall. On the left you see the studs are cooler because they don't insulate as well as the insulation in the wall cavities, which is normal.

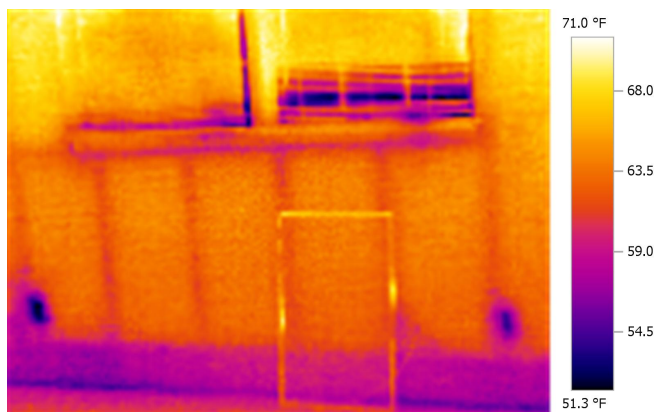
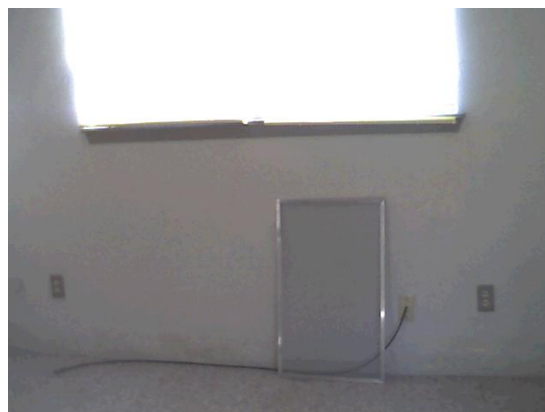
**File:**  
IV\_00219.BMT

These electrical outlets in the rear room need the same insulation treatment as the other leaking electrical outlets. You can easily see where the studs are within the wall because they are represented as cold lines.

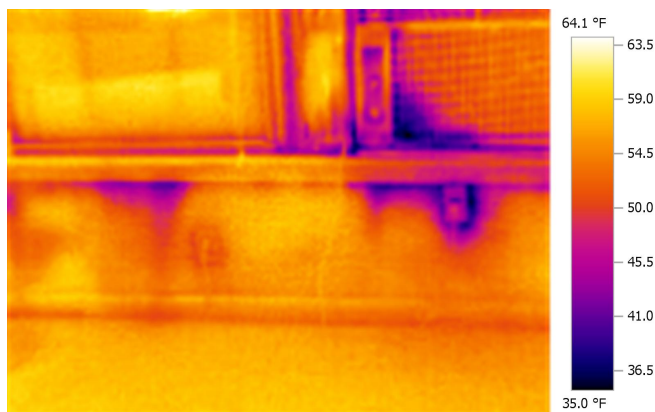
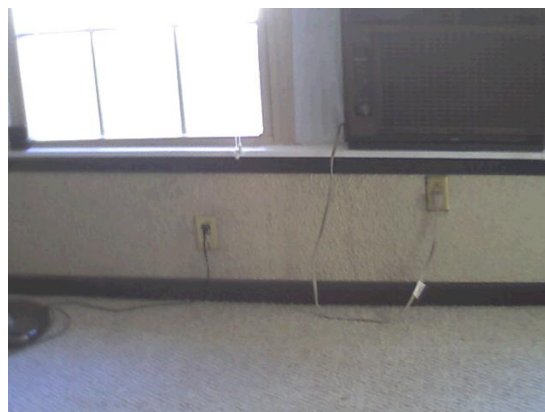
**File:**  
IV\_00198.BMT

The electrical outlet below the air conditioning unit is a source of heat loss. There is also some heat loss near the bottom left corner of the air conditioner. Both of these will benefit from some extra insulation.

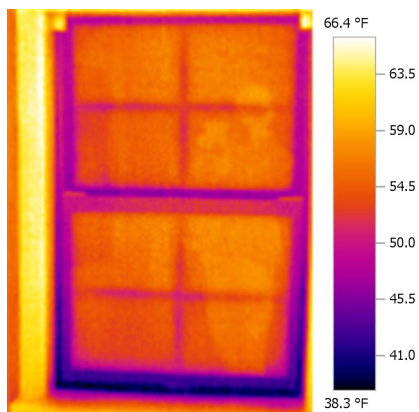
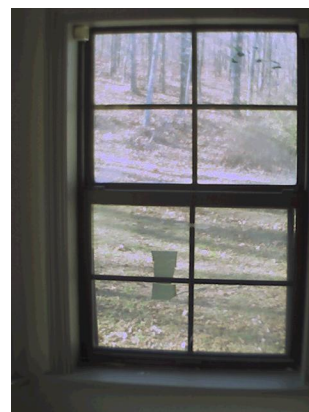
**File:**  
IV\_00224.BMT

A shot of the heat loss around one of the windows. The other windows in this alcove show very similar heat loss patterns.

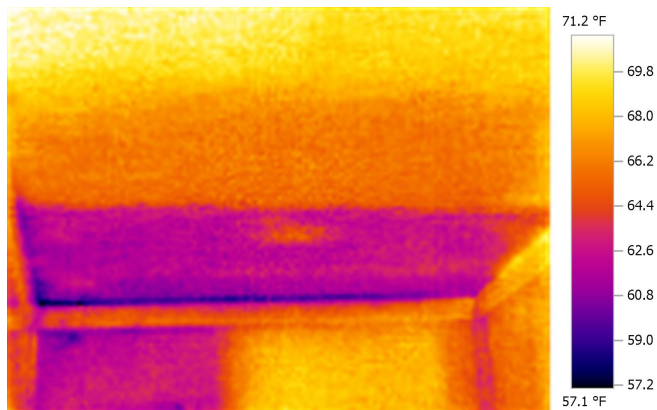
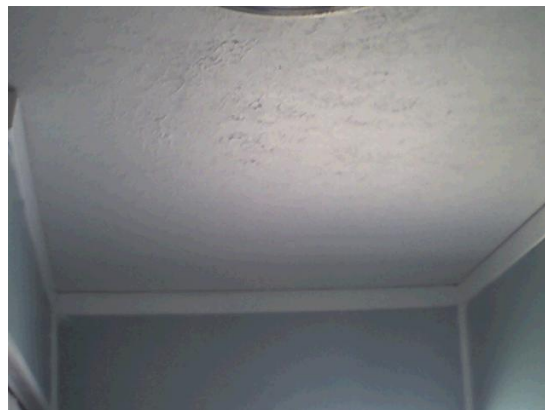
**File:**  
IV\_00215.BMT

A cold area in the ceiling behind the door of the front bathroom.

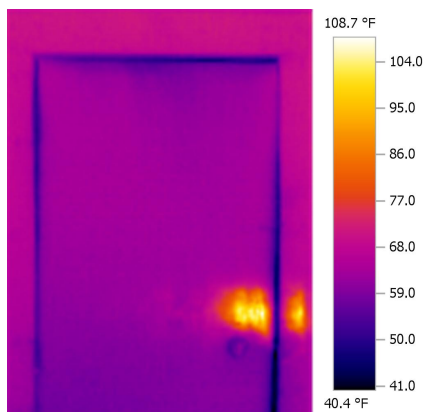
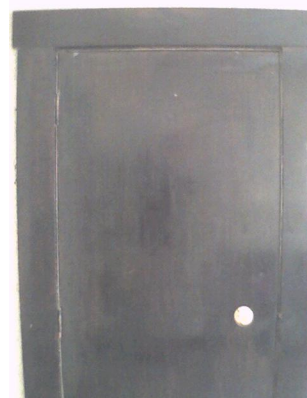
**File:**  
IV\_00197.BMT

The top of the front door has similar leaks as the bottom of the door. The hot spot above the door handle is from body heat.

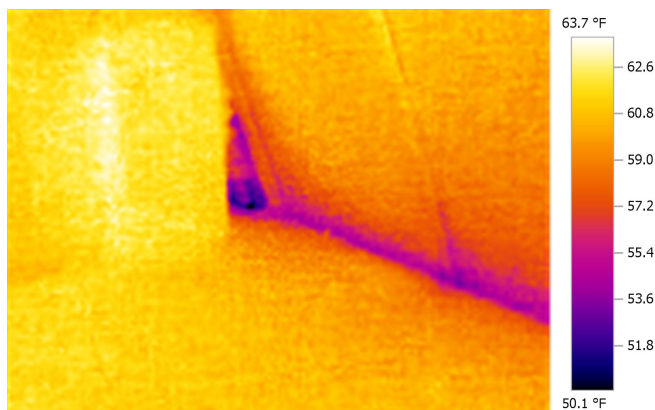
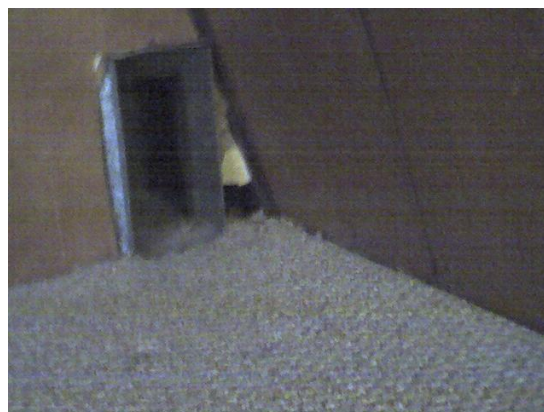
**File:**  
IV\_00232.BMT

There is a gap in the insulation in this corner of the upstairs room.
