AVR128DA28/32/48/64

Silicon Errata and Data Sheet Clarification

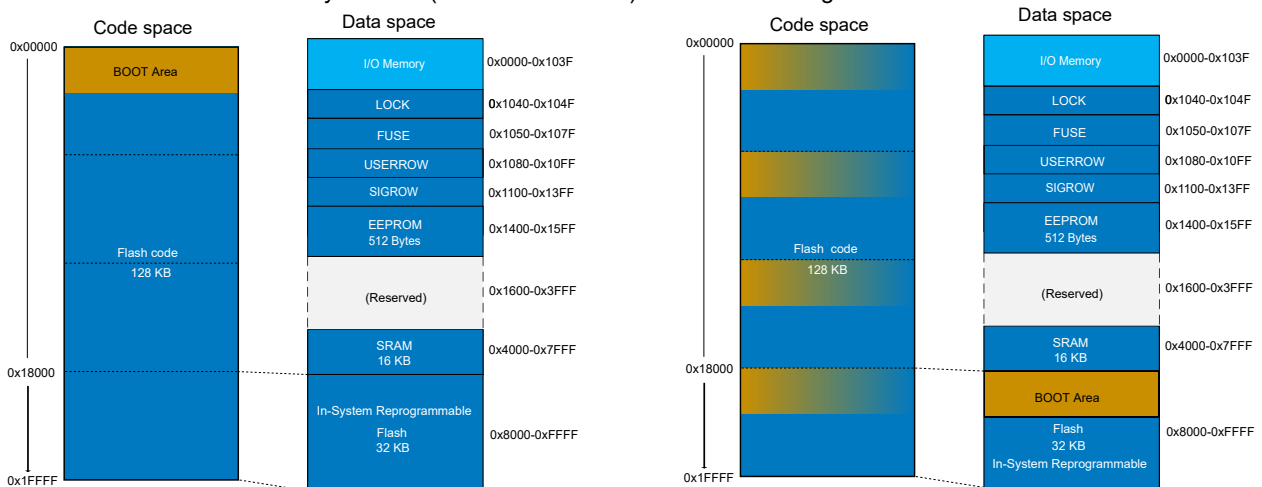
The inter-section Flash protection mechanism does not take into account the FLMAP bit field when checking if the address is in BOOT, APPCODE or APPDATA areas. It uses for comparison only the address offset between Flash start address in data space (0x8000) and the accessed address. This will cause the mirroring of the BOOT area in each Flash section selected by FLMAP (in blocks of 32 KB). Refer to the image below.

BOOT area for devices without issue

BOOT area for devices with issue

For read operations, the FLMAP bits work as documented when the Boot Read Protect (BOOTRP) bit is not enabled. For write operations, the inter-section Flash protection works properly only when FLMAP is set to '0x00'.

Use only store program memory (SPM) instructions to write and load program memory (LPM) instructions to read Flash memory.
