## **HAZARDOUS MATERIALS ASSESSMENT REPORT**

**Job details:** Owner/s: Mr. J. Felizardo & Ms. M. Pineda  
Location: 16B O'Brien Street, Mt Druitt NSW

**Plans for Job No:** 7689/15      **Revision No:** D      **Dated:** 17-11-15

**Date of assessment:** 25<sup>th</sup> November 2015

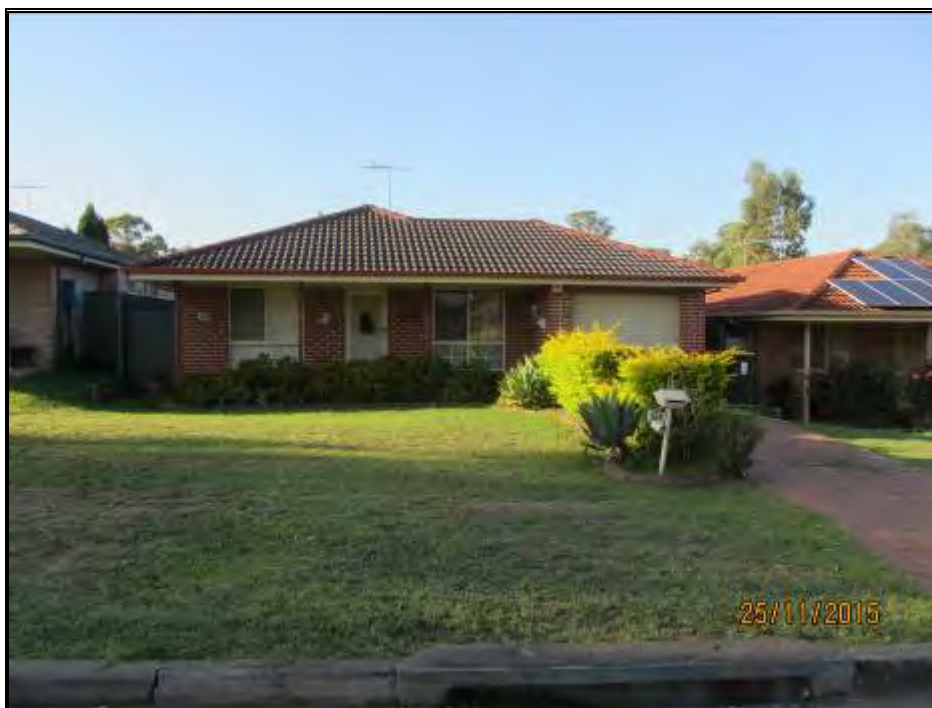
Front northern elevation of the residence
