HAZARDOUS MATERIALS ASSESSMENT REPORT

Job details: Owner: Mr. N. & Mrs. S. Gunn
Location: 16 Lady Game Drive, KILLARA.

Our reference: HM05070816

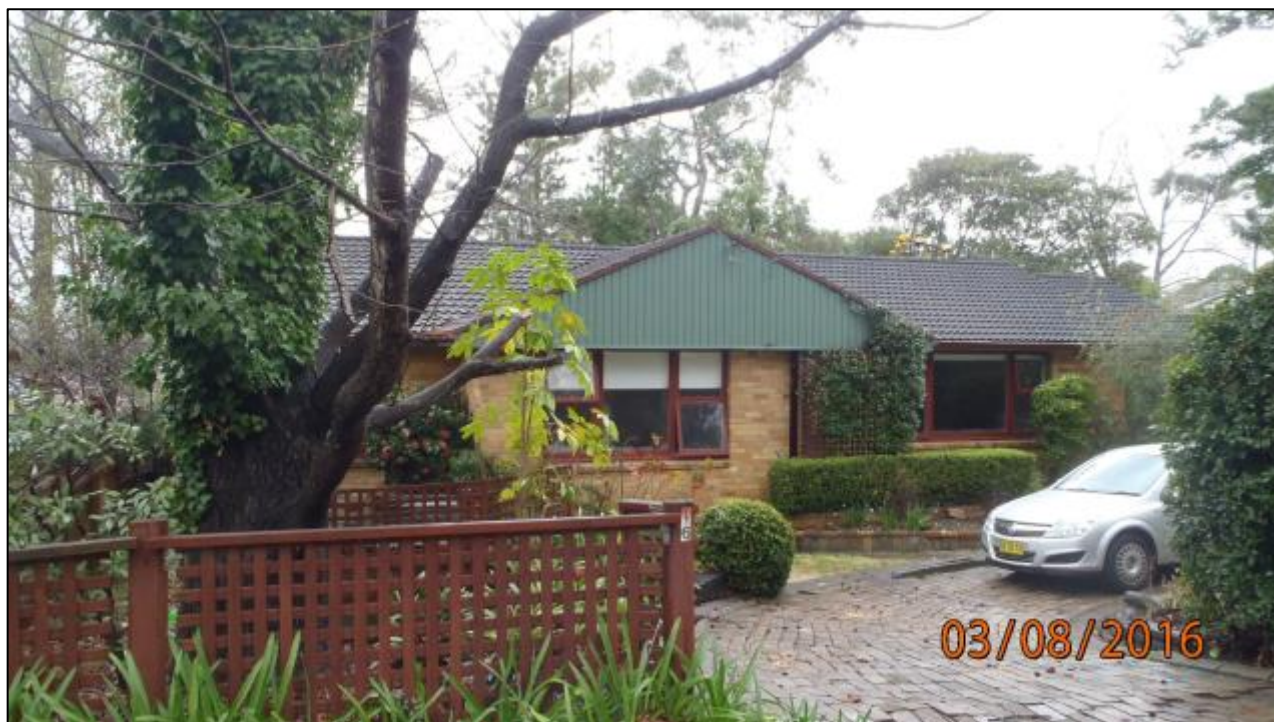
Front north eastern elevation of the residence
