HAZARDOUS MATERIALS ASSESSMENT REPORT

Job details: Owner: Mr. R. Irvine.
Location: 72 Middle Street, Kingsford.

Our reference: HM06070917

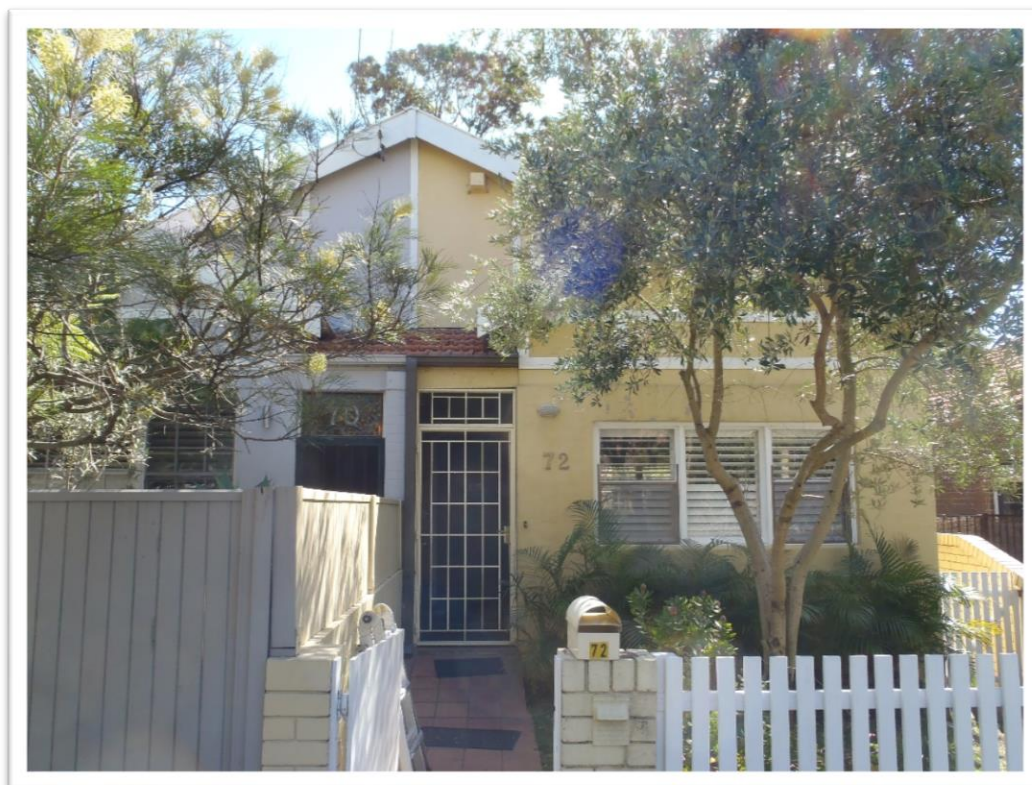
Front southern elevation of the residence
