## Dilapidation Assessment Report

Prepared for: **Cape Cod Australia Pty. Limited**

Job address: **6 Surfside Avenue, Clovelly NSW 2031**

Date of assessment: **5<sup>th</sup> August 2015**

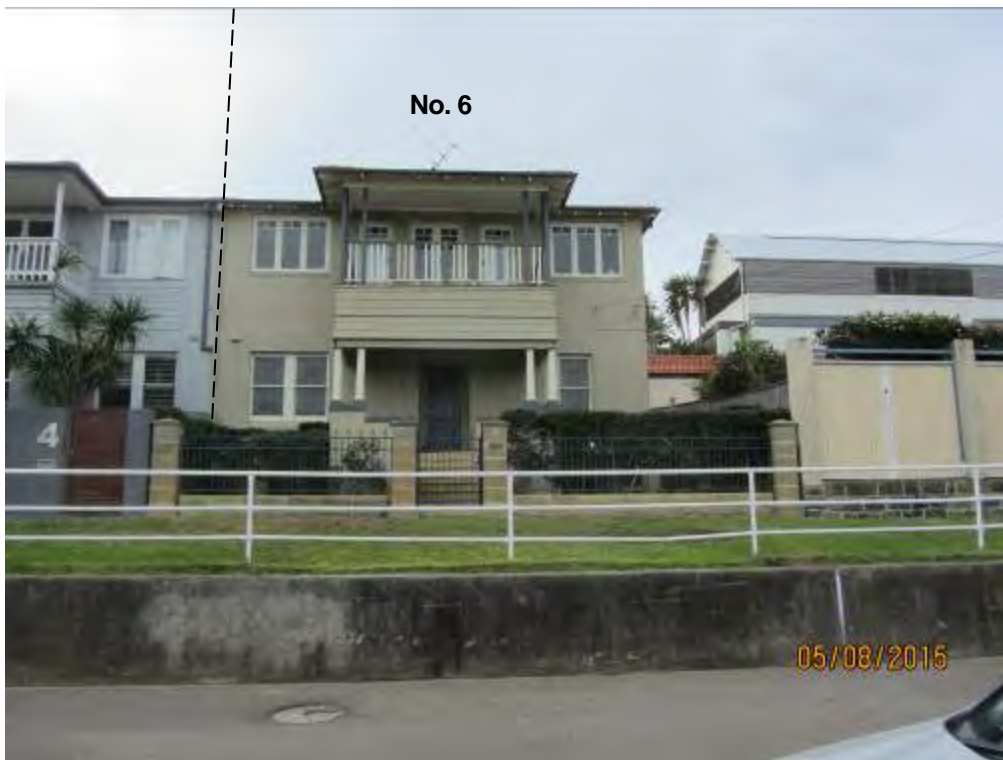
The property is situated on the high side of the roadway and on a sloping site that falls from rear to front and across the site from northwest to southeast with a south westerly facing frontal aspect. [**Photograph 1**]

**Photograph 1** shows the front south western elevation of this property

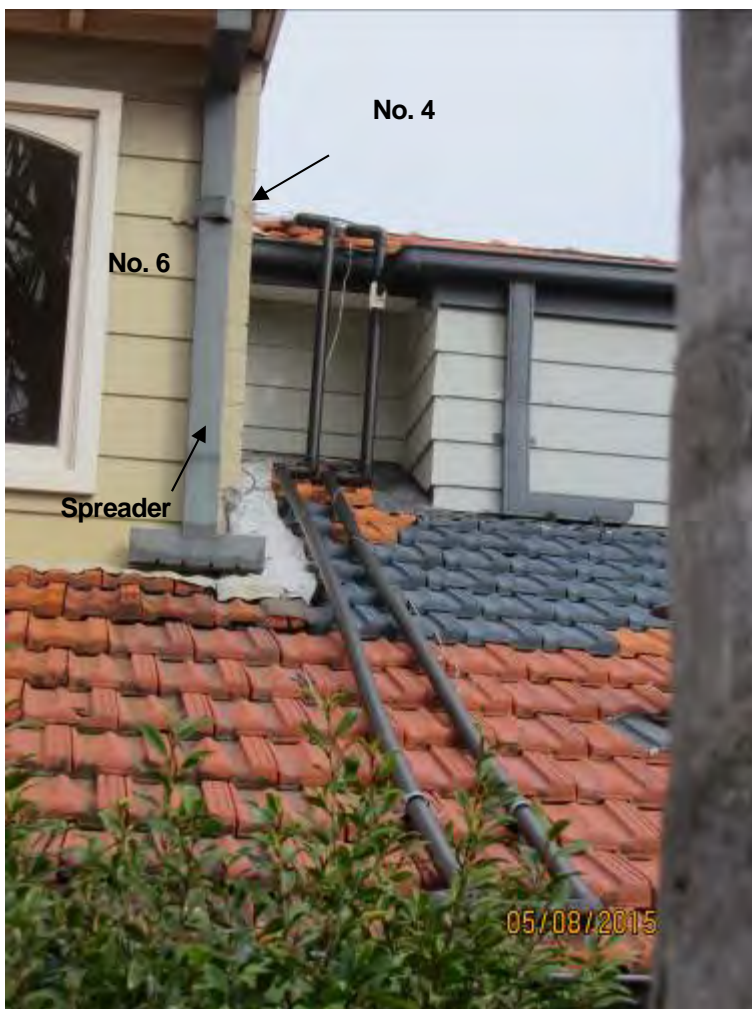
We noted that the north eastern surface water from the upper floor addition roof discharges via a spreader onto the flashing between the rear wall and lower level tiled roof surface. We noted that the top bracket to the down pipe is loose. **[Photograph 2]**

We also noted that the stepped flashing between the wall of the upper floor addition and the terra cotta tiled roof of the adjoining property, No. 4 Surfside Avenue is intact and forming a weather resistant seal between the wall and the roof surface. **[Photograph 2]**

**Photograph 2** shows the junction of the rear roof surfaces between the properties - Note: spreader discharging onto flashing and bracket supporting the downpipe is displaced

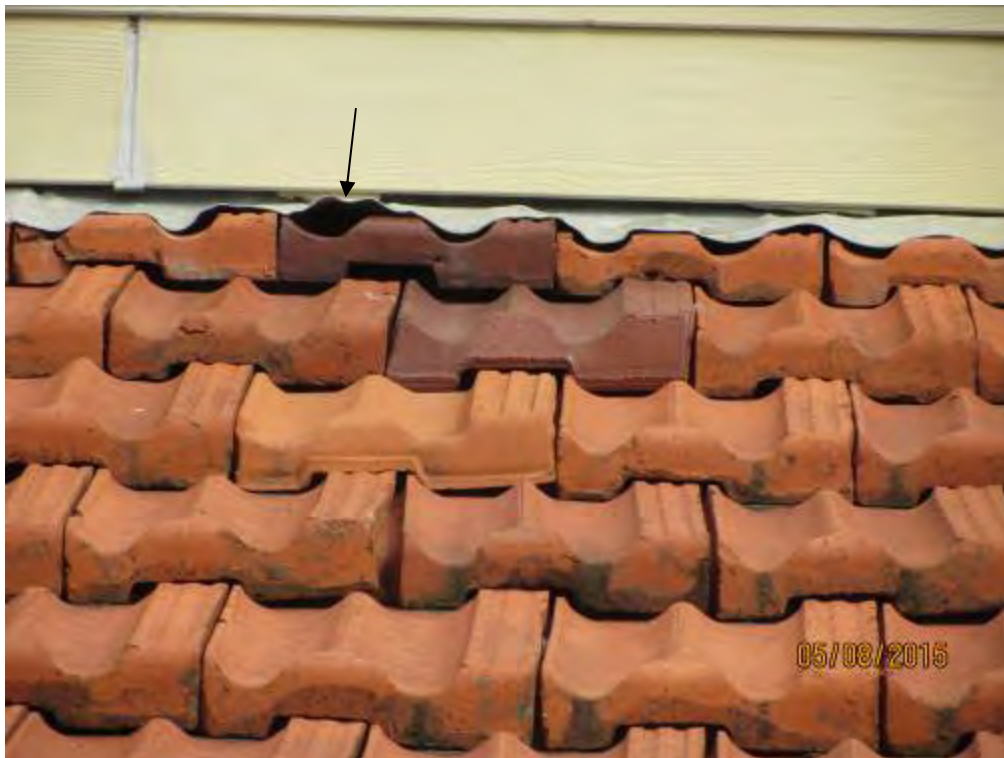
We noted that there is a section of 'lifted' flashing between the between the rear wall of the upper floor addition and lower level tiled roof surface. We noted that the 'lifted' flashing is located approximately 1.0m from the spreader at the north western end of the wall. **[Photograph 3]**

**Photograph 3** shows lifting of the flashing between the rear upper floor wall and the roof tiles over the Kitchen

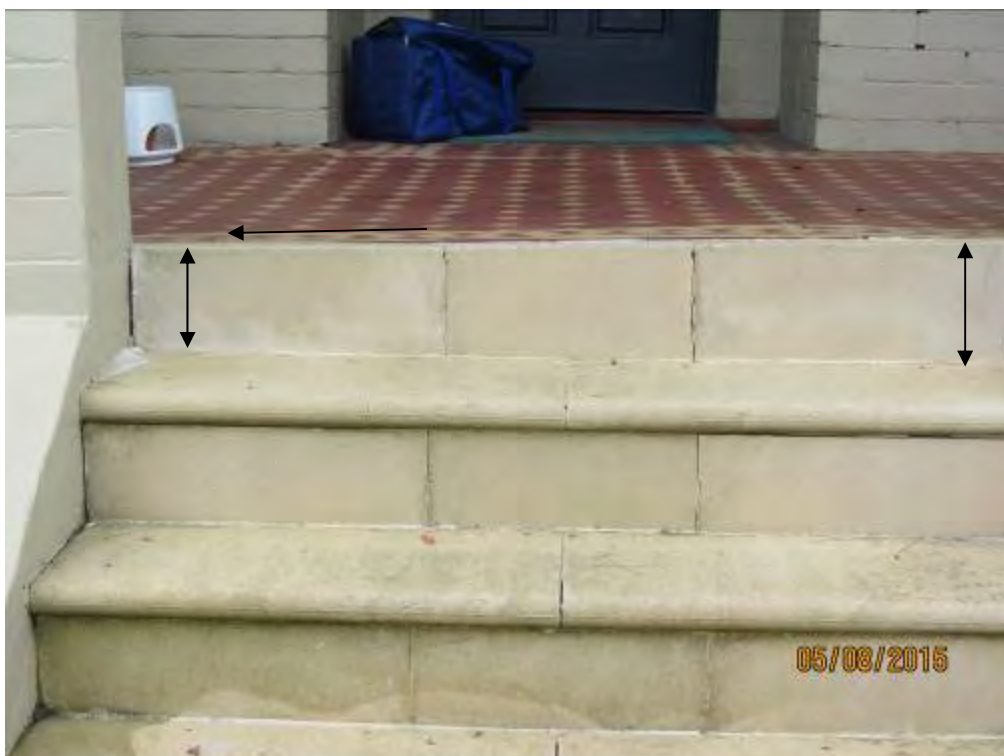
We noted settlement and movement in the front steps including cracking between the steps and the cement rendered stringers to the steps. **[Photographs 4 and 5]**

**Photograph 4** shows the settlement / fall in the front Verandah at the top step of the entry steps

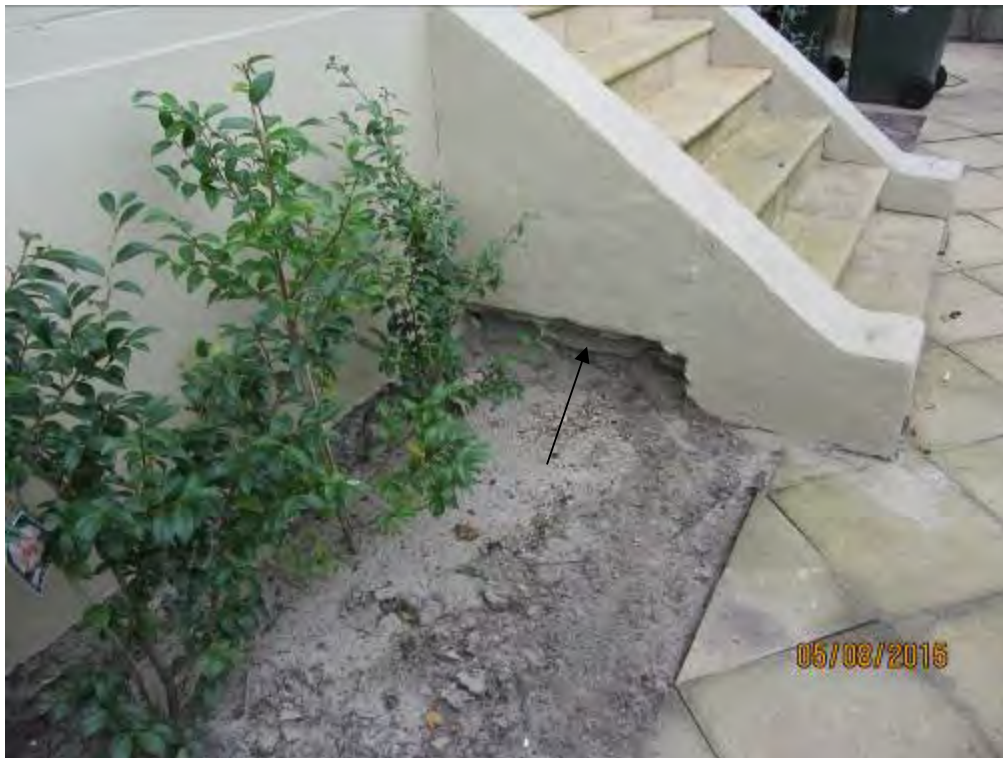
**Photograph 5** shows the exposed footing supporting the front entry steps

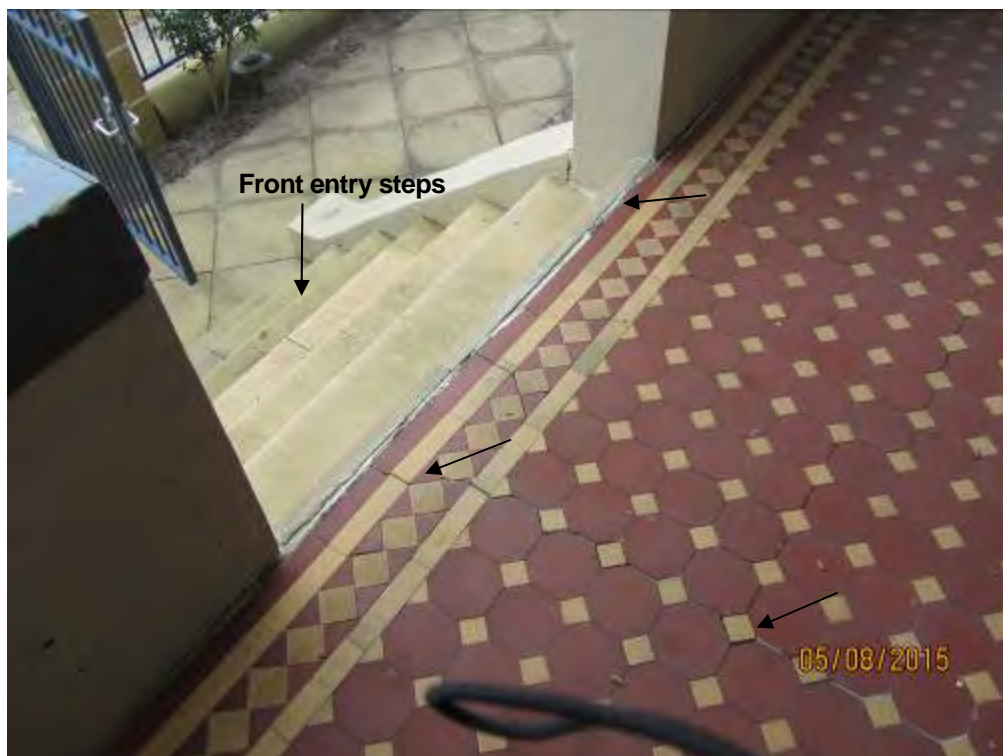
We noted that the front verandah is finished with tessellated pattern tiles. We noted that there is settlement in the plane of the tiles and cracking to the tiles. **[Photographs 6 and 7]**

**Photograph 6** shows settlement and cracking to the tessellated tiles to the front Verandah abutting the front entry steps

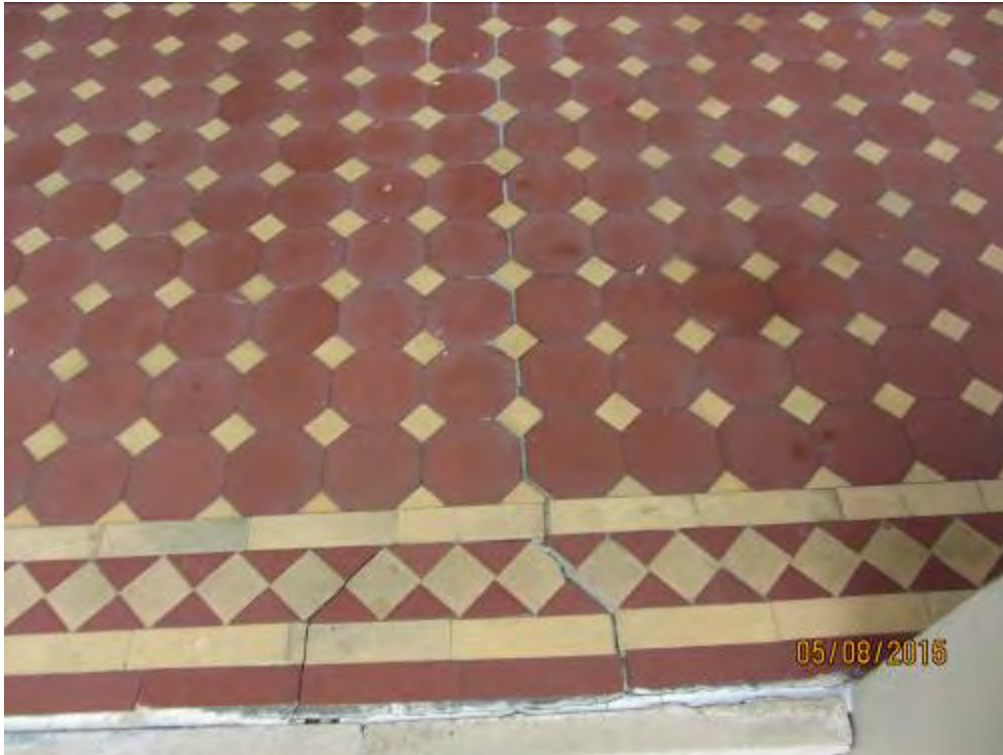
**Photograph 7** shows cracking and settlement in the tessellated tiles to the front Verandah

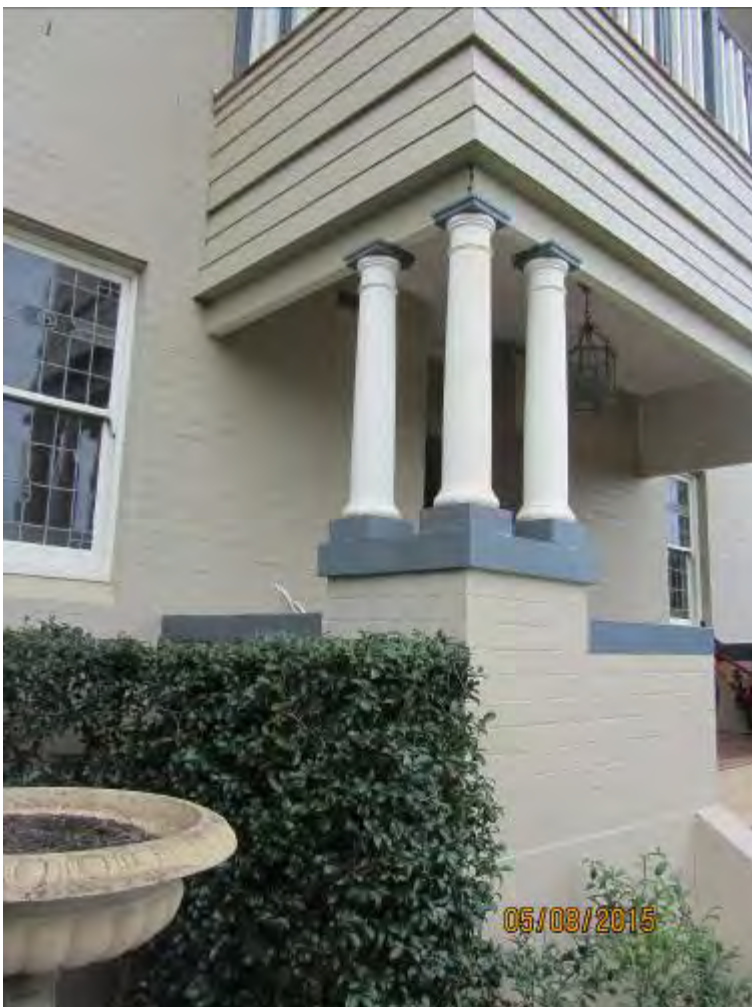
We noted that there is movement in the western corner of the front verandah extending to the first floor balcony. **[Photographs 8, 9, 10 and 11]**

**Photograph 8** shows the western corner of the front Verandah supporting the upper floor level

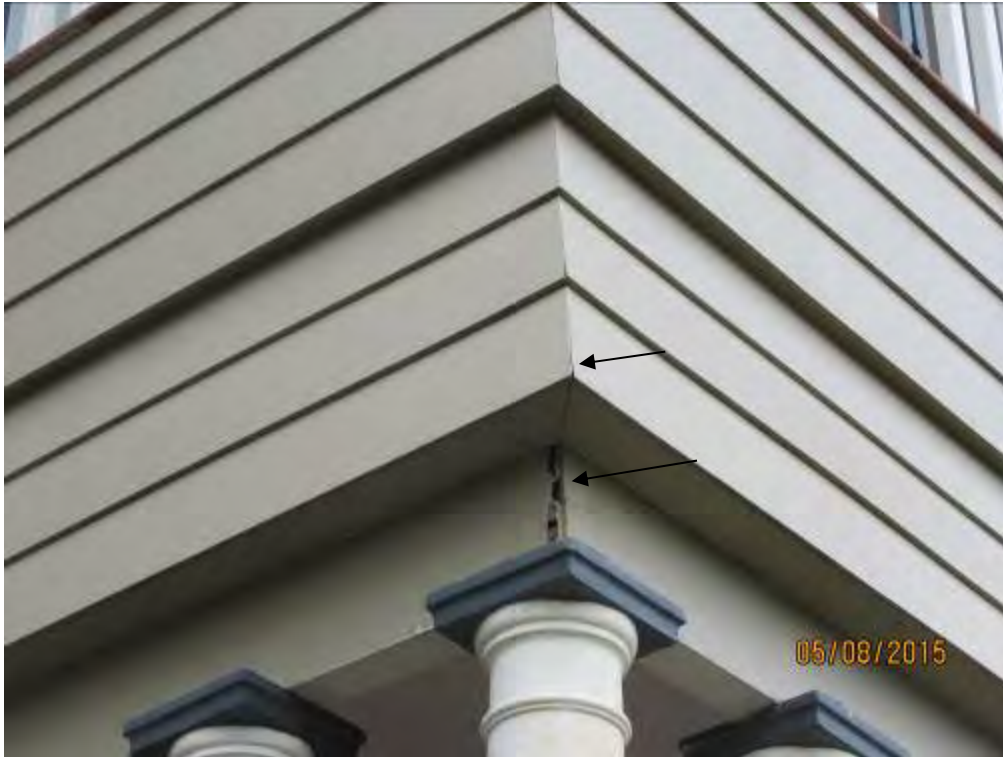
**Photograph 9** shows movement to the beam supporting the upper floor front balcony at the western corner of the front Verandah

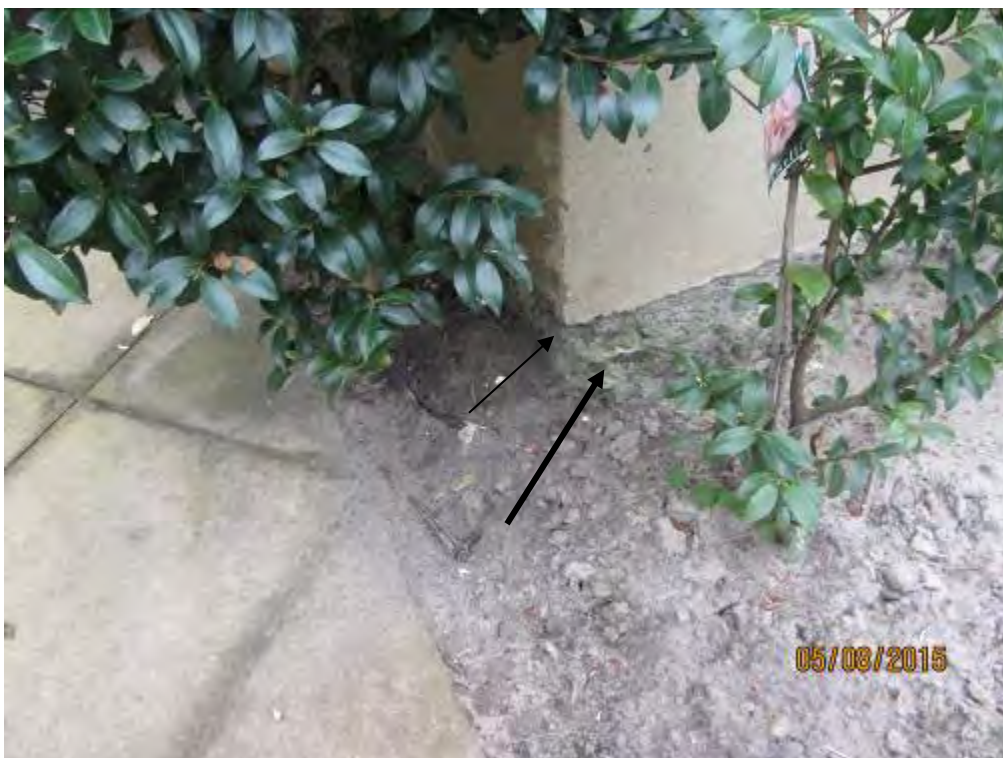
**Photograph 10** shows the exposed footing supporting the western corner of the front Verandah and the upper floor balcony

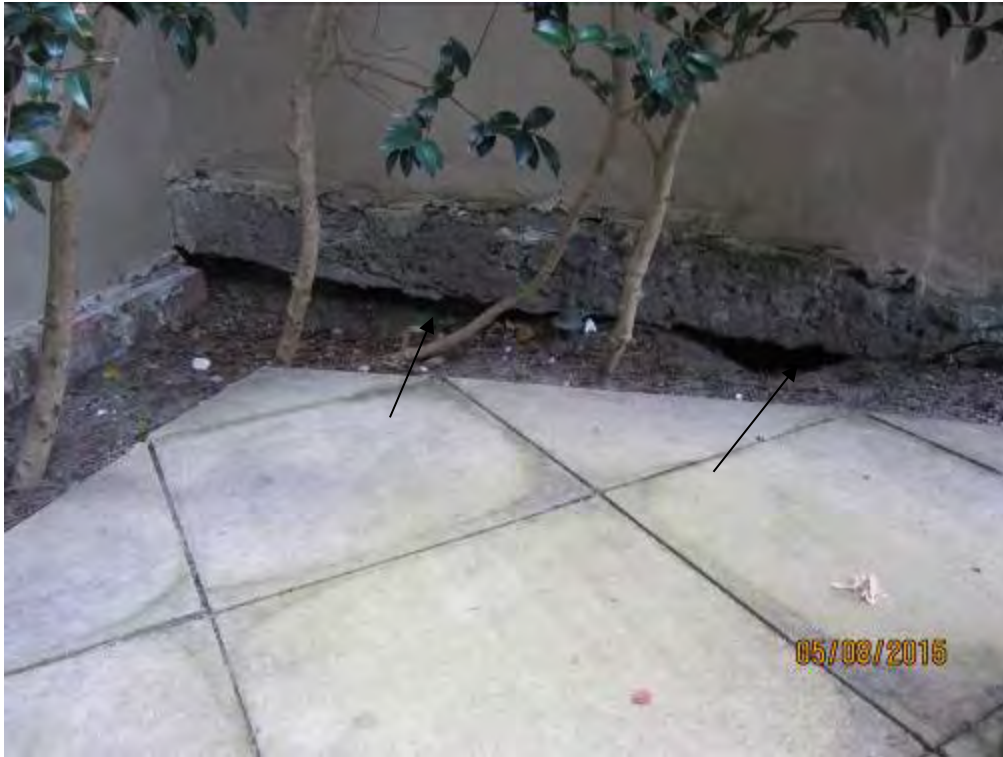
**Photograph 11** shows the tilt in the footing supporting the north western wall of the front Verandah and upper floor balcony

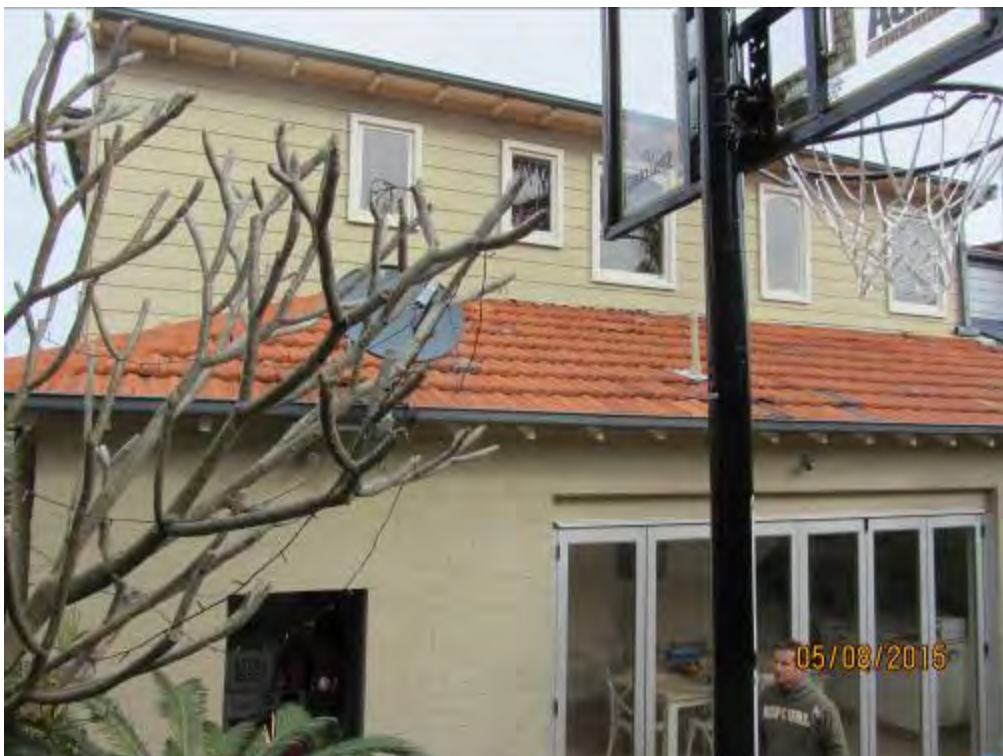
We noted that the fibre-cement weatherboards to the upper floor addition are generally securely fixed and the joints are sealed. **[Photograph 12]**

**Photograph 12** shows the rear elevation of the property

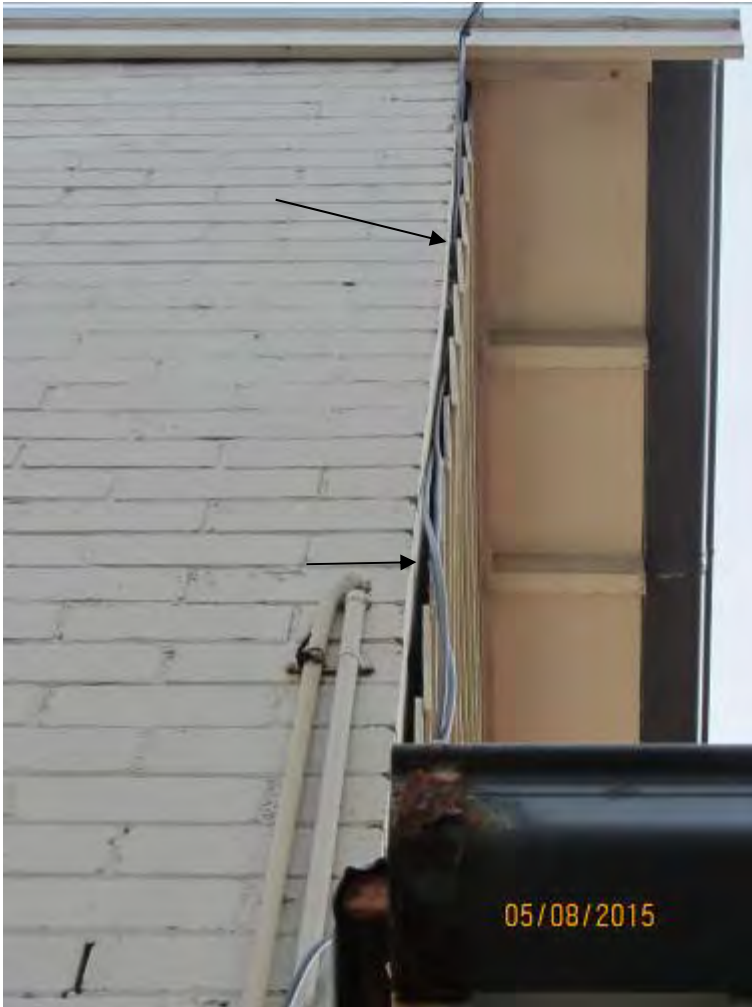
We also noted that there is a void [gap] between the fibre-cement weatherboards and the brickwork at the south eastern end of the wall. We are unable to determine the weather tightness of the junction. **[Photograph 13]**

**Photograph 13** shows the gap between the fibre-cement weatherboards and the brickwork at the rear eastern corner of the upper level

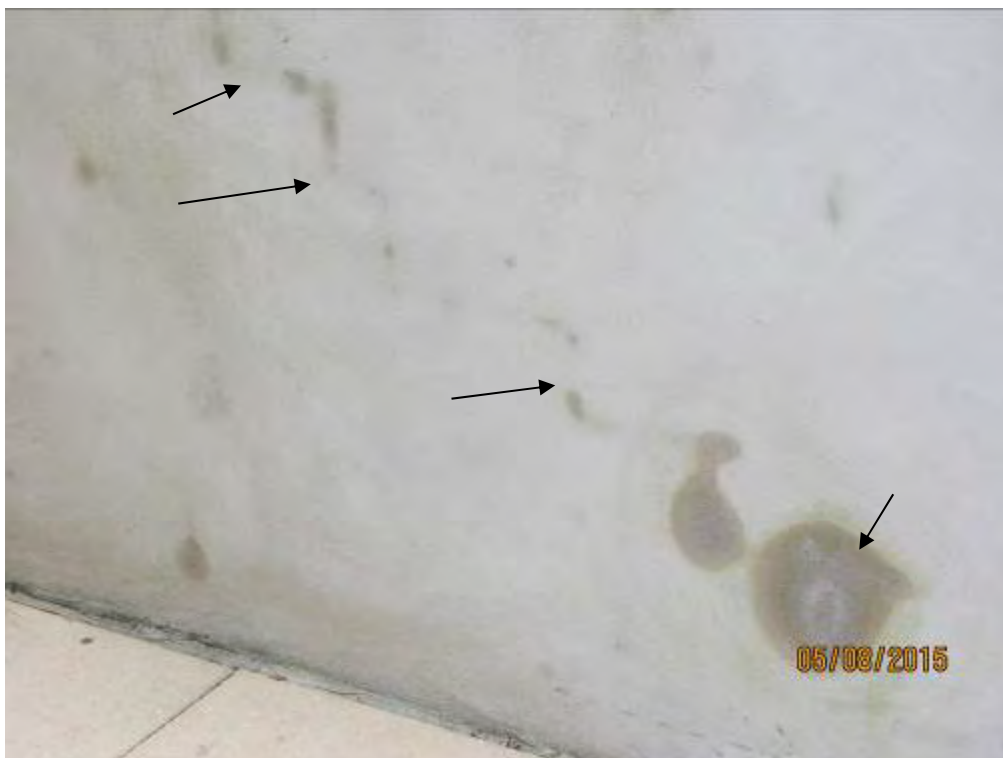
We noted seepage through the face of the cement rendered wall and evidence of a previous stepped crack to the wall under the cement render. **[Photograph 14]**

Due to concealment we are unable to determine if there is drainage provided to the rear of the wall.

**Photograph 14** shows dampness and a stepped crack to the south eastern end of the rear retaining wall

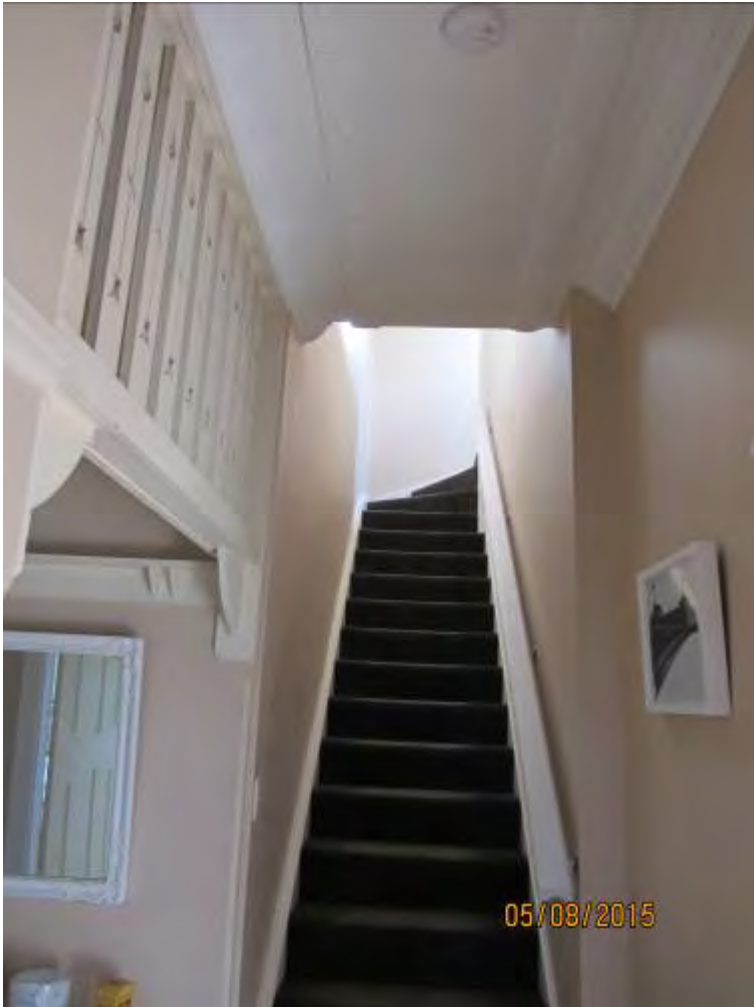
We did not observe any recent noticeable cracking to the surface coated cement rendered wall surfaces or to the plasterboard lined bulkhead into the Kitchen. **[Photograph 15]**

We did not observe any recent noticeable cracking to the ground floor level surface coated cement rendered wall surfaces or to the plasterboard lining to the framed walls. **[Photograph 15]**

**Photograph 15** shows the layout of the internal staircase

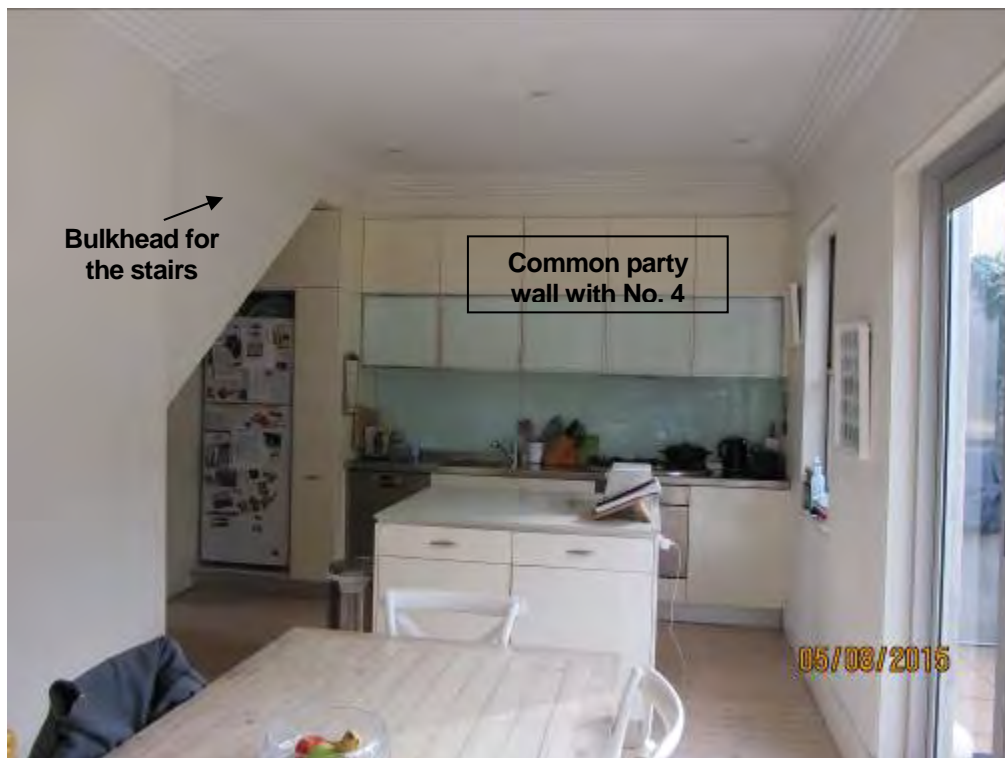
We noted that the north western wall of the room is the *common party / separation* wall with the adjoining property, No. 4 Surfside Avenue. **[Photograph 16]**

**Photograph 16** shows the Kitchen layout viewed from the Dining room towards the *common party wall* with No. 4

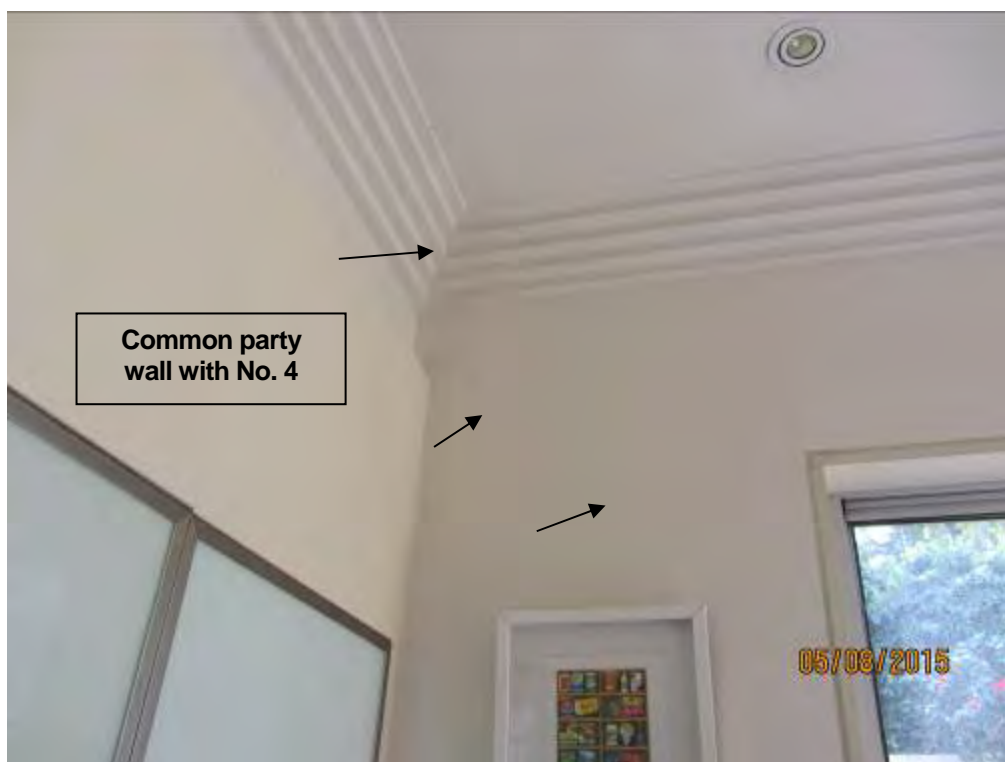
We noted a hairline [ $<1.0\text{mm}$ ] radial crack to the northern corner of the room abutting the *common party / separation* wall and extending from the window opening towards and into the cornice. **[Photograph 17]**

**Photograph 17** shows a hairline radial crack to the northern corner of the Kitchen extending into the cornice and abutting the *common party* wall

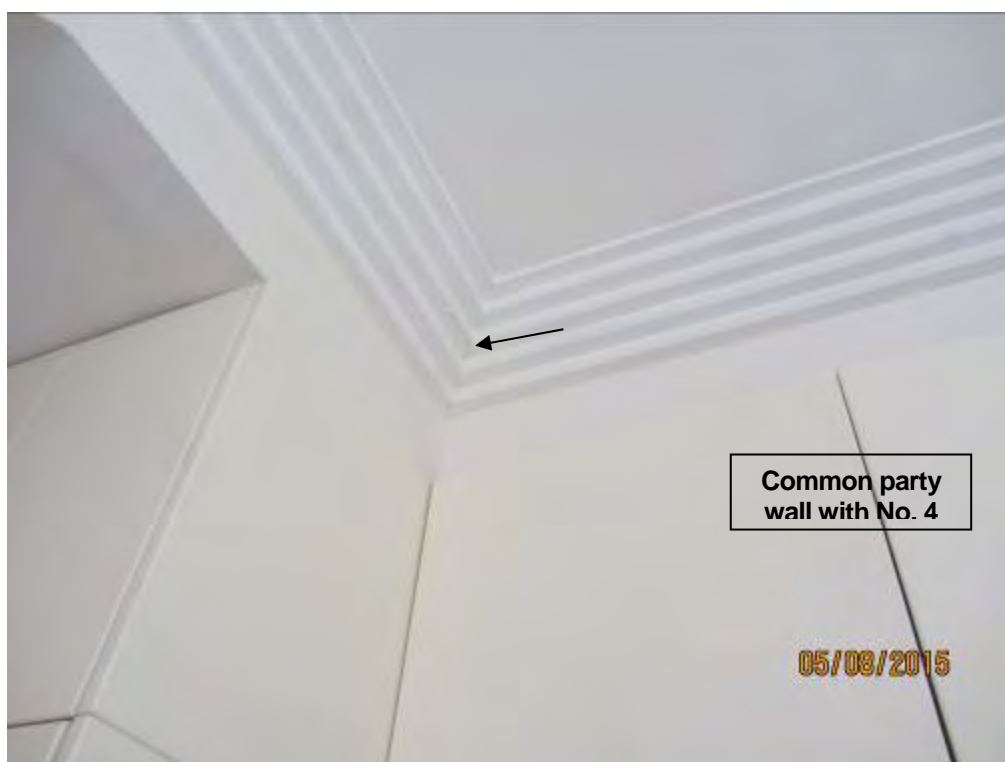
We noted a hairline crack [ $<1.0\text{mm}$ ] to the cornice at the western corner of the room and abutting the *common party / separation* wall. **[Photograph 18]**

**Photograph 18** shows a crack to the cornice to the western corner of the Kitchen abutting the *common party* wall with No. 4

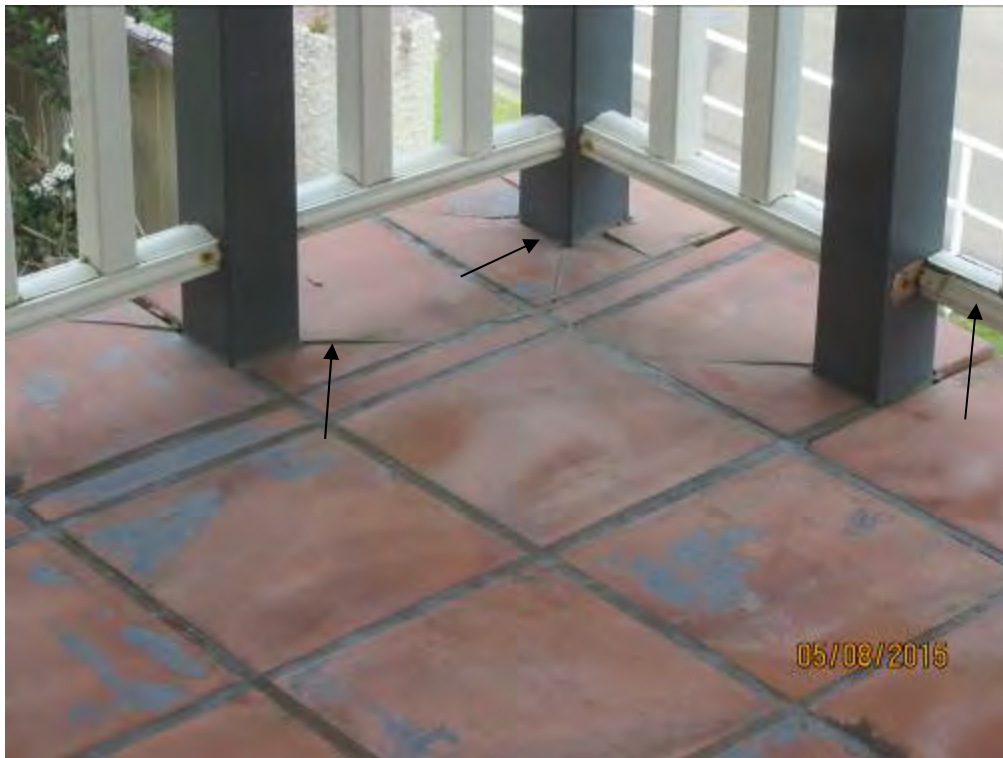
We noted that the deck surface is tiled with falls to the timber balustrade. We notes that there is corrosion of the balustrade fixings and that there is displacement to the bottom rail of the balustrade at the southern end of balustrade. **[Photograph 19]**

We noted that there is movement within the tiles at the southern corner of the balcony and in the immediate vicinity of the roof support posts. **[Photograph 19]**

**Photograph 19** shows the condition of the tiles at the front southern corner of the upper floor balcony – Note: the displacement of the bottom rail of the timber balustrade and the corrosion of the frames

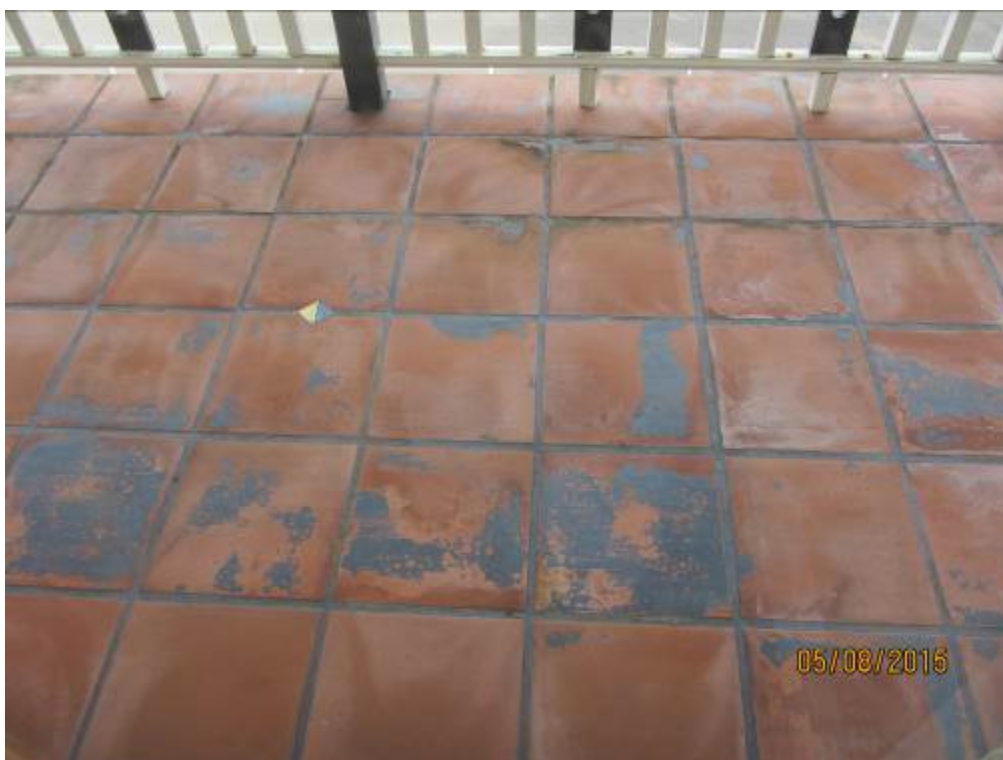
We noted that the surface of the tiles is scuffed overall the balcony deck. **[Photograph 20]**

**Photograph 20** shows the condition of the quarry tiles to the upper floor balcony deck

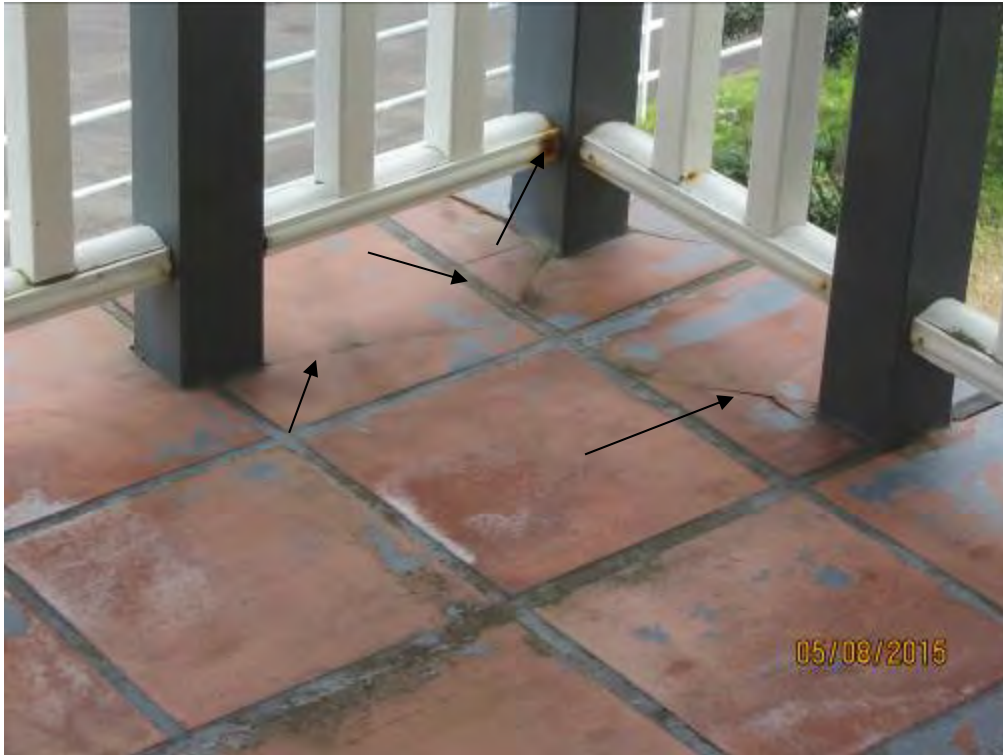
We also noted that there is movement within the tiles at the western corner of the balcony and in the immediate vicinity of the roof support posts including shear cracking of the tiles. **[Photograph 21]**

**Photograph 21** shows the condition of the tiles at the front western corner of the upper floor balcony – Note: the corrosion to the fixings and stress cracking to the tiles

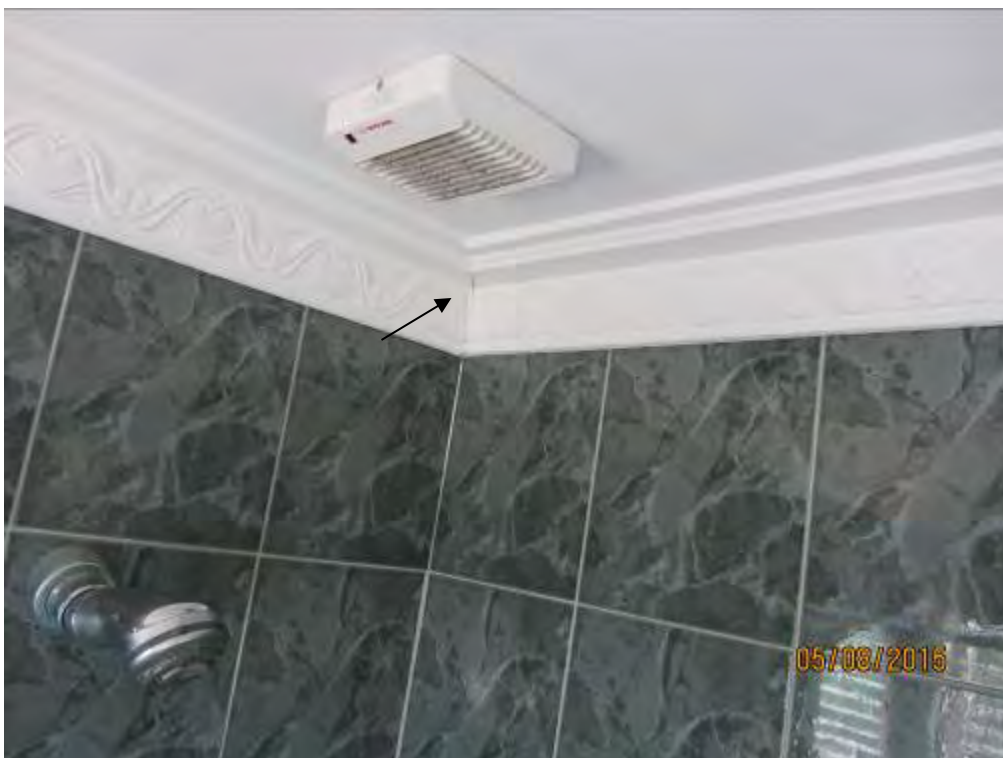
We noted a hairline crack [ $<1.0\text{mm}$ ] to the mitre joint to the cornice at the southern corner of the room and over the shower recess. **[Photograph 22]**

**Photograph 22** shows the crack to the cornice above the shower recess to the southern corner of the upper floor Bathroom
