## **HAZARDOUS MATERIALS ASSESSMENT REPORT**

**Client:** Cape Cod Australia Pty. Limited

**Job details:** Owner: Ms. M. Quibell  
Location: 35 Holdsworth Street, Neutral Bay

**Our reference:** HM03330914

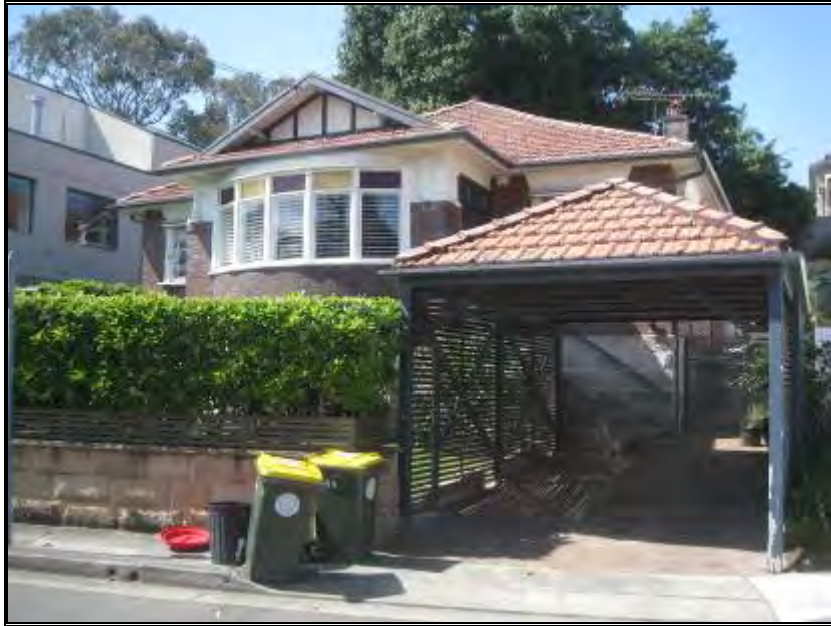
**Front west elevation of the residence**
