## Loose-fill Asbestos Insulation Ceiling Cavity Inspection Report

26 Ivey Street Lindfield NSW 2070

Work Order Number: 43051/2016/LUM  
Report number: 816043-B152-034  
Issue Date: 4-Jan-17

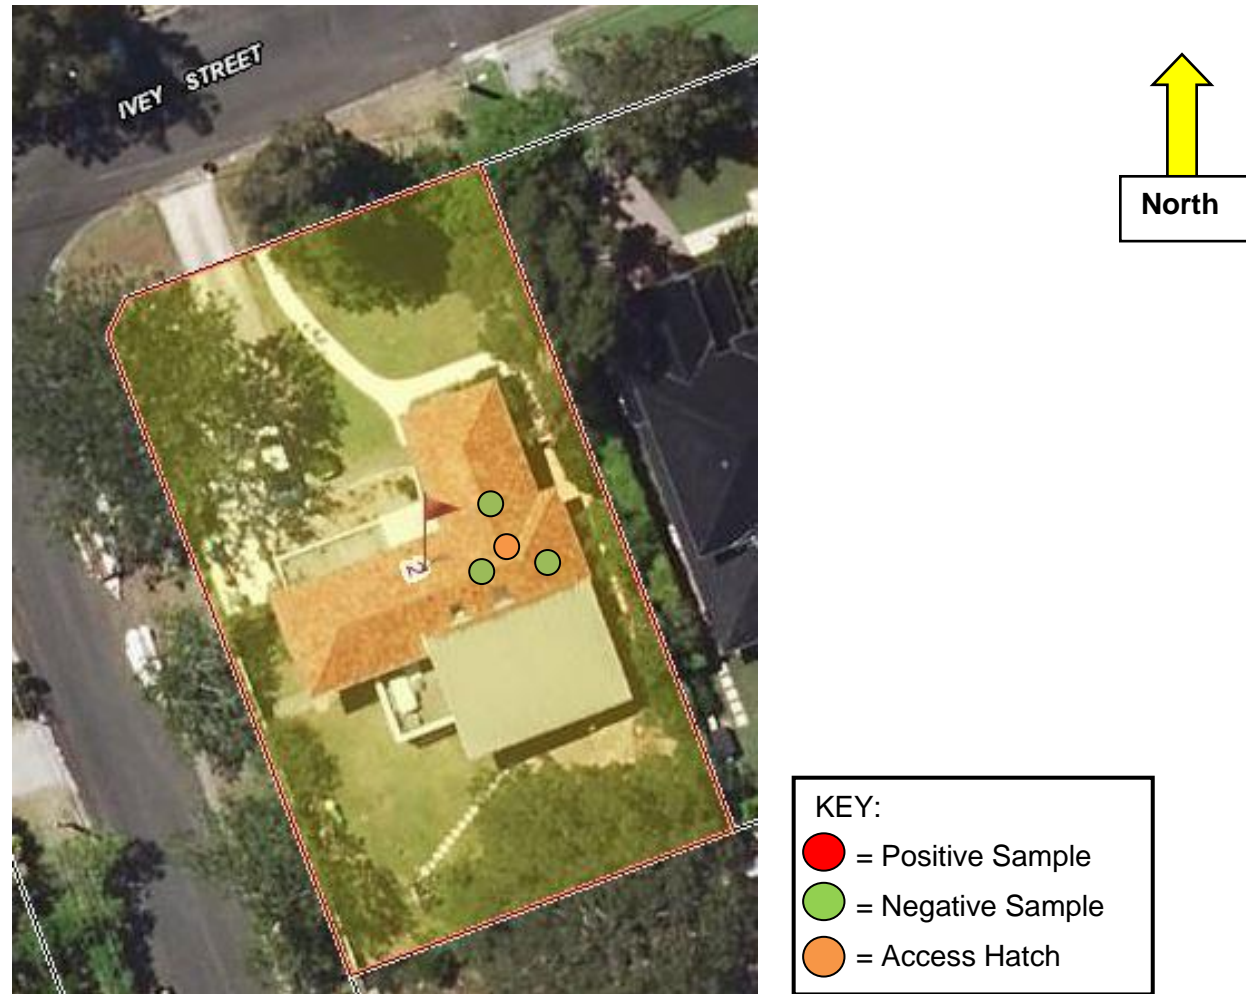
**Figure 1: Site Plan Showing Location of Samples Taken and Approximate Extent of any Loose-fill Asbestos Insulation**

No asbestos was identified within the roof space and there were no signs of loose-fill asbestos.

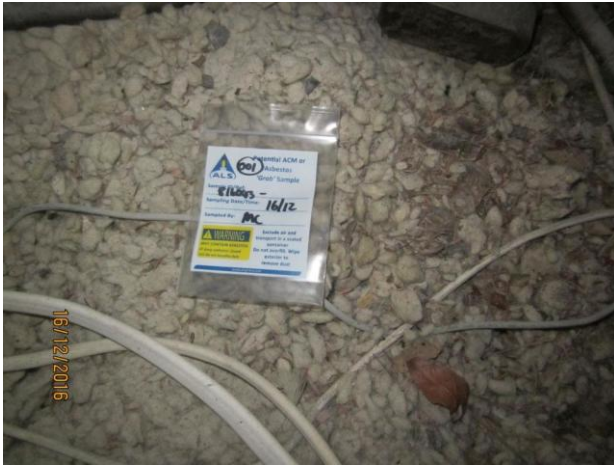
Sample Reference		Sample Description	Location	Photo No.	Results
816043-B152-034	001	Insulation	South west of hatch	1	No Asbestos Detected
816043-B152-034	002	Insulation	East of hatch	2	No Asbestos Detected
816043-B152-034	003	Insulation	North of hatch	3	No Asbestos Detected

**Photo 1.** Roof cavity – Sample 001 location.

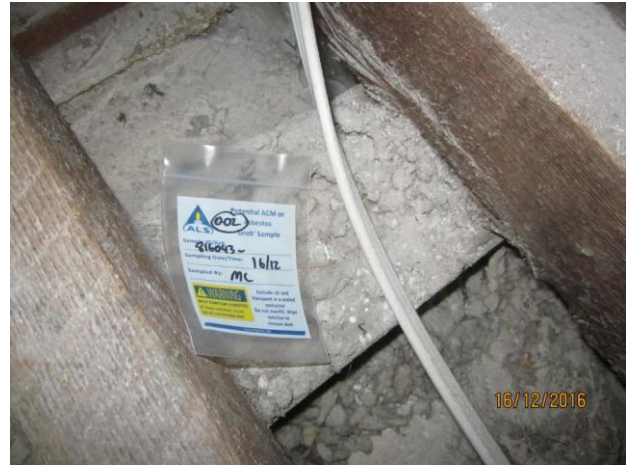
**Photo 2.** Roof cavity – Sample 002 location.

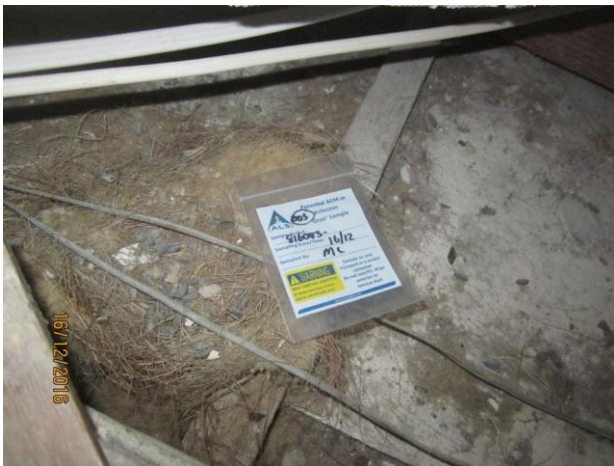
**Photo 3.** Roof cavity – Sample 003 location.
