HAZARDOUS MATERIALS ASSESSMENT REPORT

Job details: Owner/s: Mr. M. Bicknell & Ms. F. Cattell
Location: 66 Plowman Street, North Bondi

Our reference: HM03561214

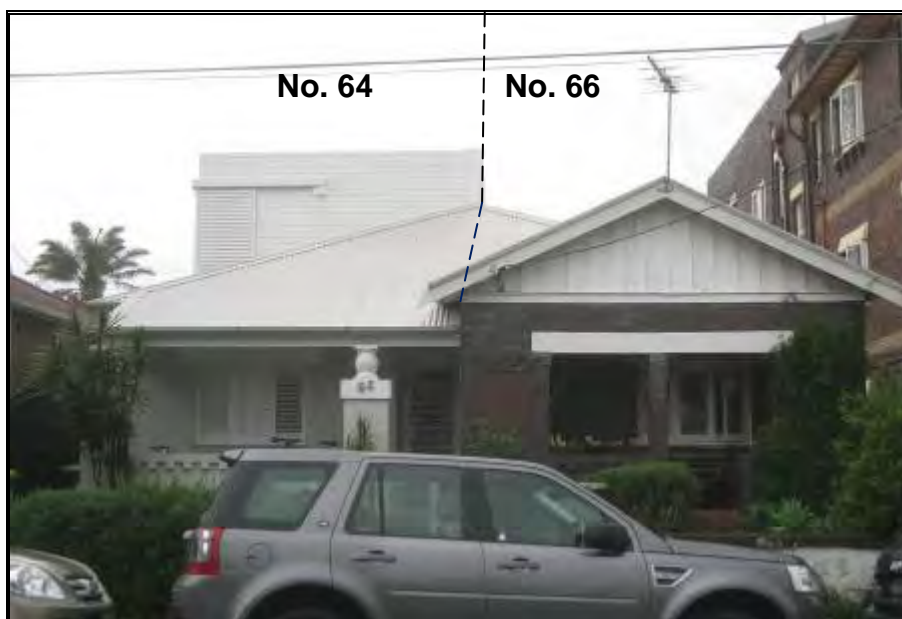
Front north western elevation of the adjoining properties:
No. 64 & No. 66 Plowman Street, North Bondi
