HAZARDOUS MATERIALS ASSESSMENT REPORT

Job details: Owner/s: Mr. C. Milroy & Ms. K. McKeown
Location: 10 Barwon Road, Lane Cove West

Date of assessment: 18th November 2015

Our reference: HM04391115

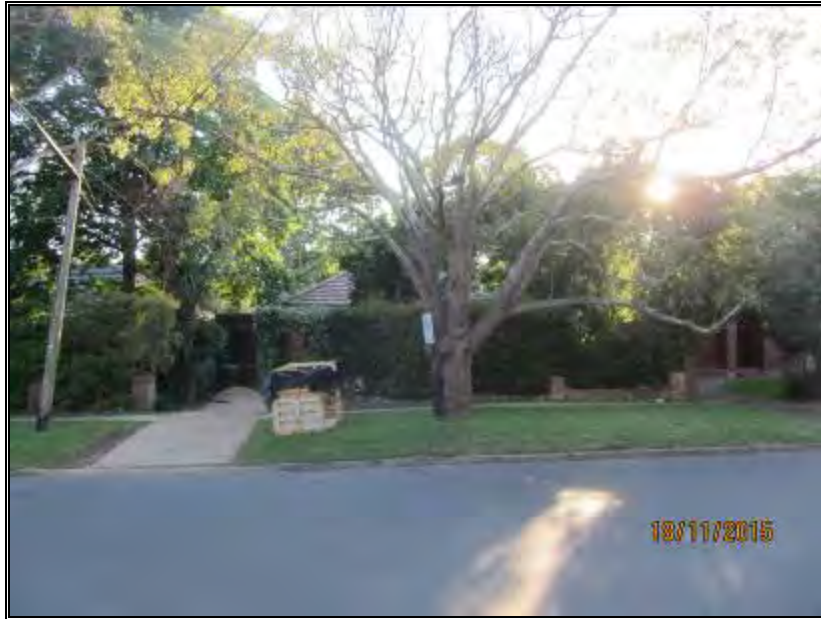
Front western elevation of the residence
