## **HAZARDOUS MATERIALS ASSESSMENT REPORT**

**Client:** Cape Cod Australia Pty. Limited

**Job details:** Owner: Dilon Pty. Ltd.  
Location: 43 Llandaff Street, Bondi Junction

**Our reference:** HM03820315

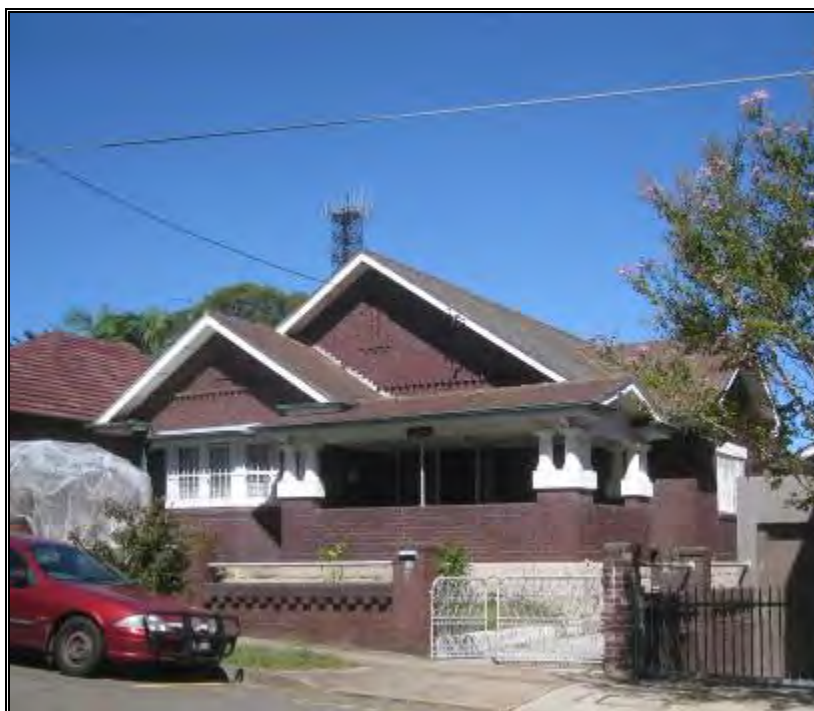
**Front northern elevation of the residence**
