HAZARDOUS MATERIALS ASSESSMENT REPORT

Job details: Owner: Mr. N. & Mrs. C. Lyras.
Location: 57 Universal Avenue, Georges Hall.

Date of assessment: 28th April 2017

Our reference: HM05670417

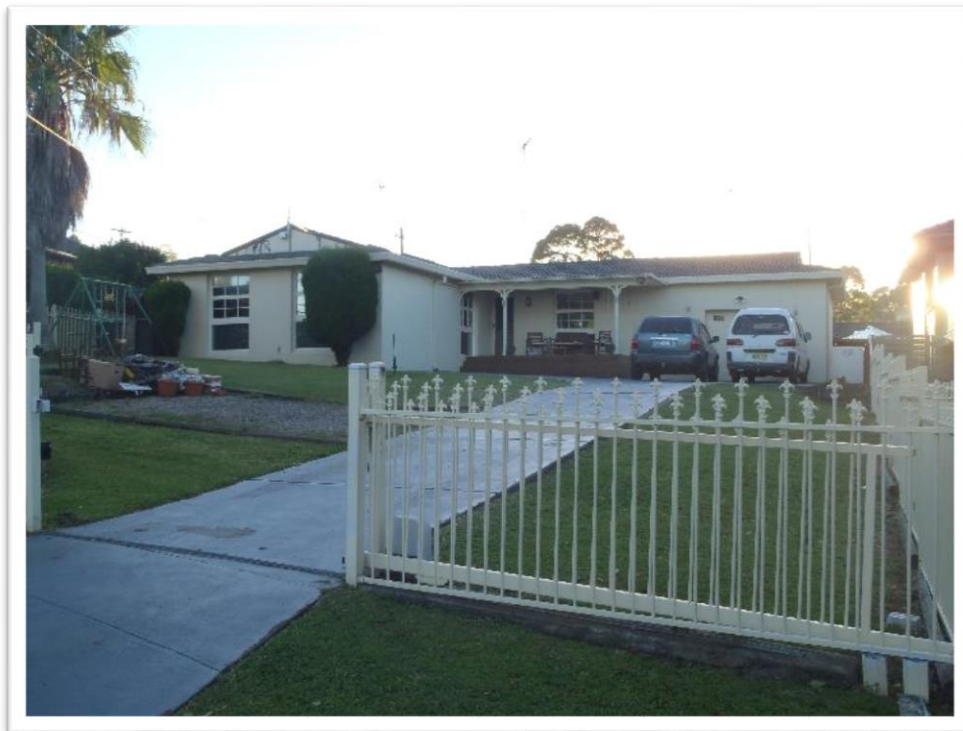
Front western elevation of the residence
