HAZARDOUS MATERIALS ASSESSMENT REPORT

Job details: Owner: Mr. M. & Mrs. C. Luzar.
Location: 21 Ramsay Avenue, WEST PYMBLE.

Date of assessment: 27th July 2016

Our reference: HM05060716

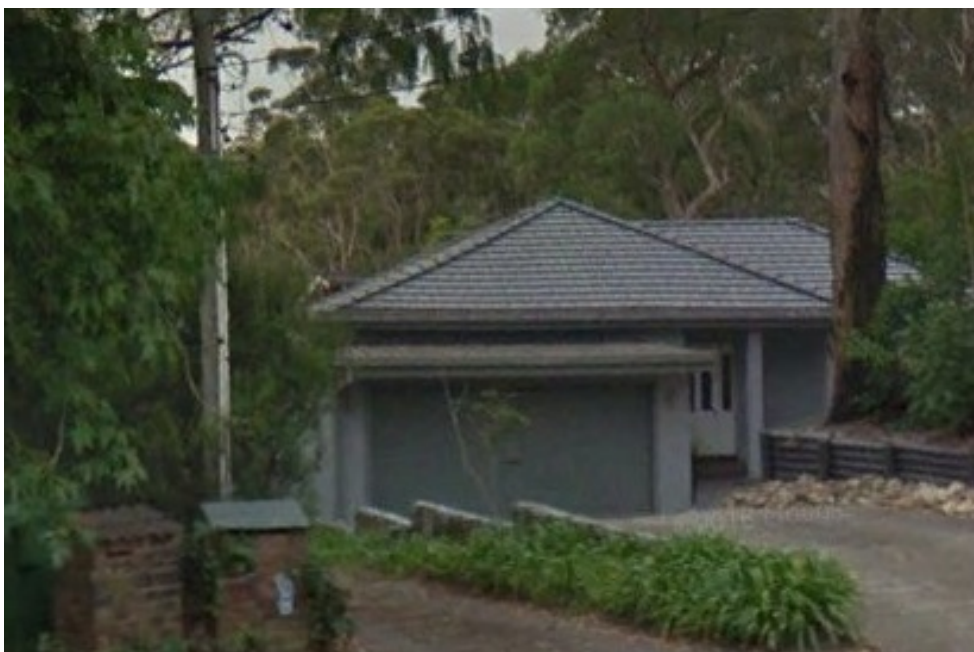
Front southern elevation of the residence
