## Dilapidation Assessment Report

Job address: Unit 5 / 59 Gould Street, Bondi Beach NSW 2026

Date of assessment: 11<sup>th</sup> March 2015

**Re: Dilapidation Report – Unit 5 / 59 Gould Street, Bondi Beach**

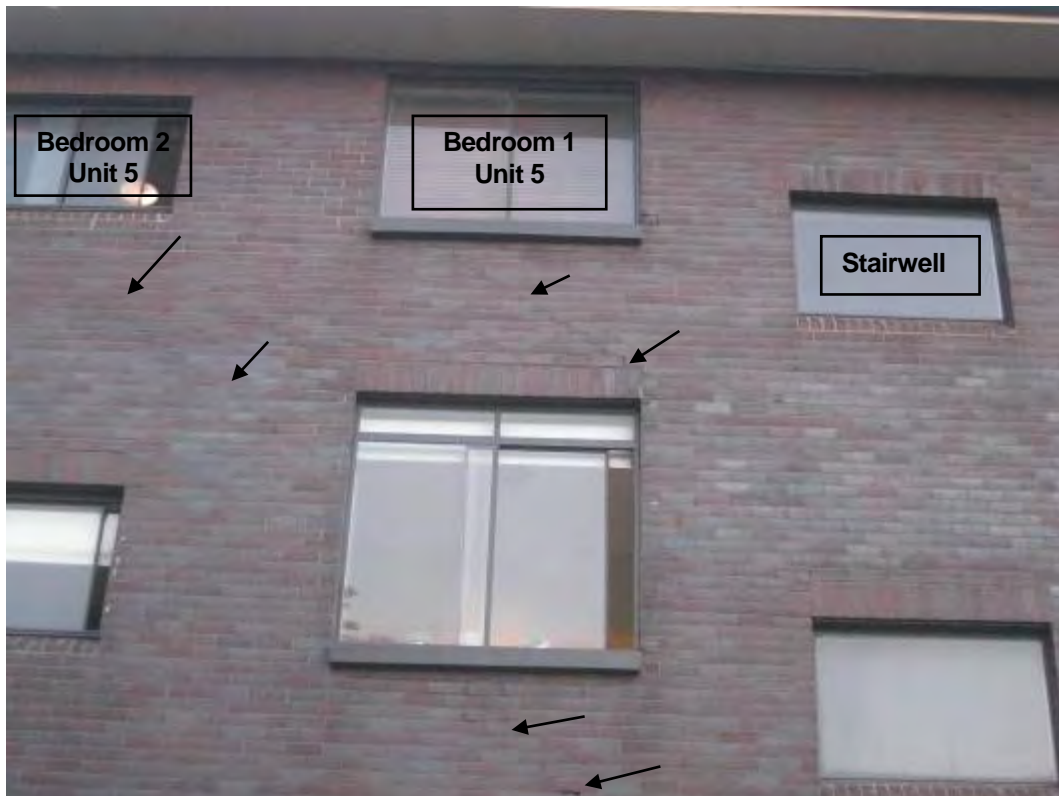
We noted that there is stepped cracking above and below the window openings to the front south eastern elevation of the building. [**Photographs 1, 2 and 3**]

**Photograph 1** shows stepped cracking to the brickwork to the front south east elevation

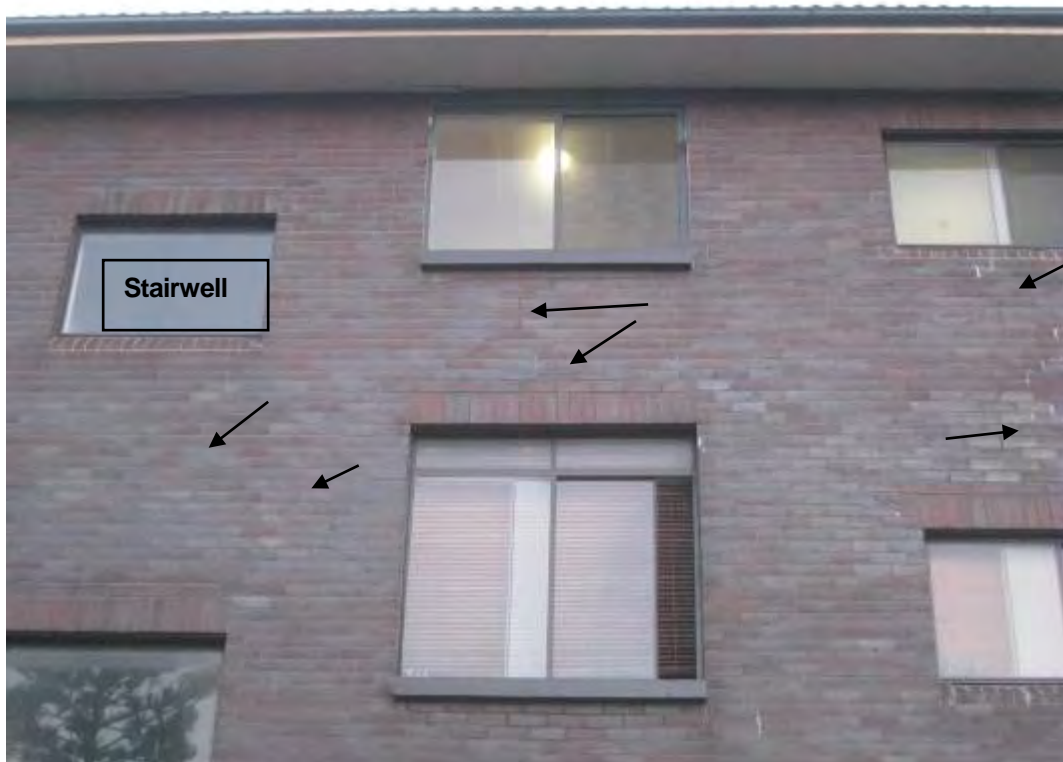
**Photograph 2** shows cracking to the brickwork to the front south east elevation

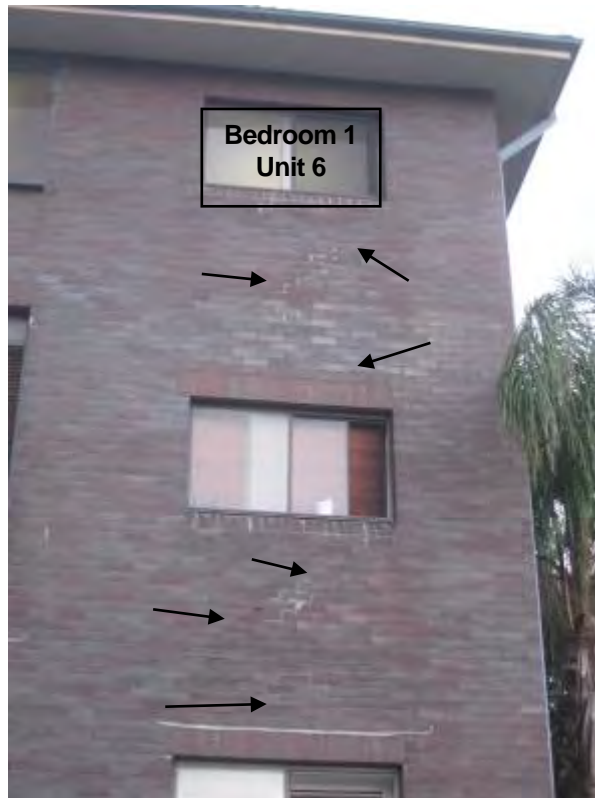
**Photograph 3** shows stepped cracking to the brickwork to the front south east elevation

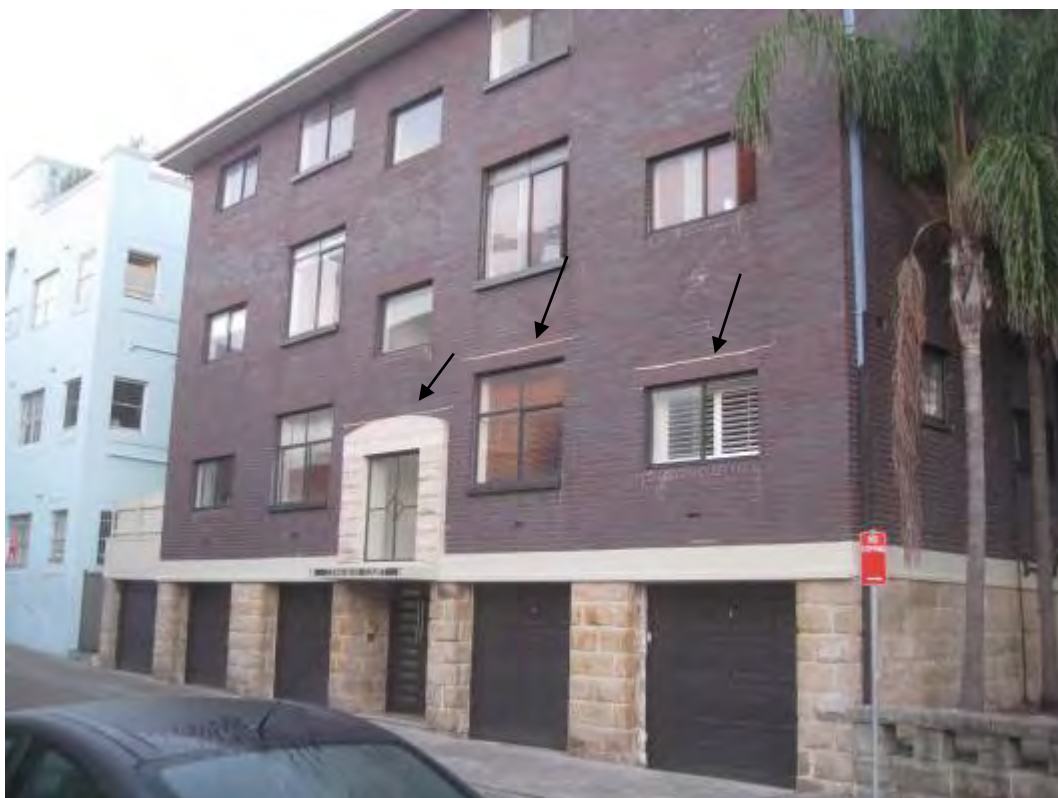
We noted that the window frames are aluminium and that there is a difference in profile of the sill bricks. We further noted that a head flashing to two [2] windows to the first floor Unit 2 had been replaced as well as the head flashing over the front entry foyer opening. [**Photograph 4**]

From our experience this is indicative of possible replacement being undertaken during the renovations / refurbishment works undertaken in 1999.

**Photograph 4** shows the front south east elevation of the building

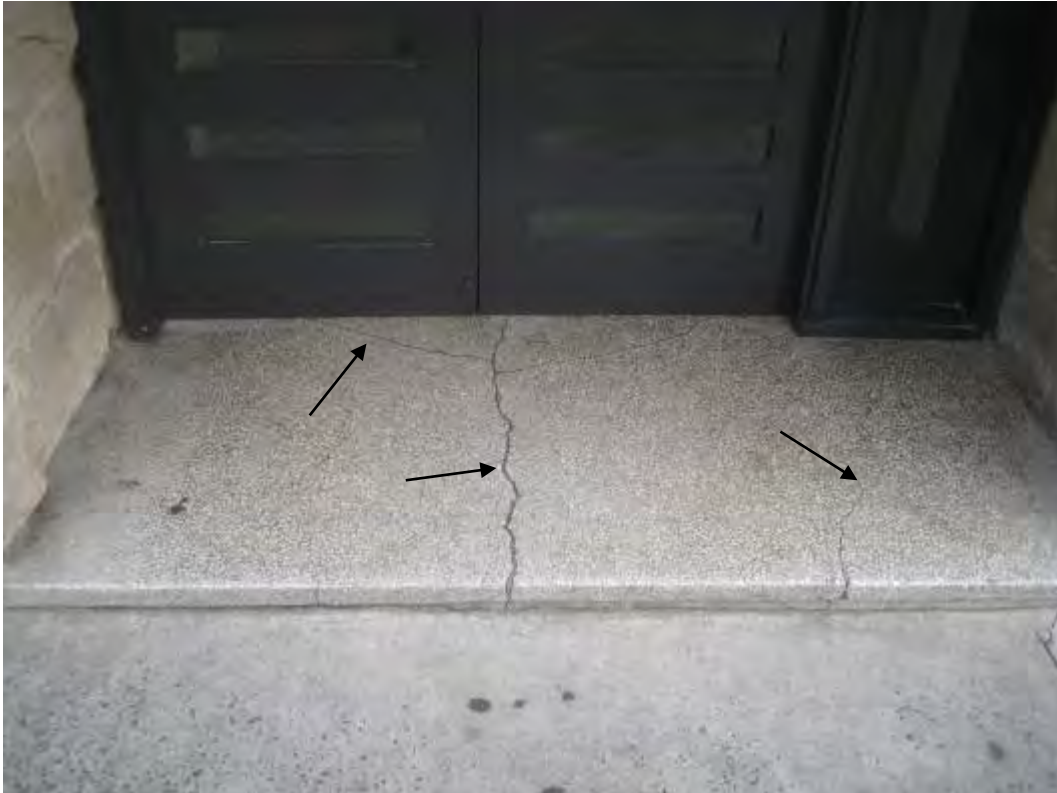
We noted cracking to the terrazzo entry foyer floor including at entry door way. [**Photographs 5 and 6**]

**Photograph 5** shows cracking to the terrazzo to the *common* property entry Foyer

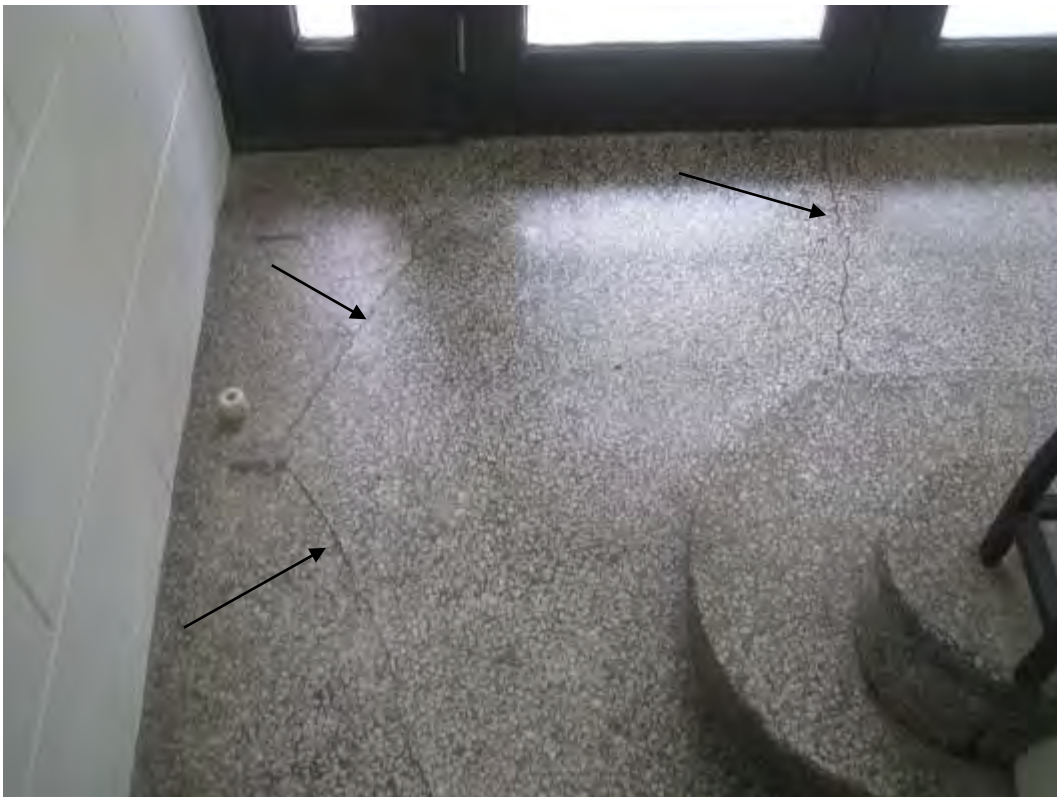
**Photograph 6** shows cracking to the terrazzo Entry / Foyer floor to the *common* property stairwell

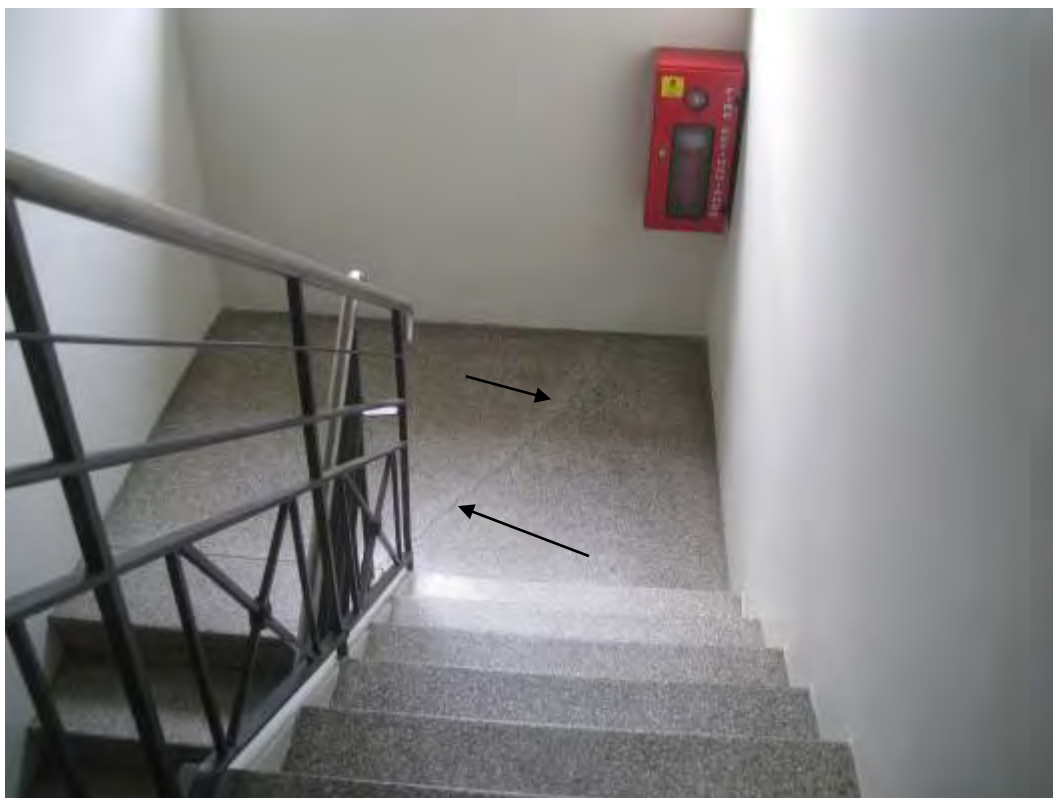
We also noted to the terrazzo second floor level landing cracking. [**Photographs 7 and 8**]

**Photograph 7** shows cracking to the terrazzo to the second floor landing

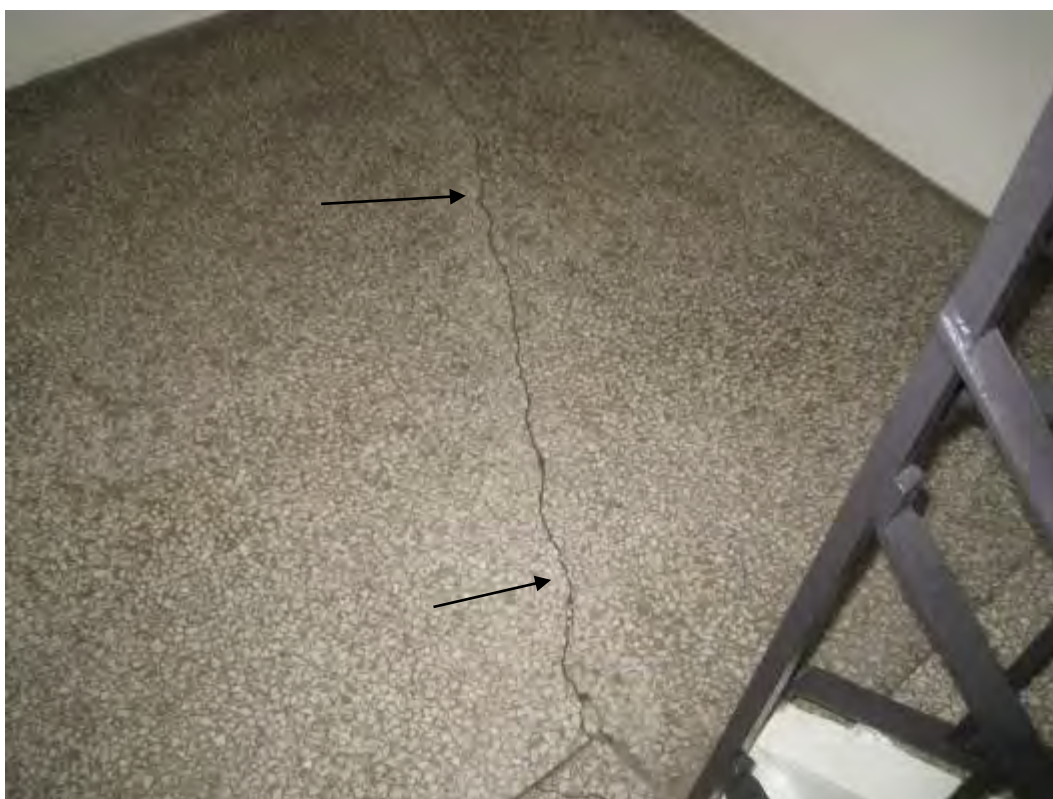
**Photograph 8** shows cracking to the second floor terrazzo landing to the *common* property stairwell

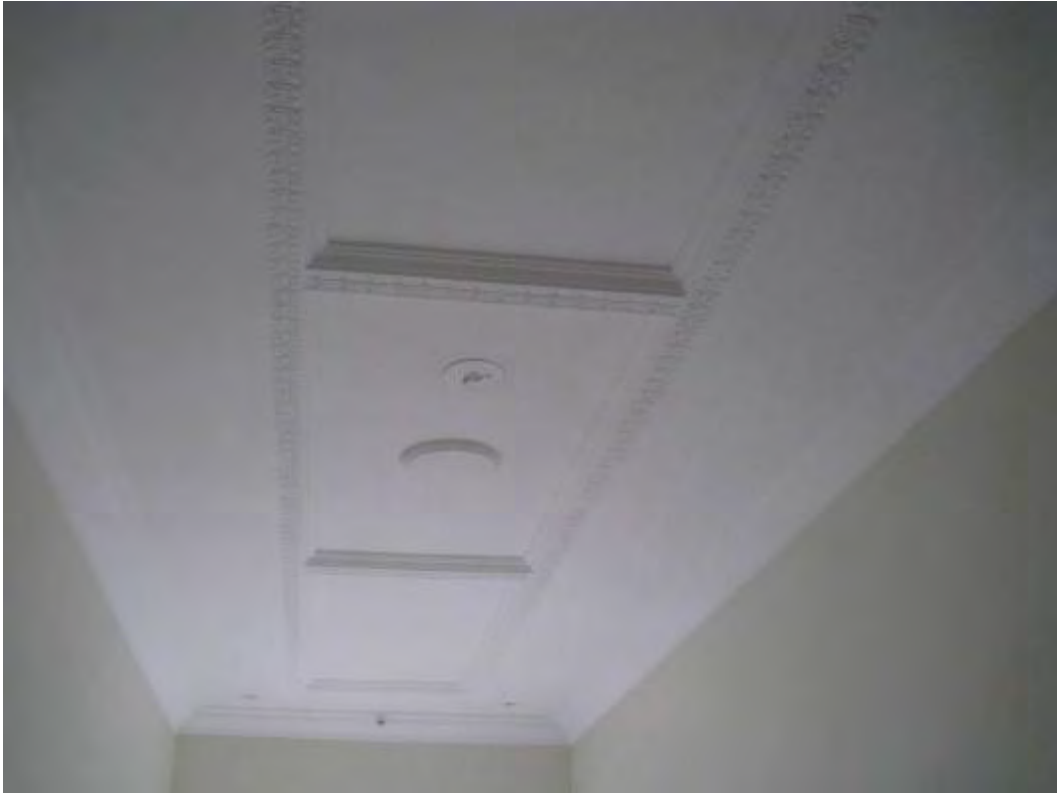
We did not observe any cracking to the decorative panel fibrous plaster ceiling lining or to the decorative profiled plaster cornices. **[Photograph 9]**

**Photograph 9** shows the condition of the ceiling to the *common* property stairwell

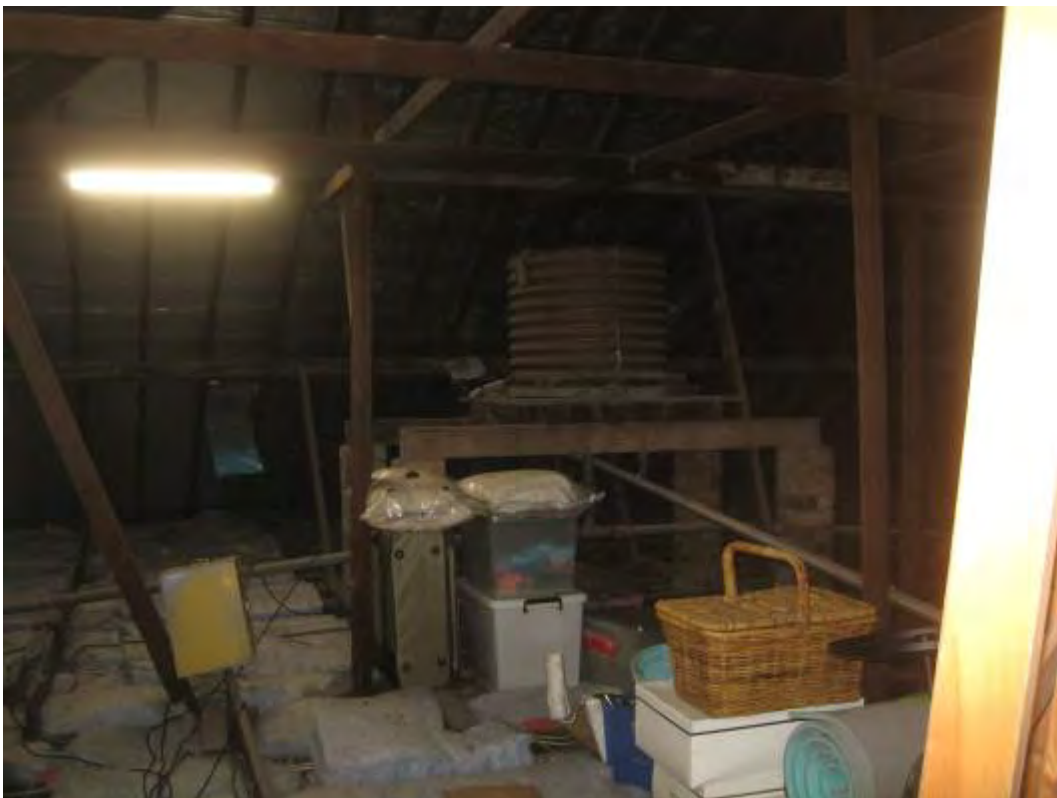
We accessed the roof space from within the adjoining Unit 6 and we observed that the common roof structure is of traditional cut and pitched timber construction. **[Photograph 10]**

We noted that there is no *common party / separation* wall within the roof space to delineate the boundary between this Unit 5 and the abutting Unit 6. **[Photographs 10 and 11]**

**Photograph 10** shows the roof space and disused water tank located over the common property stairwell

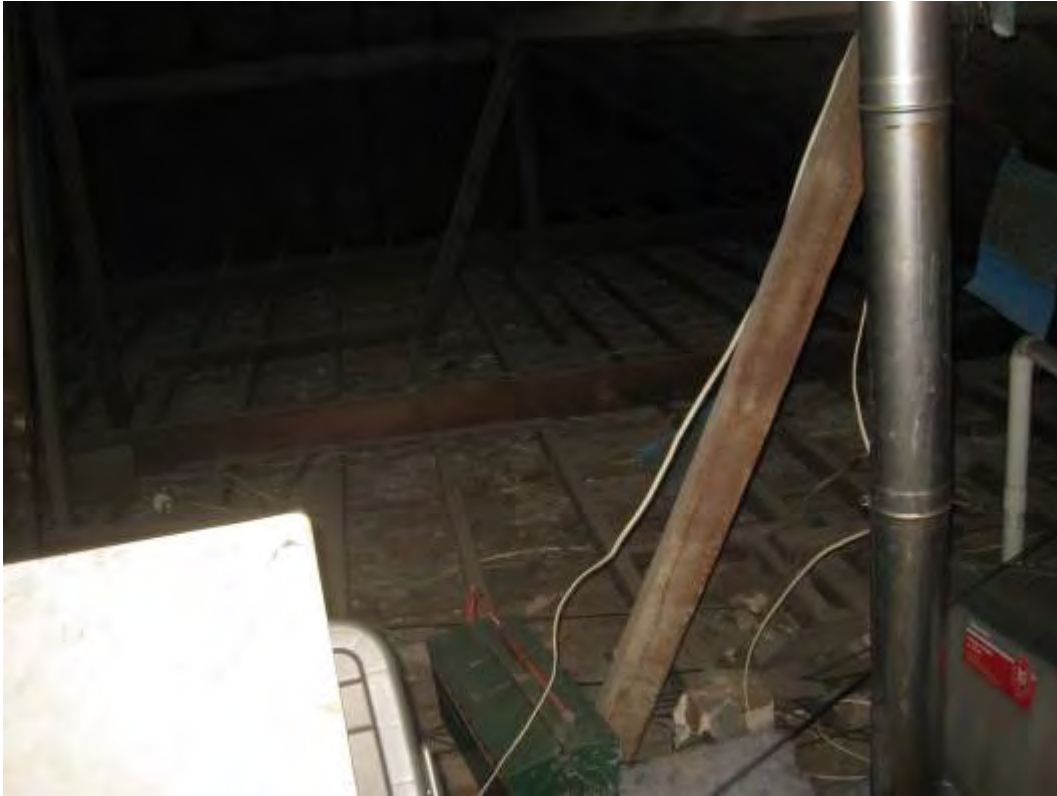
**Photograph 11** shows the roof space over Unit 5

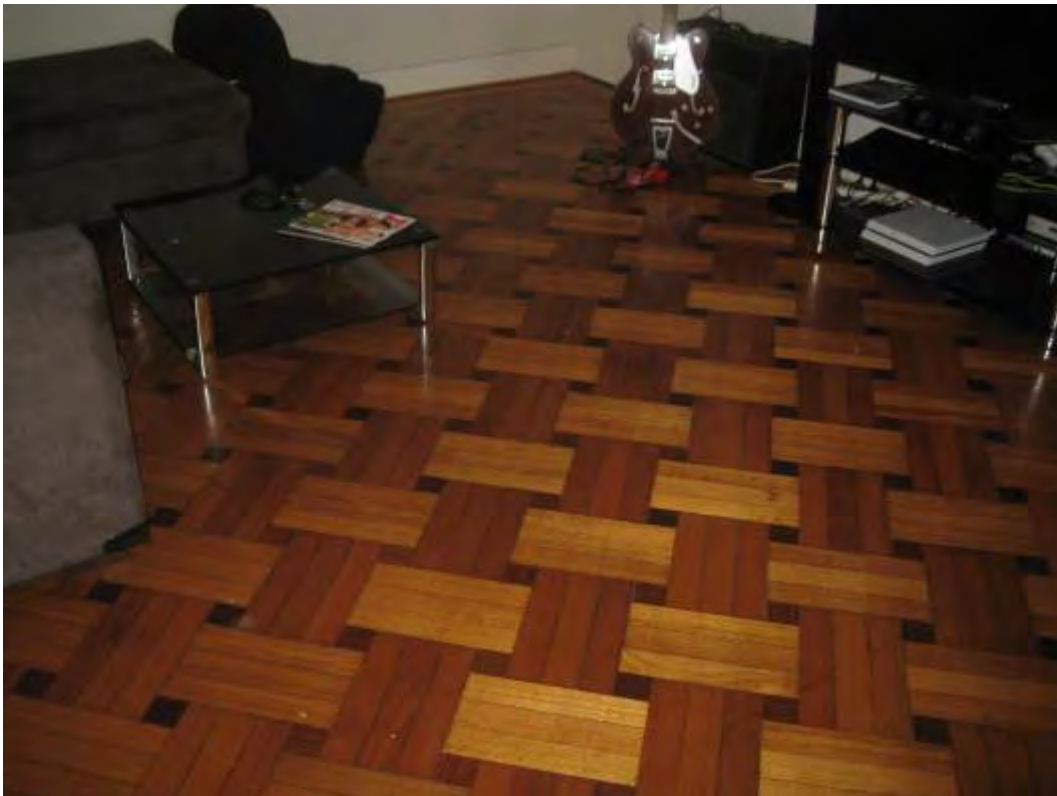
We noted that the floor is finished with polished timber parquet flooring. We randomly “tap” tested the parquet and noted that there were areas of loose or displaced parquet. We did note some movement [squeaking] in the floor system. **[Photograph 12]**

**Photograph 12** shows parquet flooring to the Living room

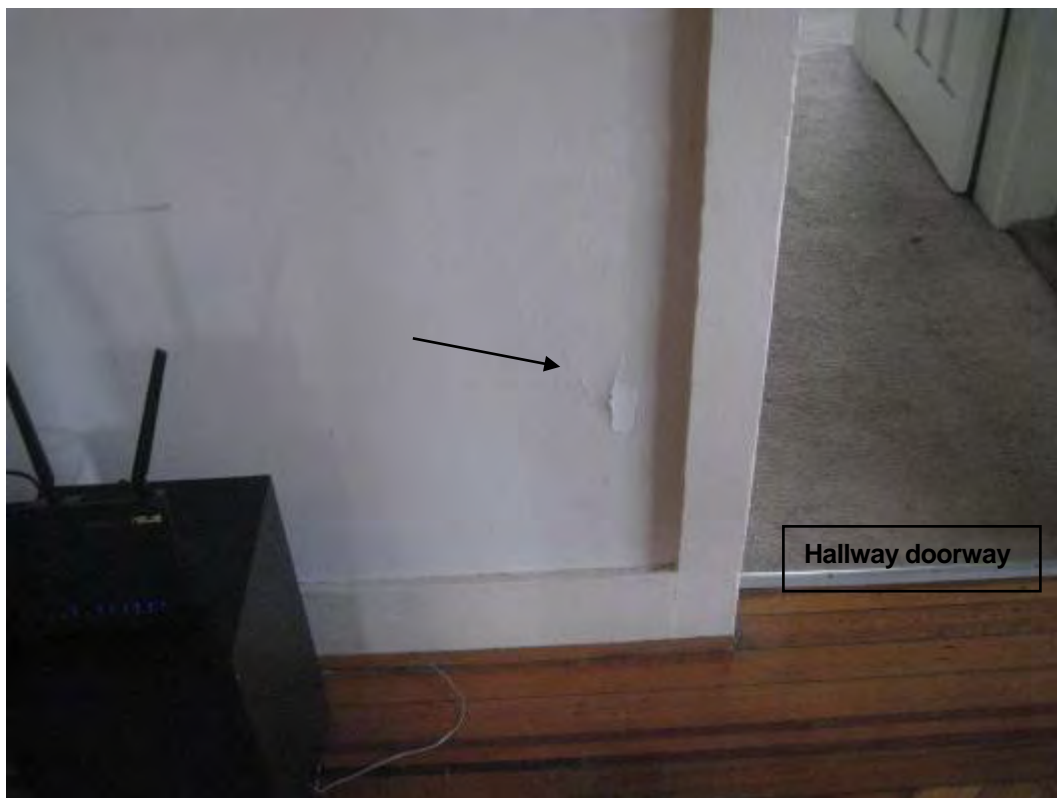
We noted an area of peeling paint adjacent the left hand side Hallway door opening. **[Photograph 13]**

**Photograph 13** shows peeling paint to the Living room wall adjacent to the door to the Hallway

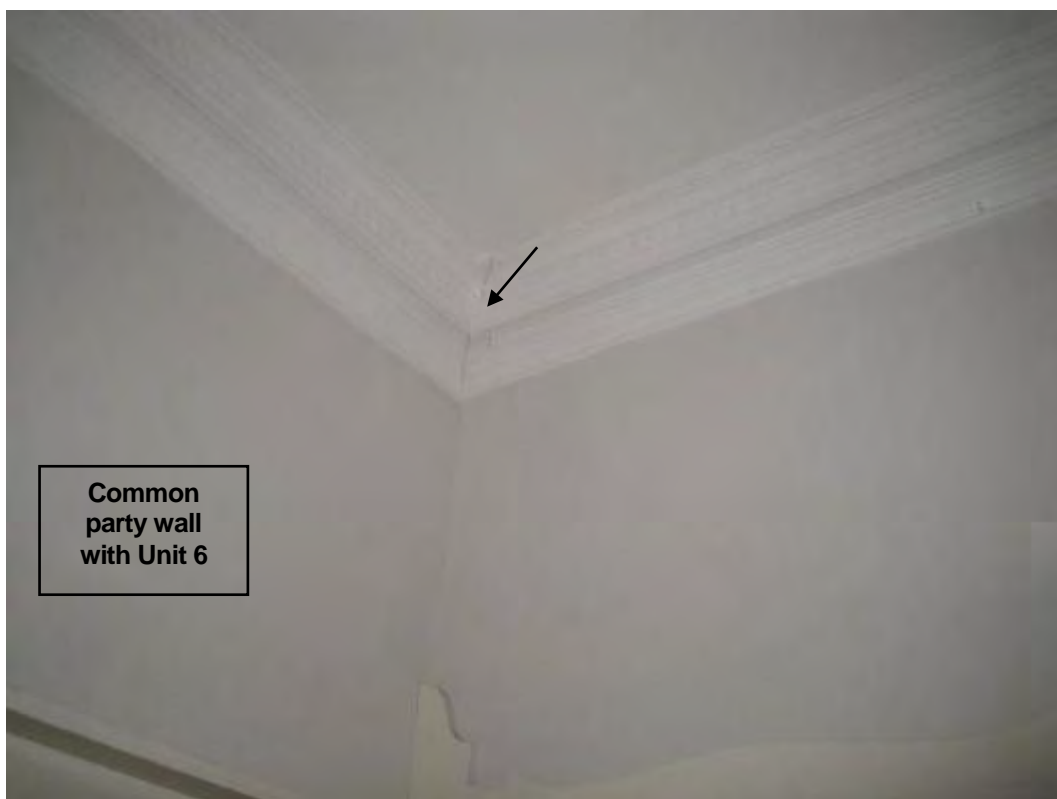
We noted a hairline crack [ $<1.0\text{mm}$ ] to mitre joint in the decorative profiled plaster cornice above the front entry door opening at the eastern corner of the room. **[Photograph 14]**

**Photograph 14** shows a crack to the cornice to the eastern corner of the Living room

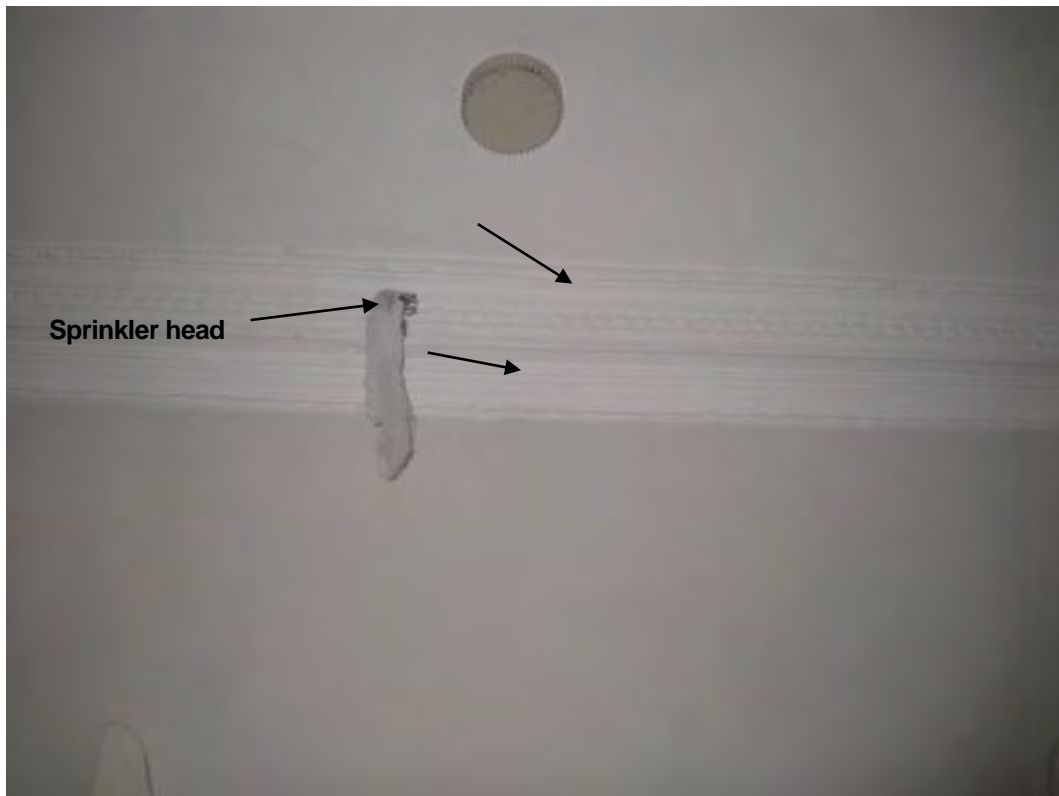
We noted a hairline crack to the butt joint in the decorative profiled plaster cornice adjacent to the sprinkler head to the common internal wall with Bedroom 1. **[Photograph 15]**

**Photograph 15** shows a hairline crack to the joint in the cornice of the Living room to the *common* internal wall with Bedroom 1

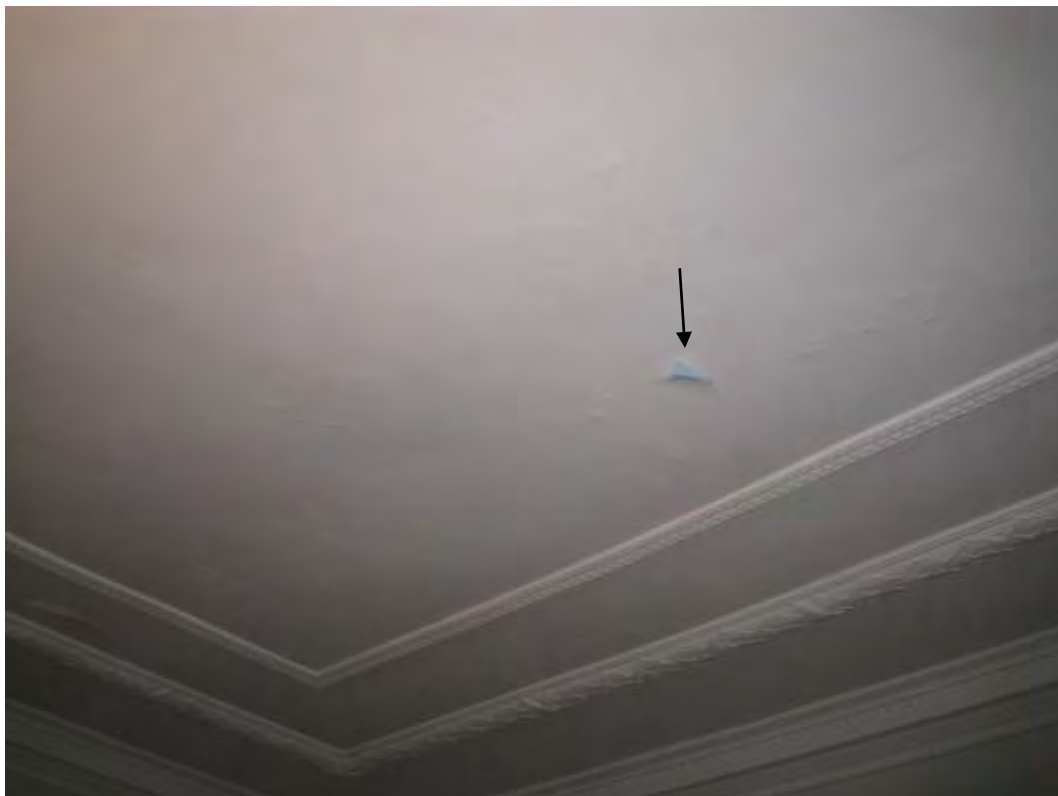
We noted areas of interlinked spider cracking and flaking/ lifting paint from the decorative panel fibrous plaster ceiling lining. **[Photographs 16 and 17]**

**Photograph 16** shows flaking / lifting paint from the Living room ceiling

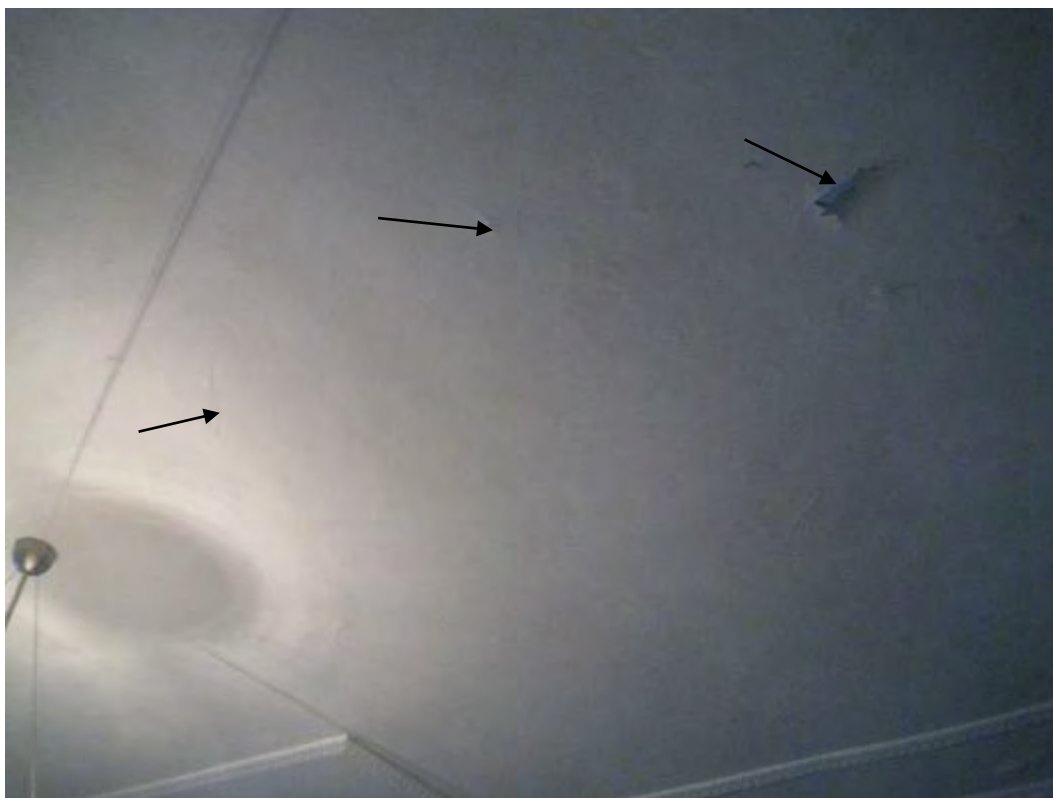
**Photograph 17** shows flaking paint and interlinked spider cracking to the Living room ceiling

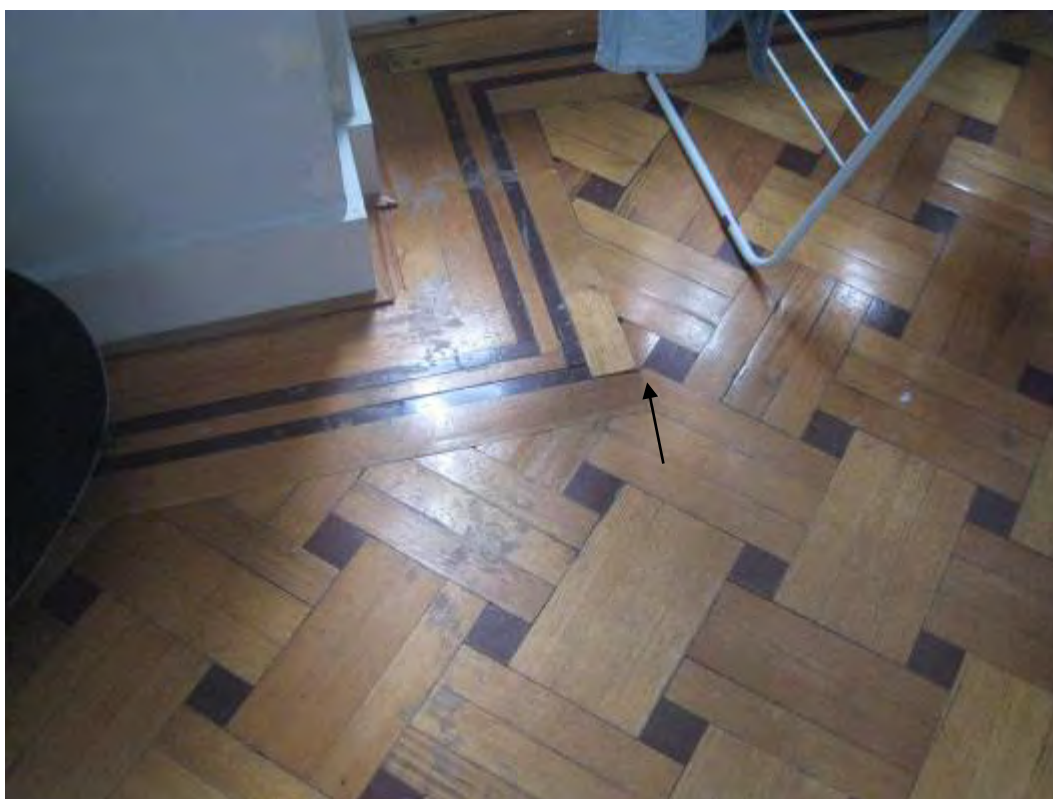
We noted that the floor is finished with polished timber parquet flooring. We randomly “tap” tested the parquet and noted that there were areas of loose or displaced parquet. We did note some movement [squeaking] in the floor system. **[Photograph 18]**

**Photograph 18** shows loose and displacement of parquet flooring adjacent to the bay window in the Dining room – Note: surface finish to the parquet

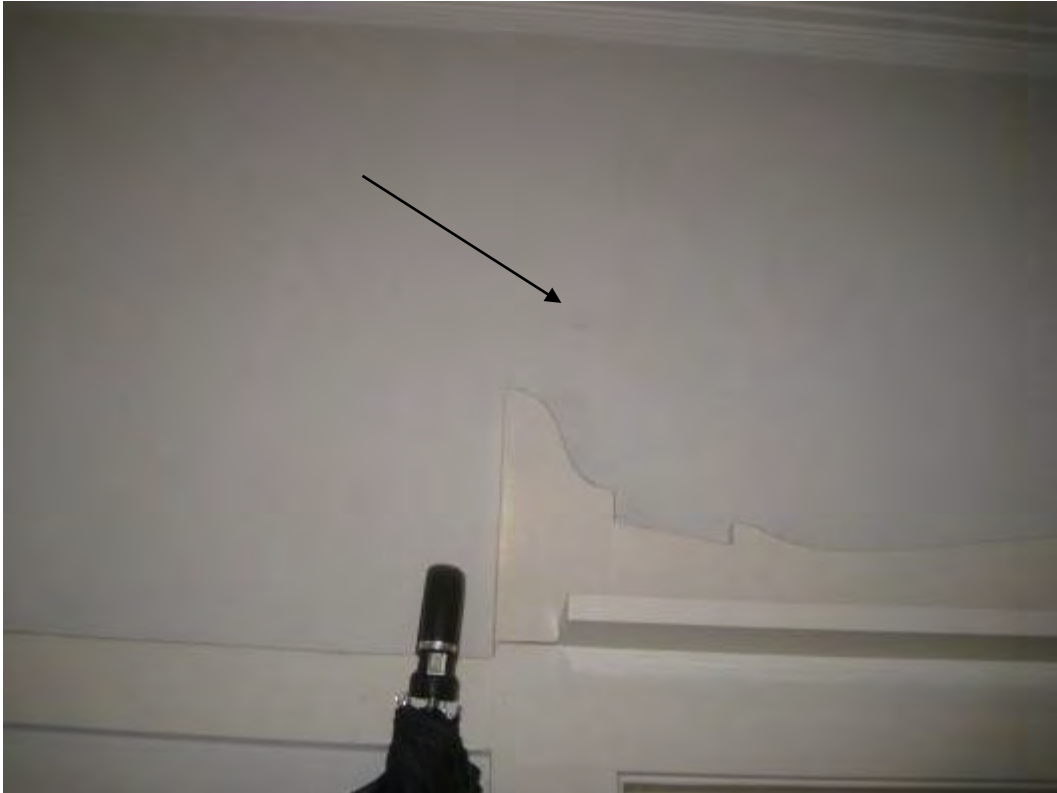
We noted previously repaired vertical crack above the left hand side of the door head towards the cornice. **[Photograph 19]**

**Photograph 19** shows previously repaired crack to the left hand side of the door head in Bedroom 1

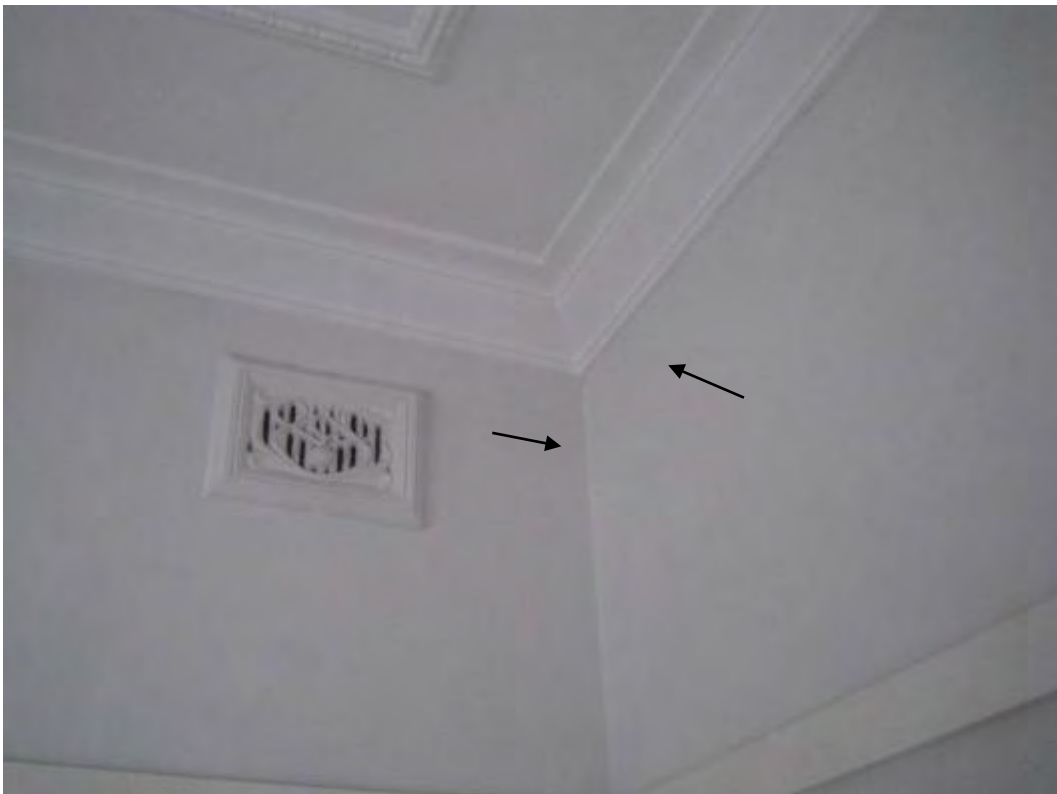
We noted a hairline radial crack [ $<1.0\text{mm}$ ] to the western corner of the room extending from the wall vent towards the cornice. **[Photograph 20]**

**Photograph 20** shows a hairline crack extending from the wall unit to the western corner of Bedroom 2

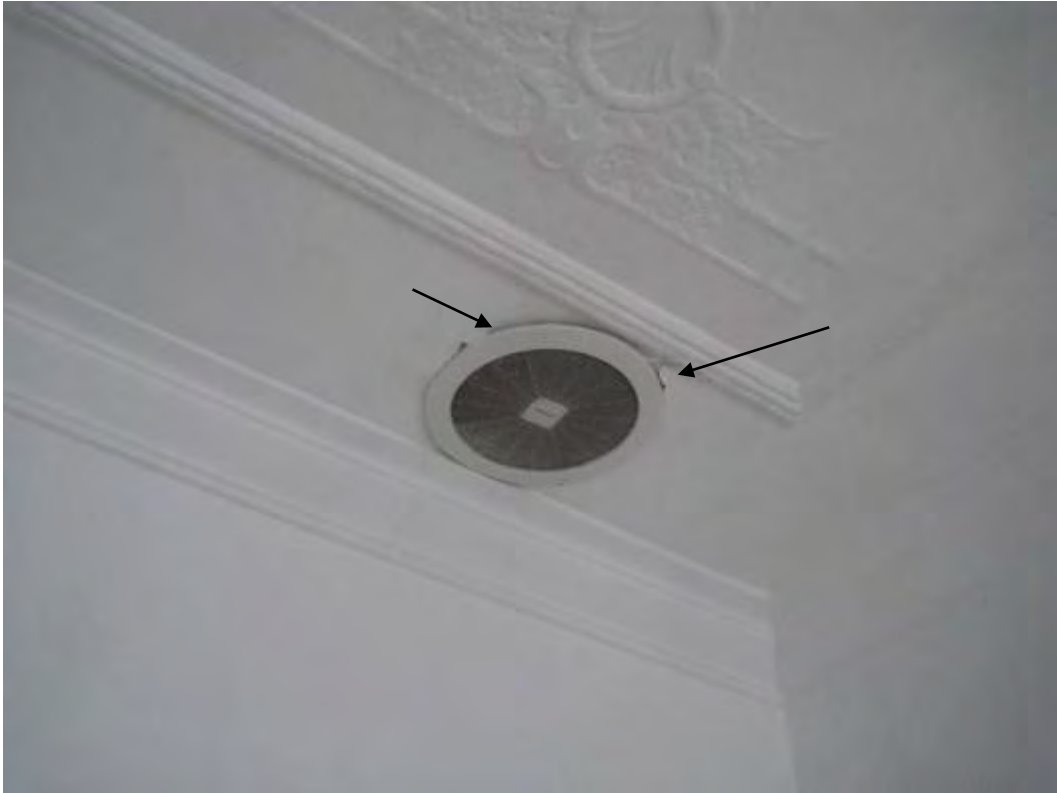
Notwithstanding this, we noted cracking to the ceiling adjacent to the fan fitting. **[Photograph 21]**

**Photograph 21** shows cracking and damage to the ceiling around the ceiling fan in the Bathroom

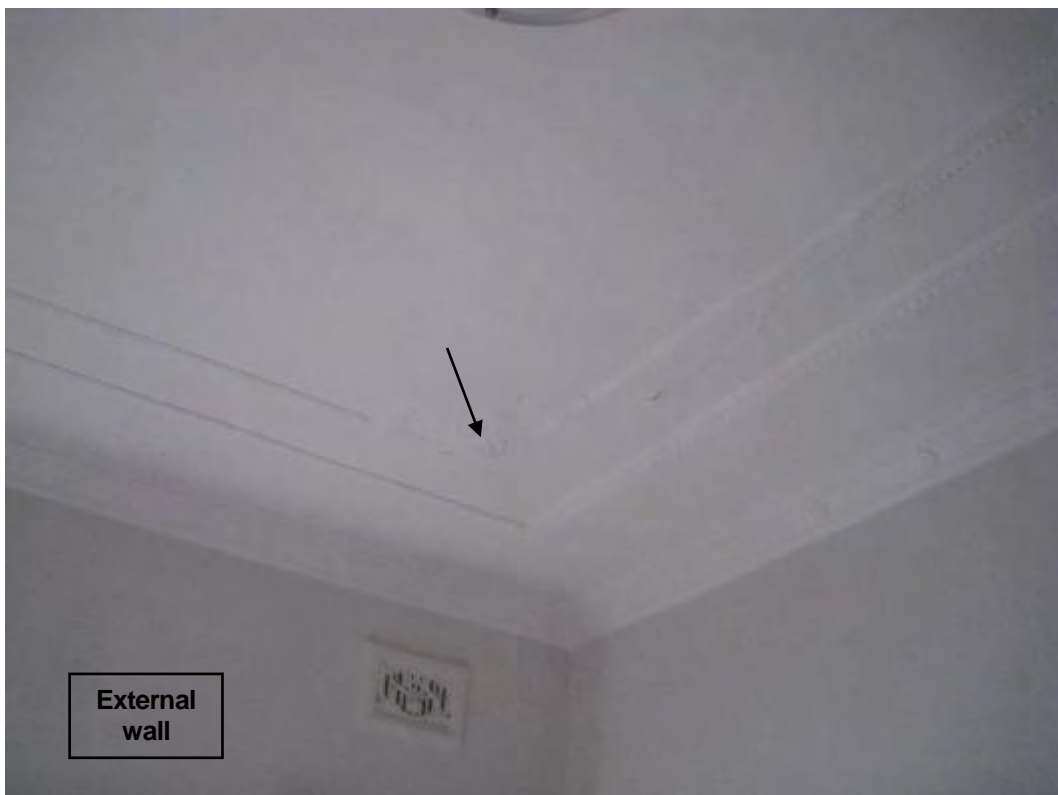
Notwithstanding this, we noted flaking/ lifting paint from the decorative panel fibrous plaster ceiling lining and cornice. **[Photographs 22 and 23]**

**Photograph 22** shows flaking paint to the cornice and ceiling to the western corner of Bedroom 3

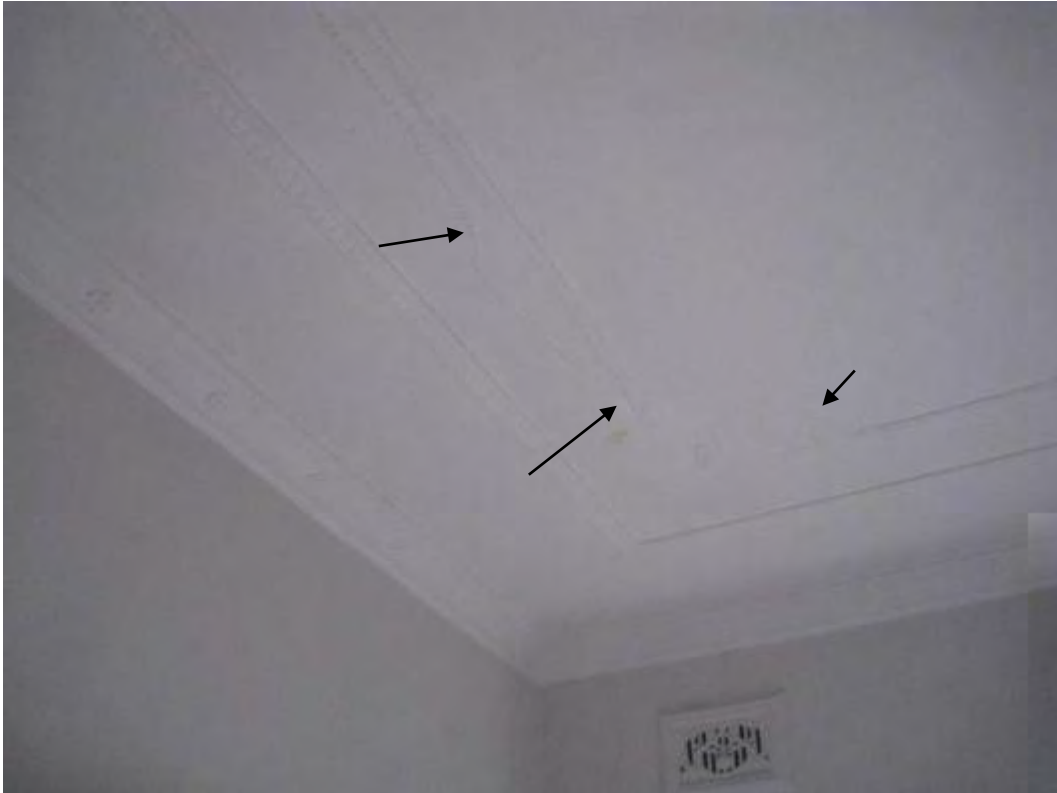
**Photograph 23** shows flaking paint to the cornice and ceiling to the southern corner of Bedroom 3

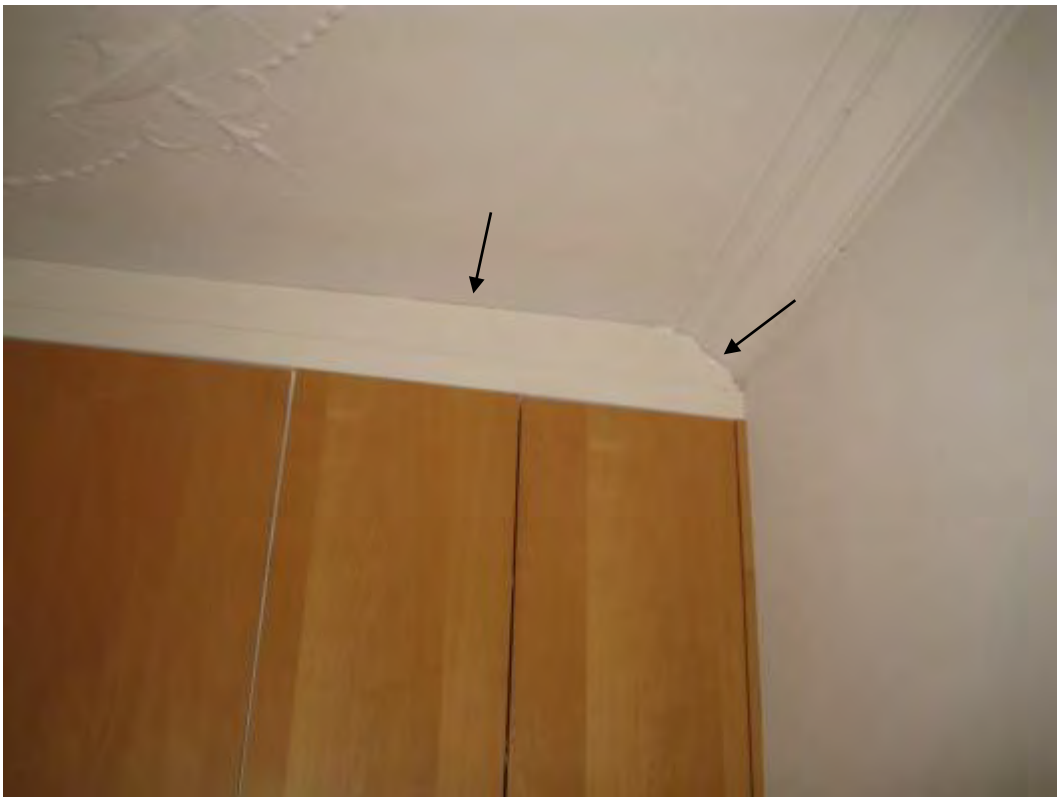
We noted differential movement cracking between the cornice and ceiling above the refrigerator located on the *common party / separation* wall with the adjoining Unit 6. **[Photograph 24]**

**Photograph 24** shows a differential movement crack between the cornice and the ceiling above the refrigerator to the *common party / separation* wall in the Kitchen

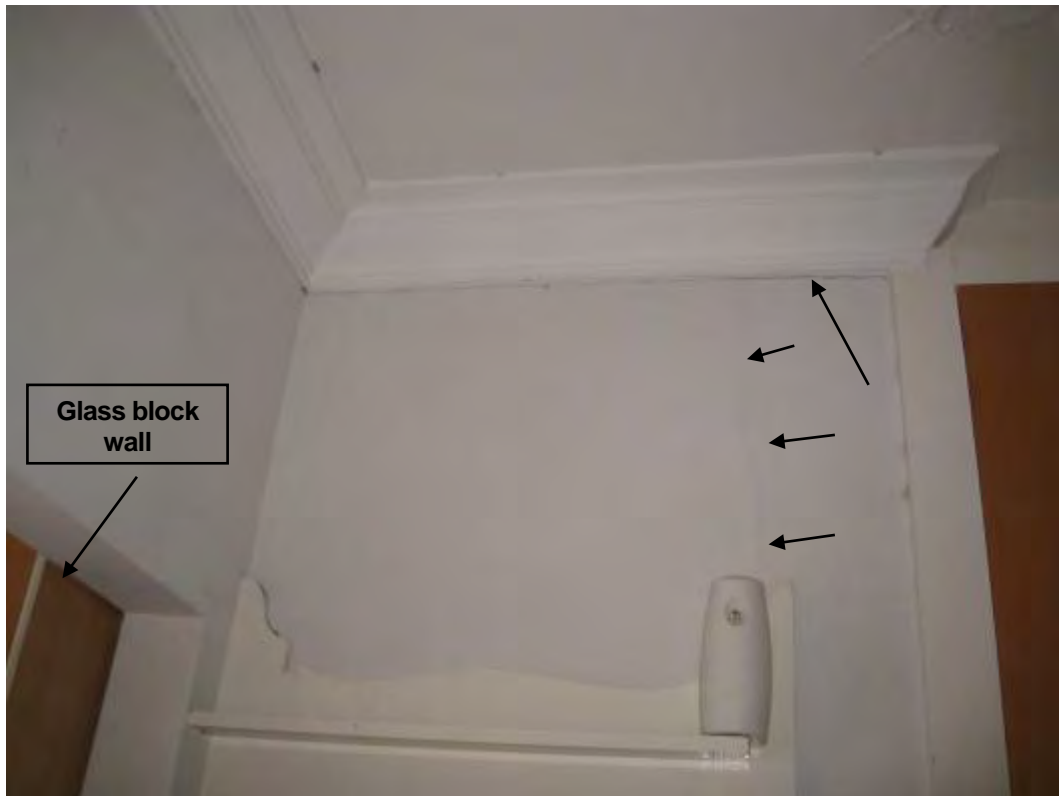
We noted a vertical crack [ $<1.0\text{mm}$ ] and separation cracking [ $<1.0\text{mm}$ ] between the decorative profiled plaster cornice and the *common party / separation* wall above the Kitchen bench top area. **[Photograph 25]**

**Photograph 25** shows a vertical crack and separation crack between the cornice and the wall surface in the Kitchen

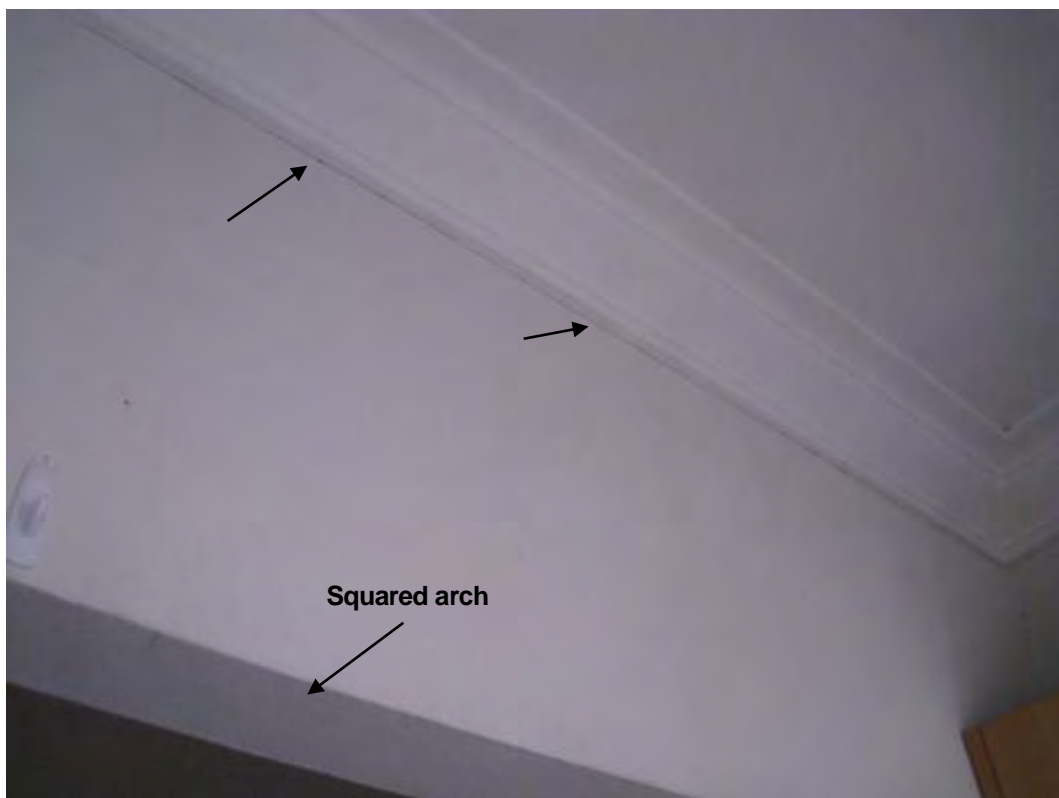
We noted separation cracking [ $<1.0\text{mm}$ ] between the decorative profiled plaster cornice and the wall surface above the squared arch opening. **[Photograph 26]**

**Photograph 26** shows a separation crack between the cornice and the wall surface above the squared arch in the kitchen
