## Dilapidation Assessment Report

Job address: Unit 5 / 59 Gould Street, Bondi Beach NSW 2026

Date of assessment: 11<sup>th</sup> March 2015

**Re: Dilapidation Report – Unit 5 / 59 Gould Street, Bondi Beach**

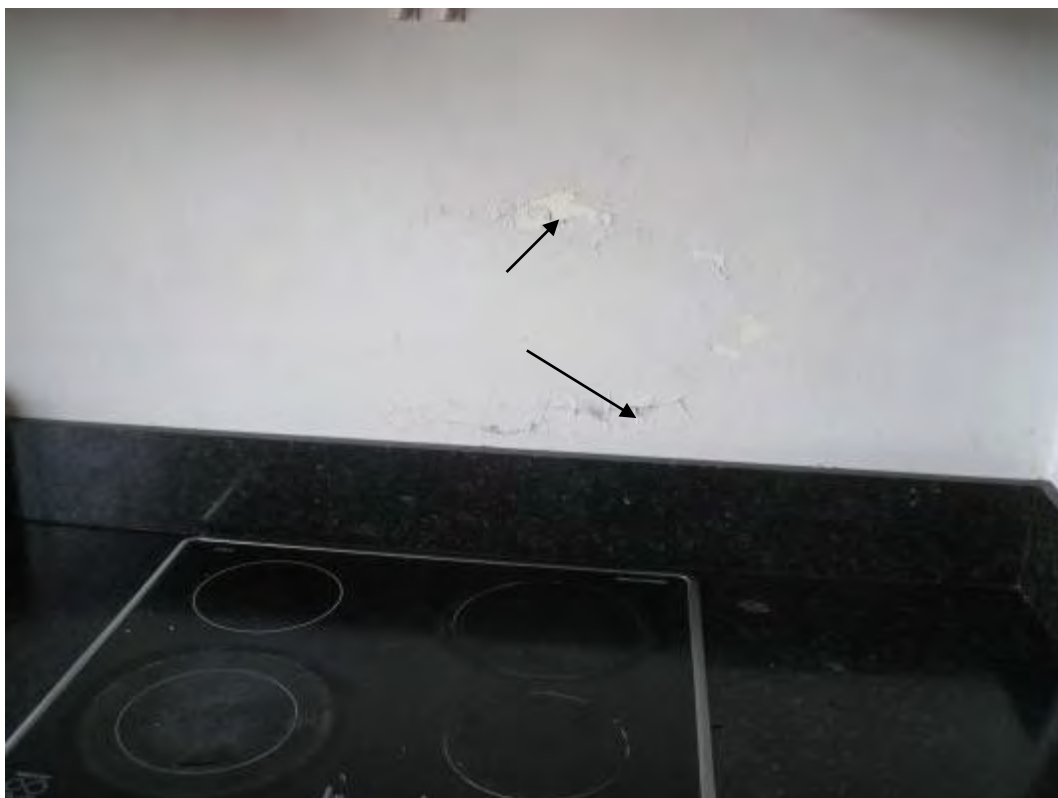
We noted flaking / staining paint from the wall surface above the cook top. **[Photograph 27]**

**Photograph 27** shows flaking paint and staining to the wall above the cook top in the Kitchen

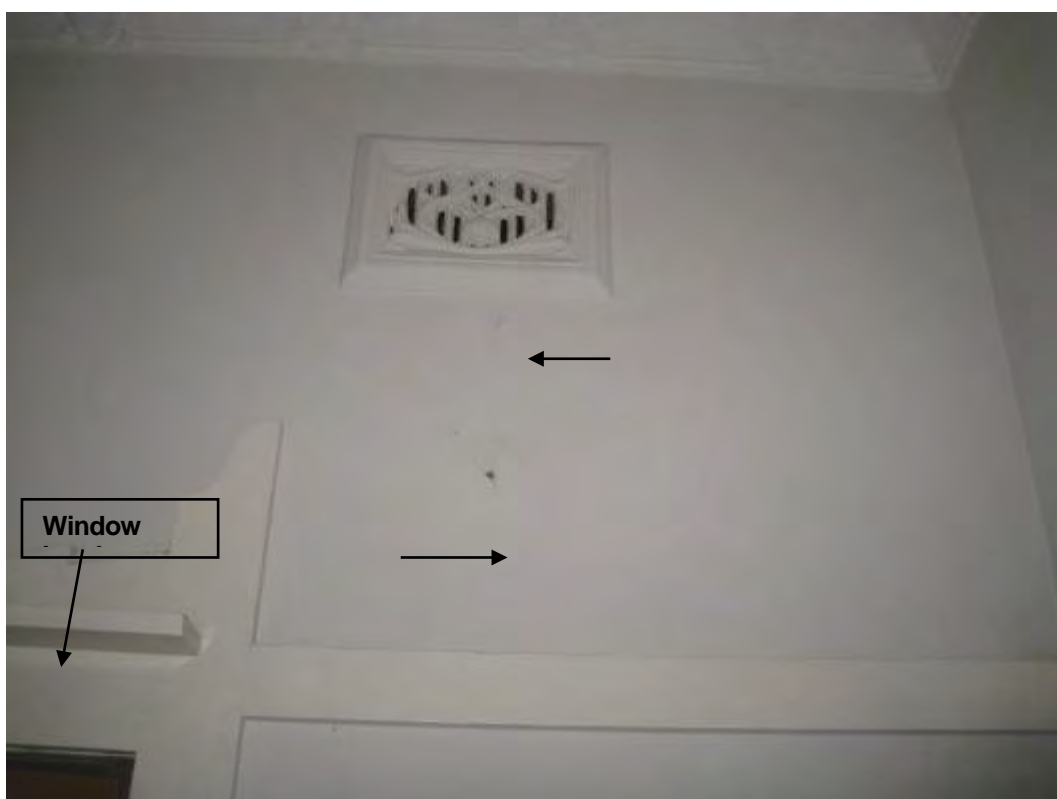
We also noted a vertical hairline crack [ $<1.0\text{mm}$ ] above the right hand side of the window head extending towards the wall vent. **[Photograph 28]**

**Photograph 28** shows a vertical crack to the right hand side of the window head towards the wall vent in the rear wall of Bedroom 4
