## **HAZARDOUS MATERIALS ASSESSMENT REPORT**

**Job details:** Owner/s: Mr. S. & Mrs. M. Butcher  
Location: 213 Sydney Road, Fairlight NSW

**Date of assessment:** 21<sup>st</sup> January 2016

**Our reference:** HM04521215

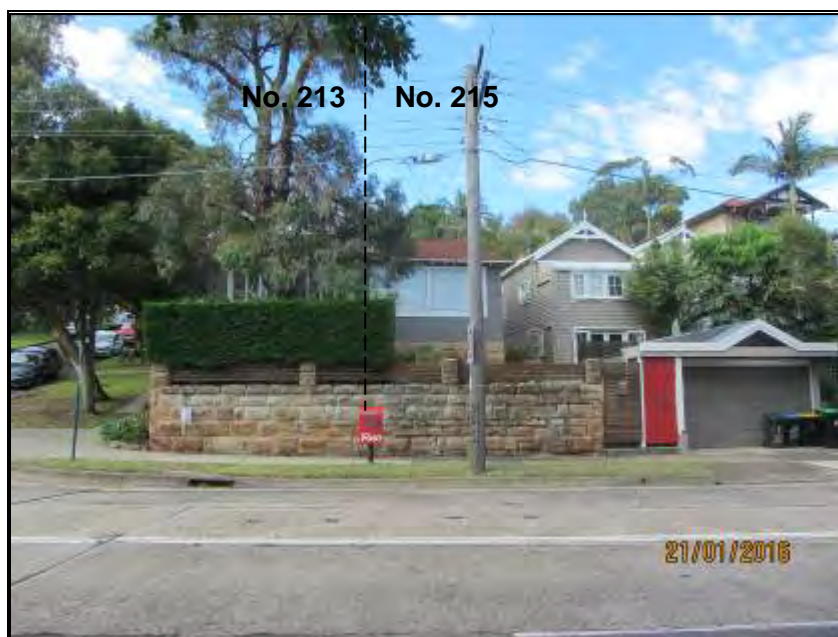
Front northern elevation of the adjoining properties:  
No. 213 & No. 215 Sydney Road, Fairlight
