DILAPIDATION REPORT

17 Morrice Street
Lane Cove NSW 2066

TYRRELLS PROPERTY INSPECTIONS PTY LIMITED

Inspection date
2 DECEMBER 2016

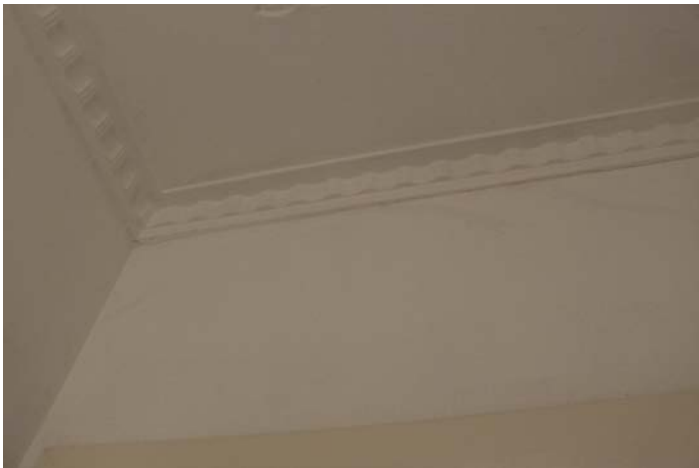
Photo 2.jpg

Item	Description	Photo No.
4.2.1	Entry – oblique cracking to upper east wall above picture rail approx. 700mm in length	2
4.2.2	Horizontal cracking between wall and cornice running length of wall above door	3-4

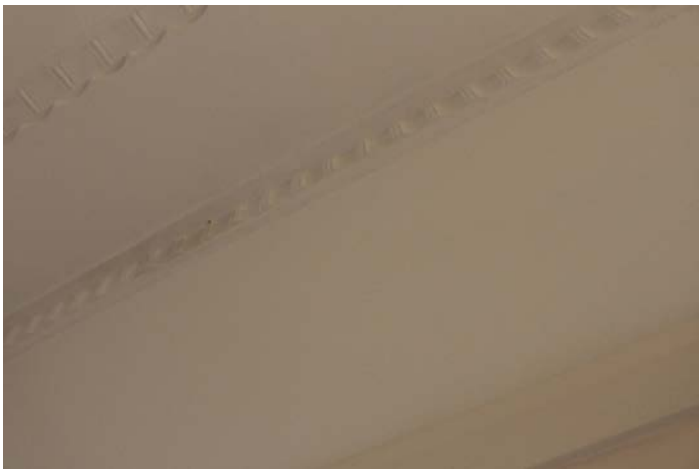
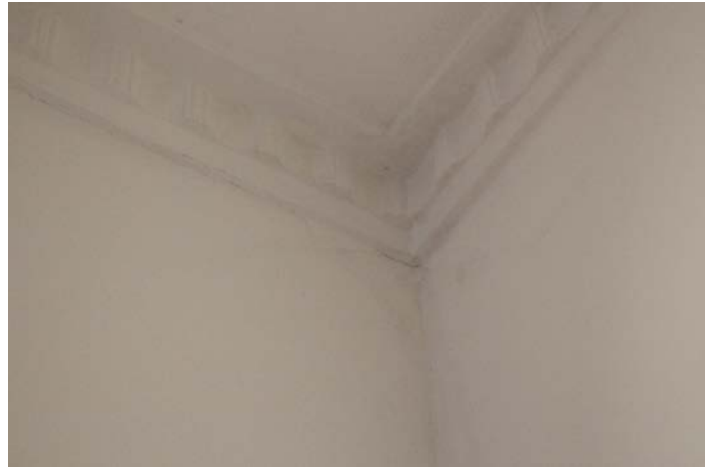
4.2.3	Cracking to northwest corner join between wall and cornice	5-7
4.2.4	Movement between picture rail and wall at northeast corner	8
4.2.5	Cracking to upper south corner and doorframe to lounge	9

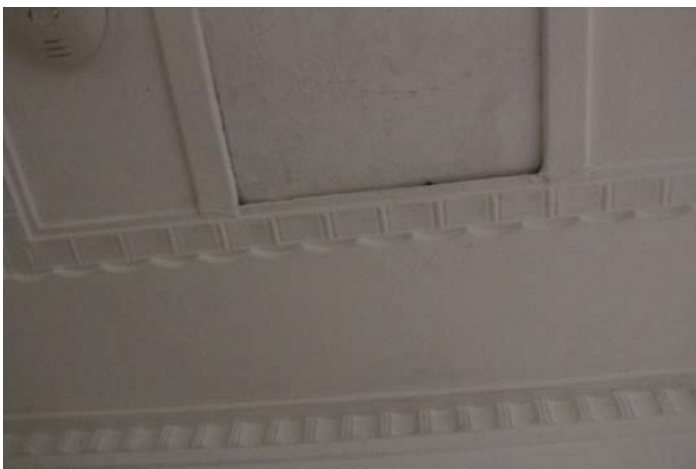
Photo 10.jpg

4.2.6	Remediated crack to south wall above bedroom 2	10
4.2.7	Cracking around service access hatch to trim, both south sides	11
4.2.8	Movement between door architrave upper east corner to bathroom door	12

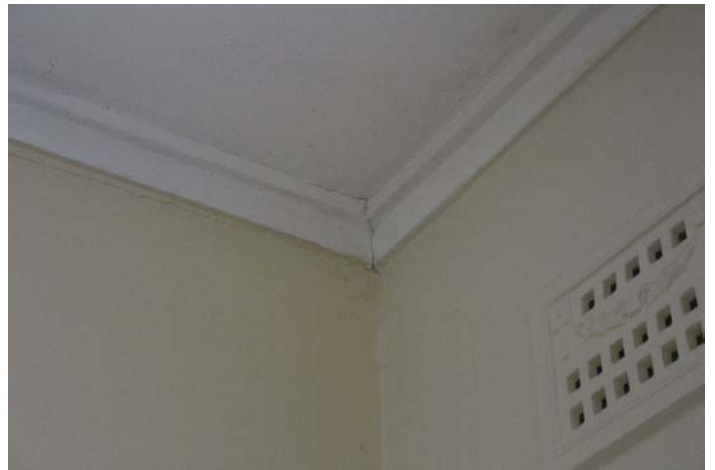
Photo 21.jpg

4.2.15	Bedroom 2 – movement between internal mitred cornice and ceiling boards northwest corner	21
4.2.16	Movement between internal cornice mitre and ceiling boards southeast corner	22

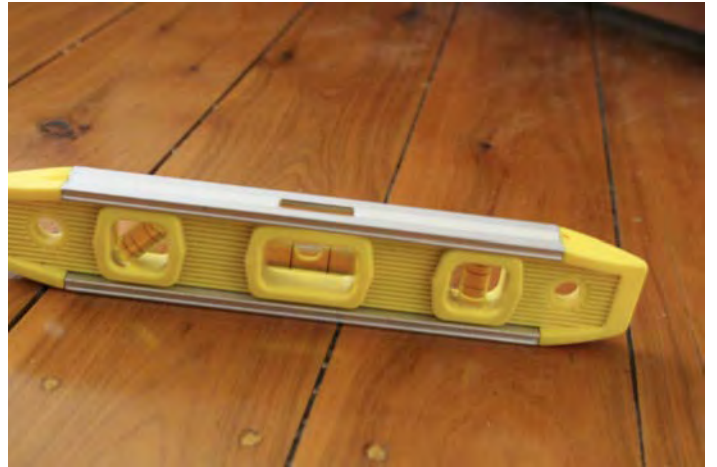
Photo 31.jpg

4.2.23	Movement between south wall and cornice adjacent fire place	31
4.2.24	Close up on level typical grade to floor	32
4.2.25	Dining/Kitchen – movement between skirting and wall north side of door way	33

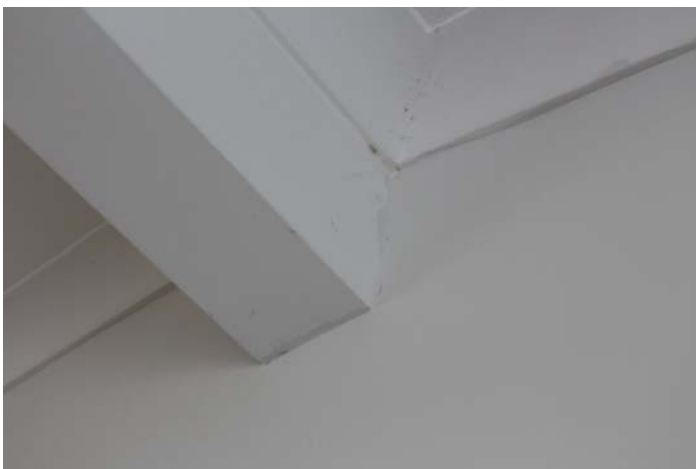
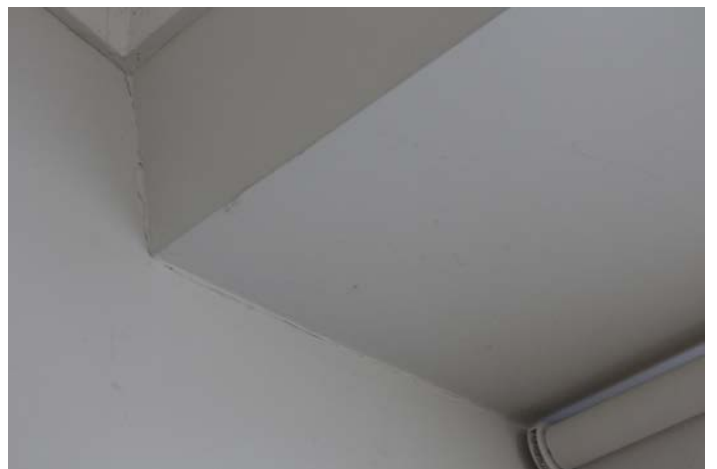
4.2.26	Movement between encased beam and north wall	34-35
4.2.27	Movement between rear northeast bulkhead and wall	36
4.2.28	Crack to bulkhead ceiling southeast corner	37

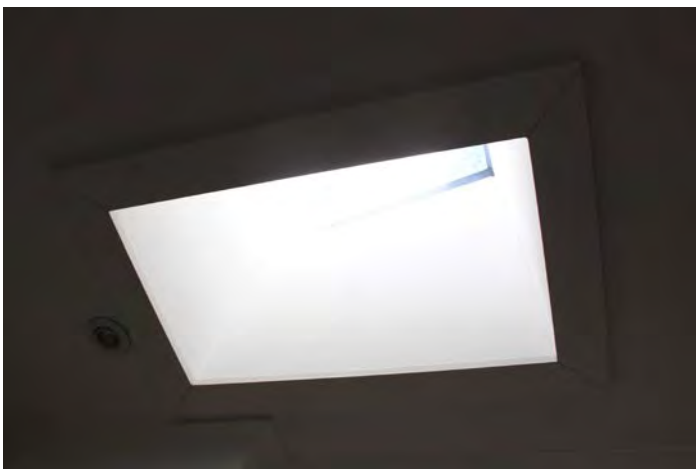
<i>Item</i>	<i>Description</i>	<i>Photo No.</i>
4.2.30	Vertical crack starting from south wall encased beam and ending at splashback panel	39-40
4.2.31	Movement to light well architrave mitre joins	41
4.2.32	Bedroom 1 – oblique cracking to east wall northeast corner above doorway	42
4.2.33	Horizontal cracking between wall and cornice starting from above entrance doorway to southeast corner	43-46
4.2.34	Movement to lower west skirting below window	47
4.2.35	Remediated/recoated crack to west wall above doorway to enclosed veranda	48
4.2.36	Enclosed veranda – remediated crack to east side masonry wall above doorway	49
4.2.37	Movement between doorjamb and lintel	50

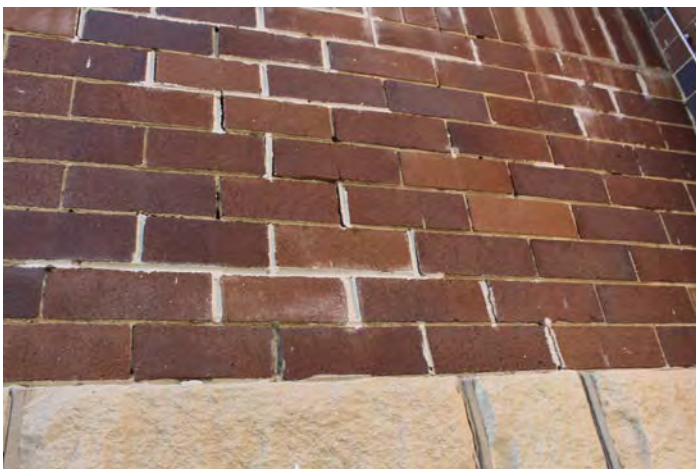
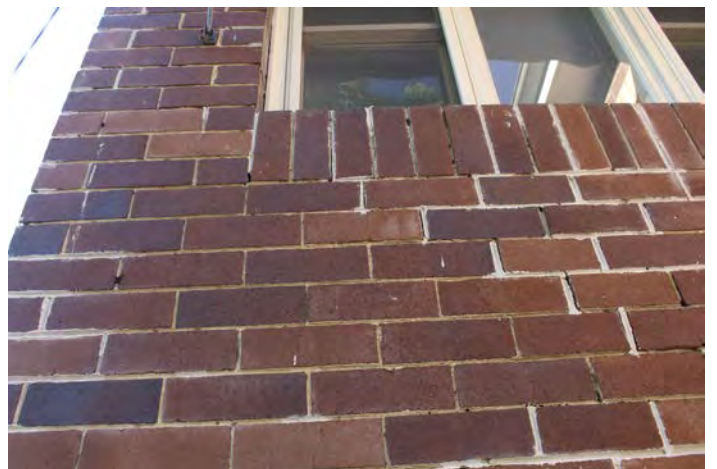
<i>Item</i>	<i>Description</i>	<i>Photo No.</i>
4.3.1	West elevation – cracking starting from ground through stone footings and then obliquely up to lower corner of south facing window	51-54

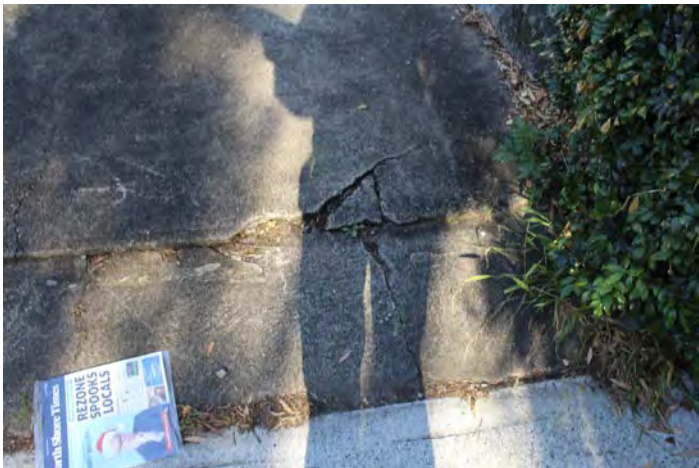
Photo 56.jpg

4.3.2	Hairline crack to top of upper left corner garage door opening	55
4.3.3	Crack to entrance pathway adjacent common path	56
4.3.4	General photographs of driveway showing cracks and overall neglect	57-61

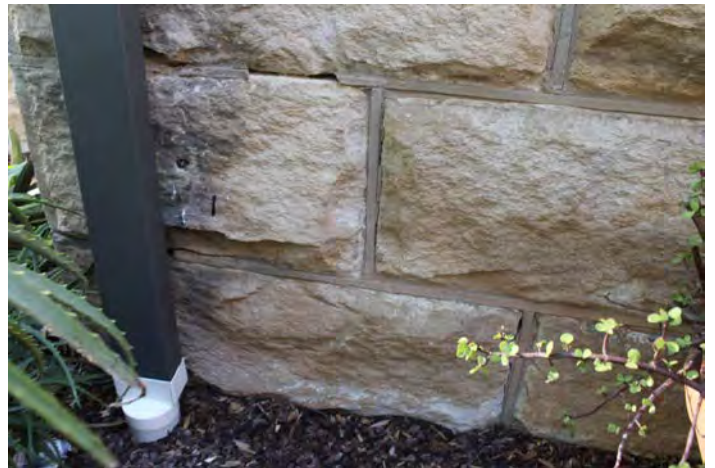
Photo 63.jpg

4.3.5	Cracking to entrance pathway adjacent AC unit	62
4.3.6	Remediated brickwork to southwest corner	63
4.3.7	South elevation - cracking to stone footings adjacent downpipe southwest corner	64

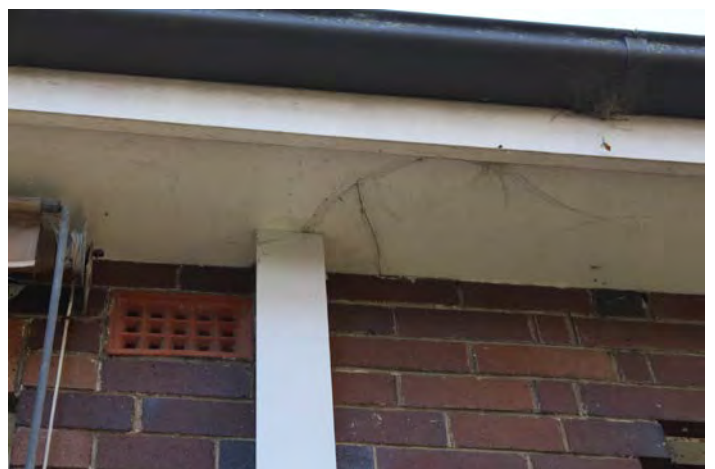
Photo 65.jpg

4.3.8	Cracking to stone footings to west wall below entrance landing	65
4.3.9	Cracking to eave board adjacent AC service penetration	66
4.3.10	Cracking to entrance pathway adjacent gully trap PVC sewage lid	67

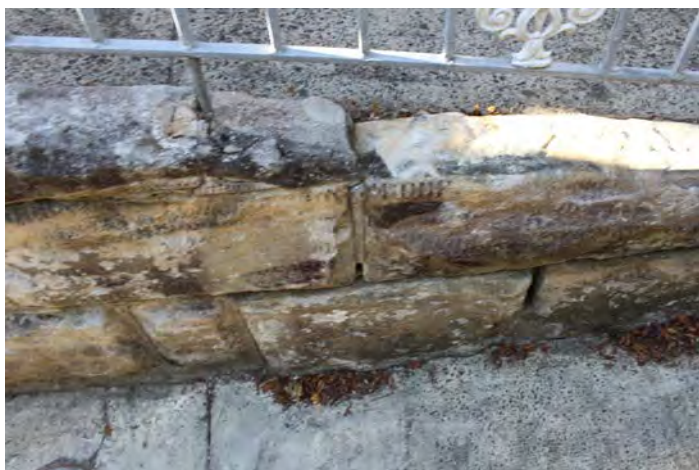
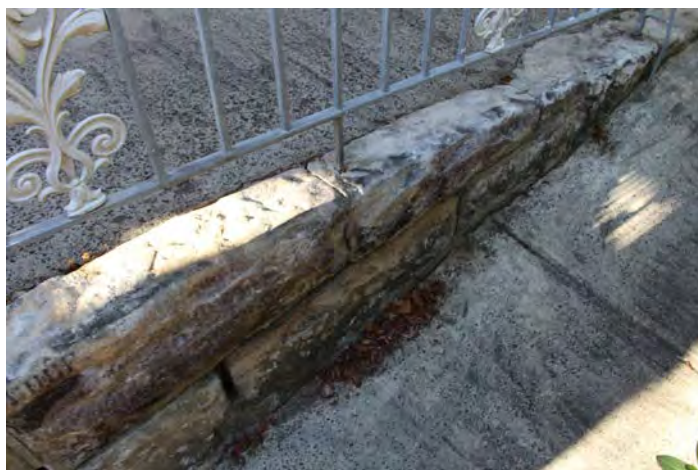
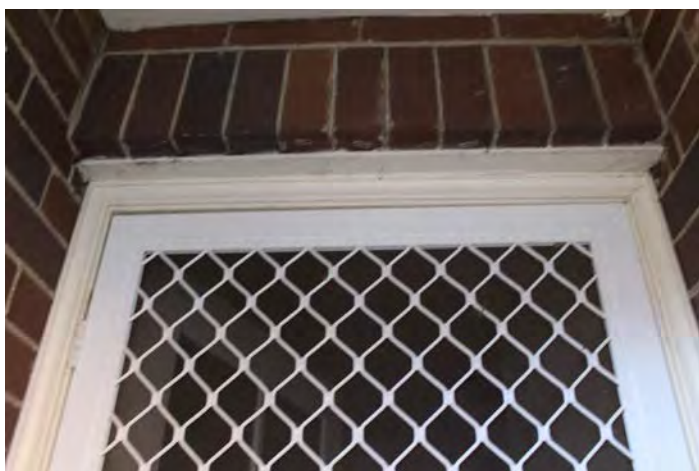
4.3.11	Cracking to footings adjacent ramp	68-70
4.3.12	Movement between lintel and top of entrance door trim	71
4.3.13	Movement between landing balustrade and dwelling wall	72

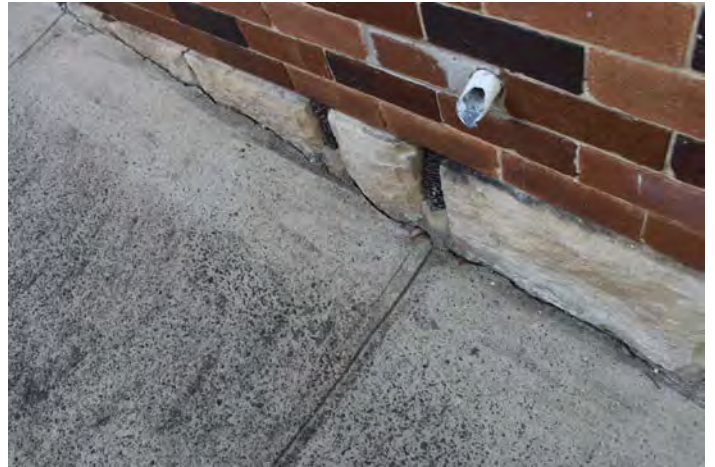
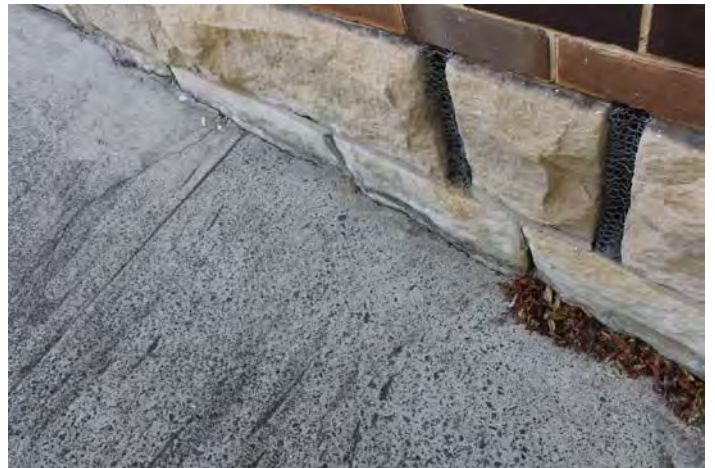
4.3.14	Movement between ramp path and entrance landing	73-76
4.3.15	Crack to ramp path	77
4.3.16	General movement/loose mortar to footings below lounge window	78

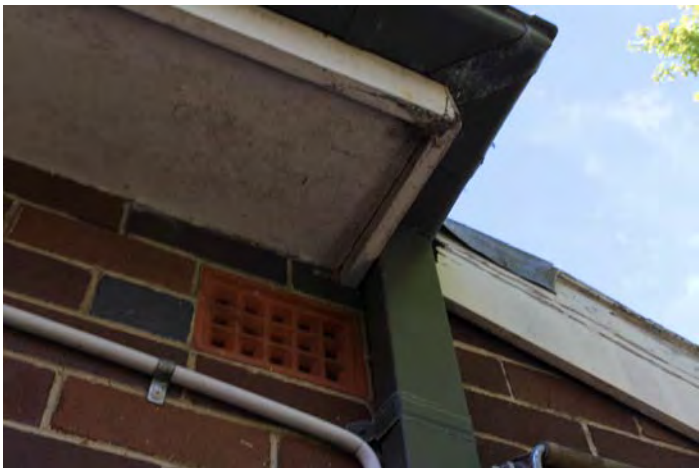
Photo 79.jpg

4.3.17	Cracking to path adjacent sewage gas exhaust stack	79
4.3.18	Movement between eave board and fascia adjacent downpipe above hot water unit	80
4.3.19	East elevation – lean to south side fence	81-86

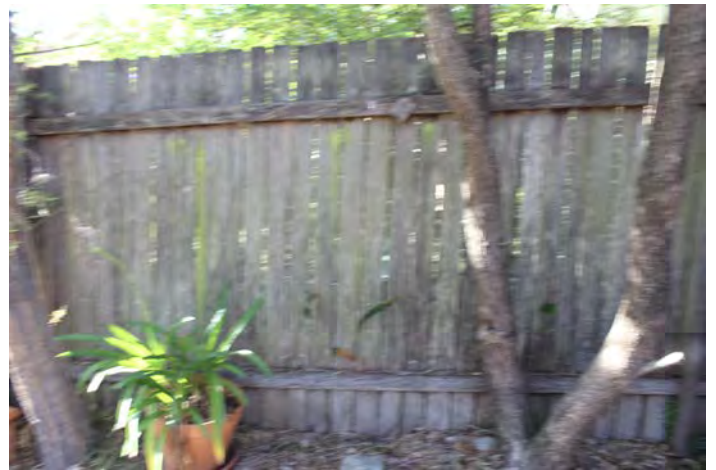
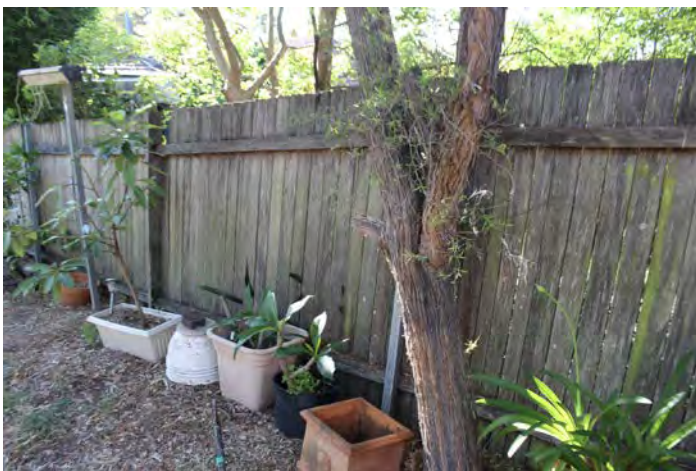
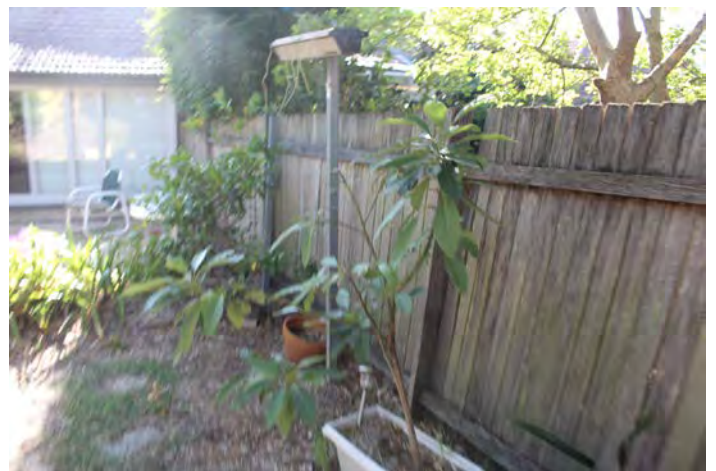
4.3.20	Lean and general neglect to north side fence	87-91
4.3.21	General cracking and neglect to upper rear yard paving	92
4.3.22	Garage – large crack running length of south wall	93-95

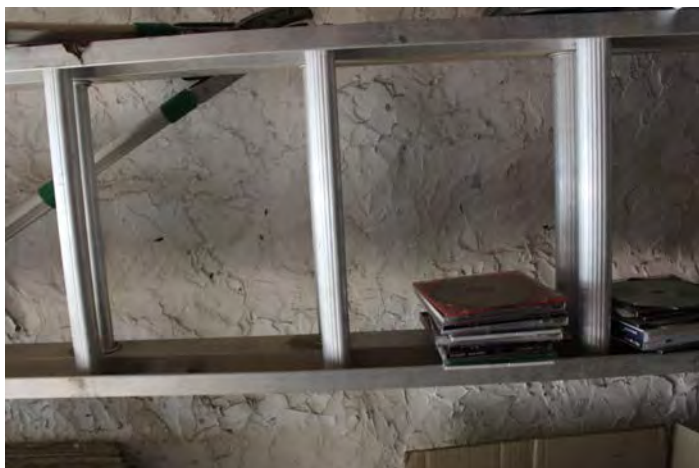
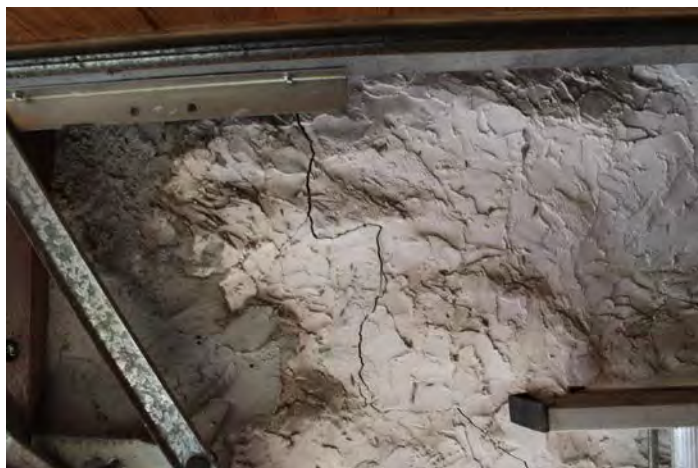
4.3.23	Cracking to north wall approx. 1.2 metres in length	96-97
4.3.24	Cracking to north wall adjacent garage door opening running approx. 2.0 metres	98-99

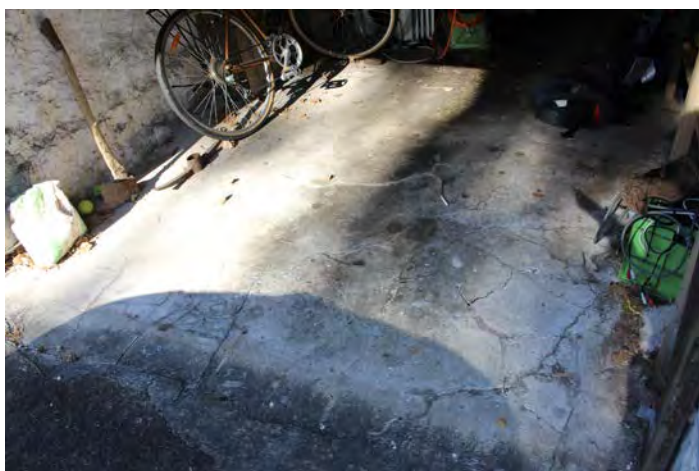
Photo 100.jpg

4.3.25	General photograph of garage showing stored goods preventing full inspection	100
4.3.26	Garage floor showing severe undulations and cracks	101
