## **HAZARDOUS MATERIALS ASSESSMENT REPORT**

**Client:** Cape Cod Australia Pty. Limited

**Job details:** Owner: Mr. H. Malcolm  
Location: 204 Whale Beach Road, Whale Beach

**Our reference:** HM04140715

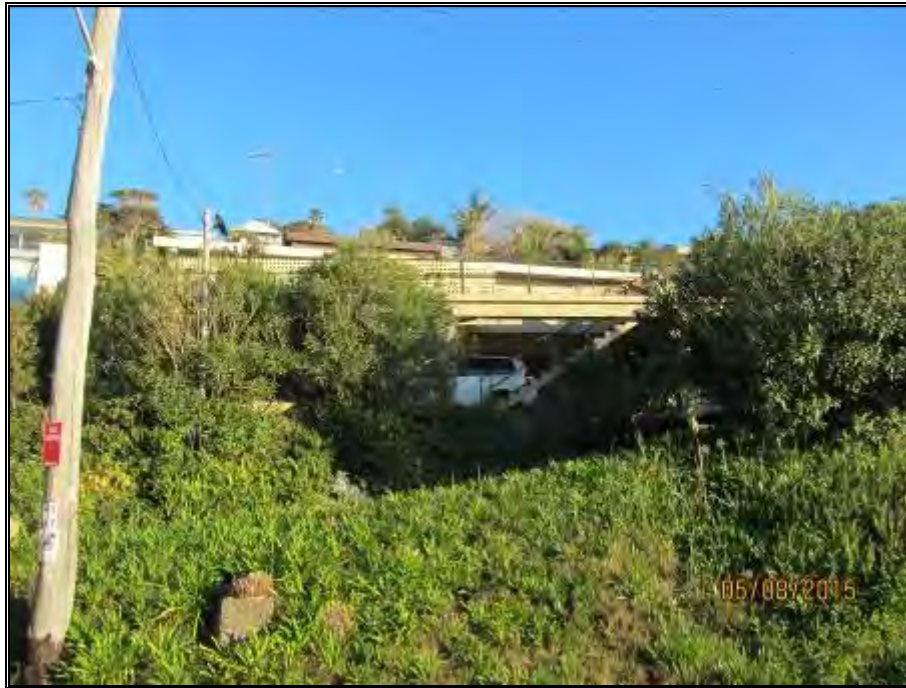
Front eastern elevation of the residence
